NEW ZEALAND SOCIETY FOR EARTHQUAKE ENGINEERING  
**2019 Pacific Conference on  
Earthquake Engineering**  
TURNING HAZARD AWARENESS INTO RISK MITIGATION  
4 – 6 April | SkyCity, Auckland | New Zealand

# Managing risk for workers on slopes following the 2016 Kaikōura Earthquakes

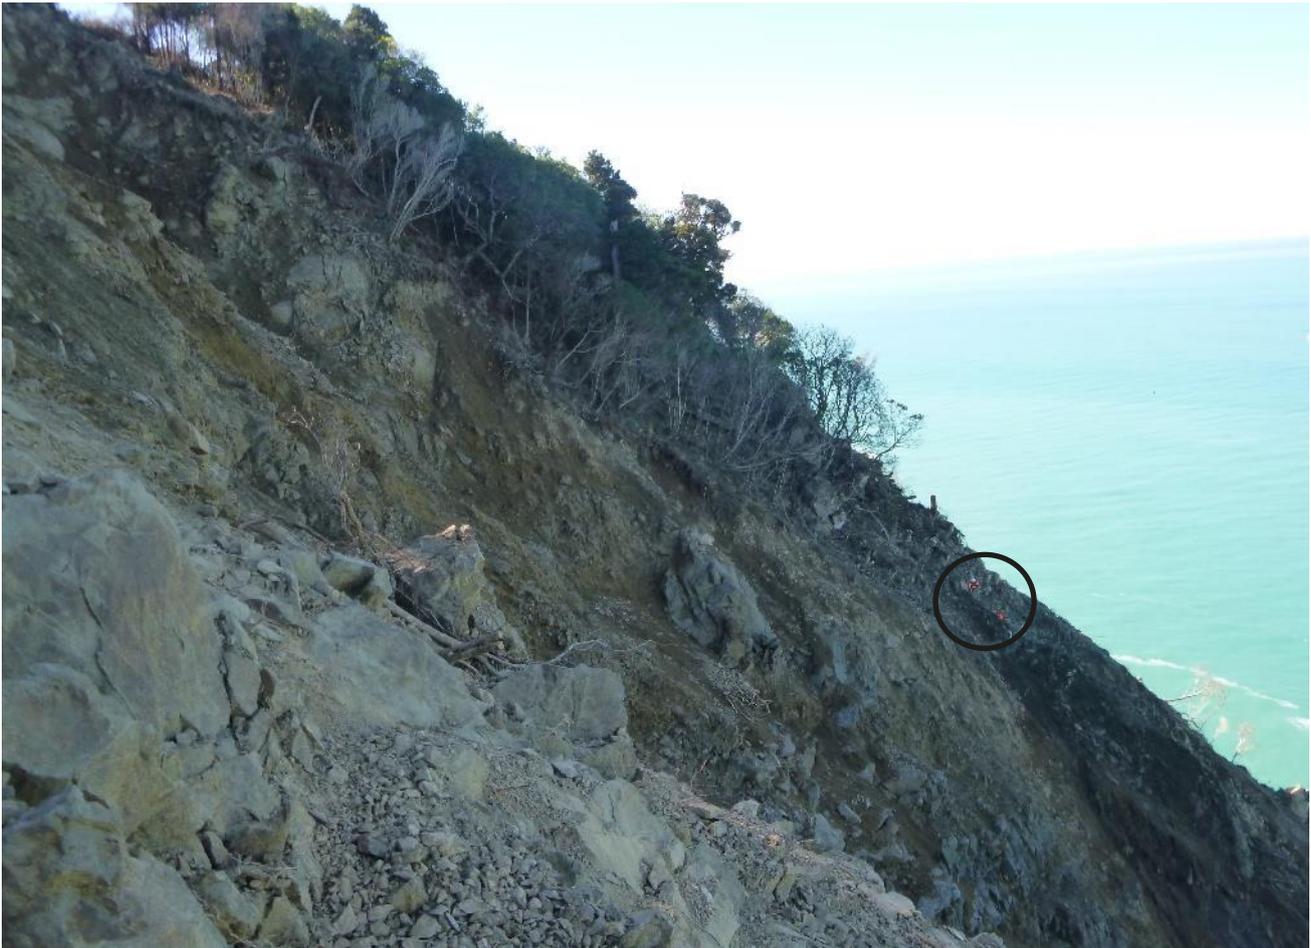
*Figure 1: Rope access technicians (circled) scaling head scarp, Slip 7 north of Ohau Point, Kaikōura, Feb. 2017. Photo: R.Musgrave*

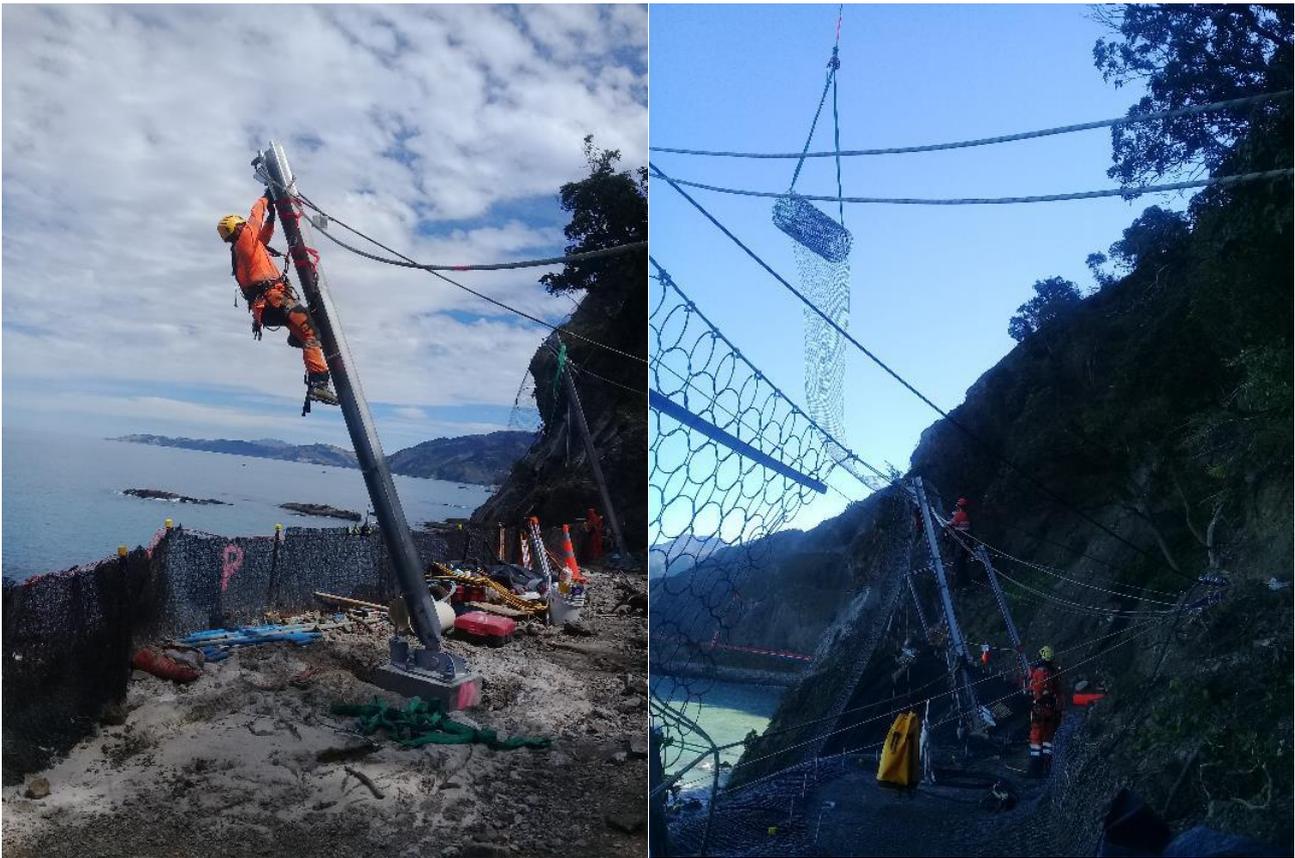
*Figure 2 (left): Construction of shallow landslide barrier, Slip 18 south of Kaikōura, Nov. 2017. Figure 3 (right): Installing mesh by helicopter sling load, a high-risk activity, Slip 18. Heli-operations were often conducted over an open highway during short road closures to minimize disruption to the travelling public. Compression of these types of construction activities in time and space increased the risk for workers.*

On November 30<sup>th</sup> 2016, the Inland Kaikōura Road was provisionally opened to civilian convoys. Work then began on SH1 and the MNL, first south and then north of Kaikōura. Construction workers began to remove debris from the toe of the landslides, in order to gain access for repairs to the road and rail. Initially, rope access technicians provided a support role, reducing risk for other workers, thus enabling important and urgent work below the earthquake-damaged slopes to proceed. Later, the construction of temporary and permanent engineered rock-fall and landslide risk mitigation structures began on the slopes. This specialist activity requires a high degree of skill and experience (Figs. 2-3).

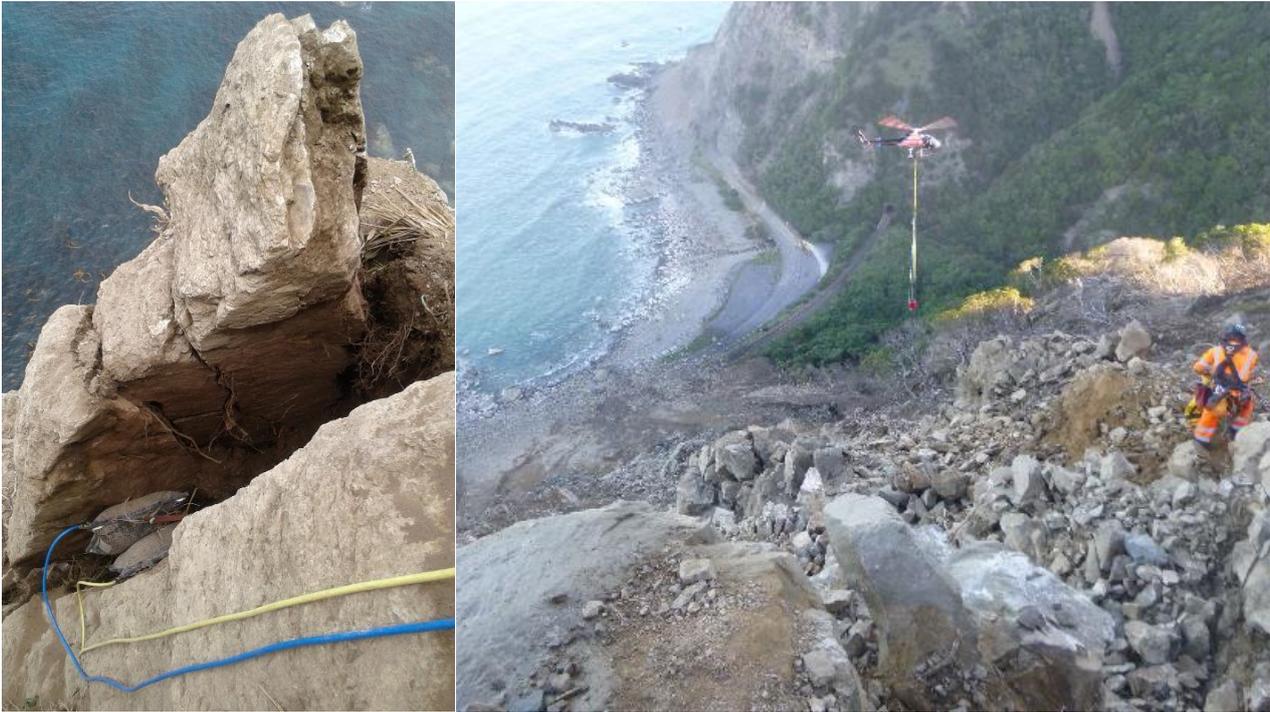
*Figure 4 (left): Air bags used to remove an unstable column of rock while operators retreat to a safer location, Slip 10, south of Kaikōura. Photo R. Musgrave. Figure 5 (right): Sluicing to remove loose debris below abseiler, Slip 7, north of Ohau Point, Kaikōura. Photo R. Musgrave*

Where possible, operators avoided accessing the hazardous lower slopes of the landslides, by substituting alternative methods for removal of hazards (Figs. 4-5).

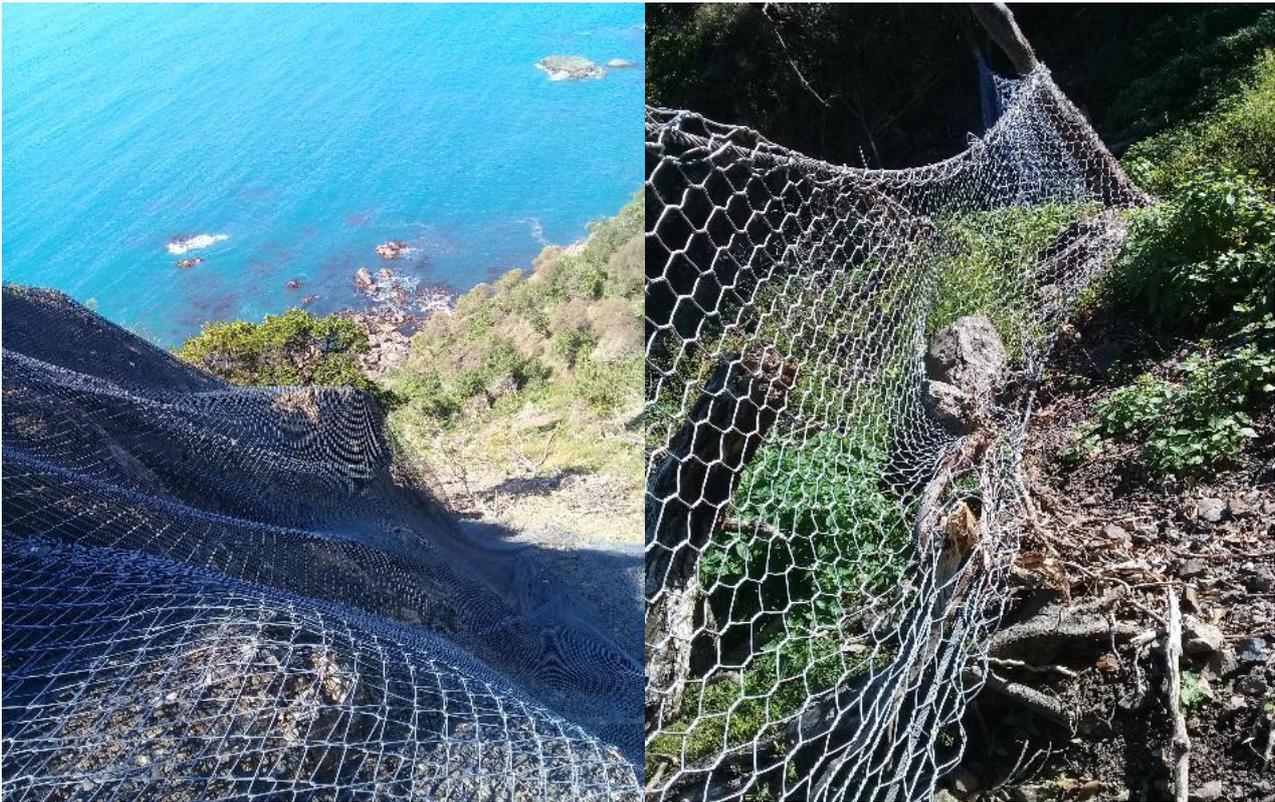
*Figure 6 (left): Example of temporary rockfall mesh installed above an occupied worksite, Slips 18 & 19, south of Kaikōura. This structure contained a ~100 m<sup>3</sup> failure which occurred during rainfall, June 2017. Figure 7 (right): Temporary rockfall catch fence above worksite, Slip 18. This structure was impacted 4 times by rocks ~1m<sup>3</sup> during the course of construction of a shallow landslide barrier directly below. Photos: R. Musgrave.*

To begin the construction of engineered risk-mitigation design structures, it was necessary in some cases to first install temporary structures for the protection of workers required to spend long periods of time below significant rock fall hazard on the lower slopes of landslides (Figs. 6-7).

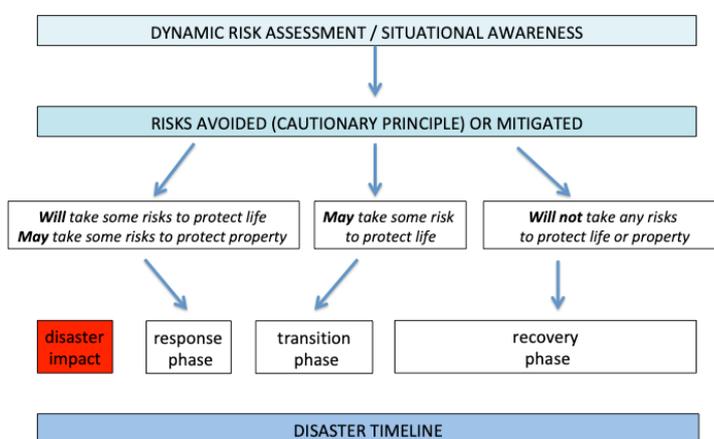
Figure 8: Suggested decision-making approach for operators during different phases of disaster. Practitioners require communication and support from regulators during transition between the phases. Where clear boundaries do not exist, risk levels and accident rates should be trending down. Image adapted from (FEMNZ 2017).

A suggested approach to clarify decision-making at practitioner level is based on the Fire and Emergency NZ (FEMNZ) “safe person” concept where an emergency responder “will, may, or will not” take risks, depending on the context (Fig. 8). The regulatory decision-maker should be able to take a dynamic approach, i.e. be able to give weight to an extreme economic perspective, or an extreme safety perspective, or a perspective on a continuum in between (according to the adopted risk management approach and the context) (Sorskar & Abrahamsen 2017) (Fig. 9).

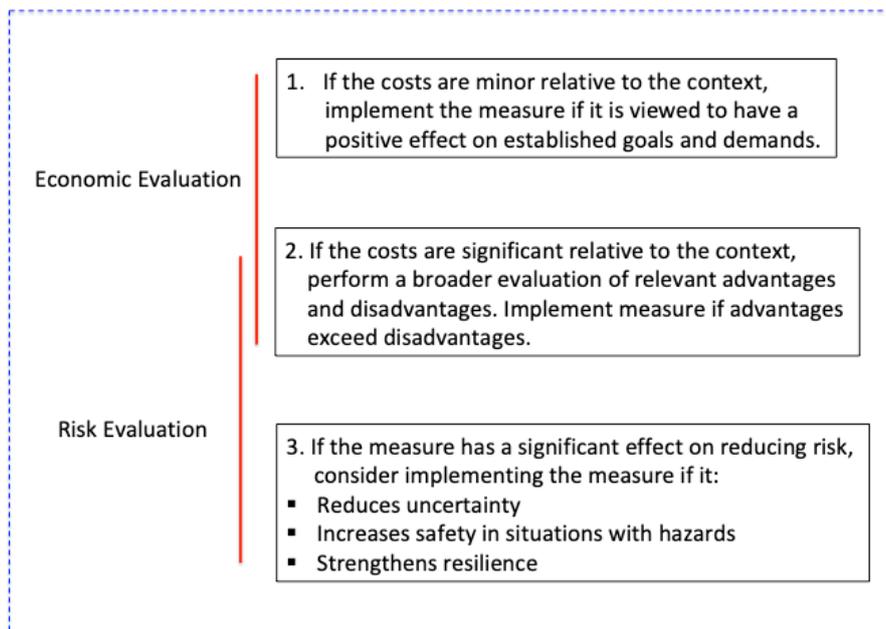
Figure 9: Suggested decision-making approach for regulators and stakeholders during times of uncertainty. A dynamic approach is recommended, giving weight to either an economic or safety perspective, depending on the context, Image adapted from (Sorskar & Abrahamsen 2017).
