NEW ZEALAND SOCIETY FOR EARTHQUAKE ENGINEERING  
**2019 Pacific Conference on  
Earthquake Engineering**  
TURNING HAZARD AWARENESS INTO RISK MITIGATION  
4 – 6 April | SkyCity, Auckland | New Zealand

# Progressive failure of house foundations on slopes in earthquakes

*G. Thomas*

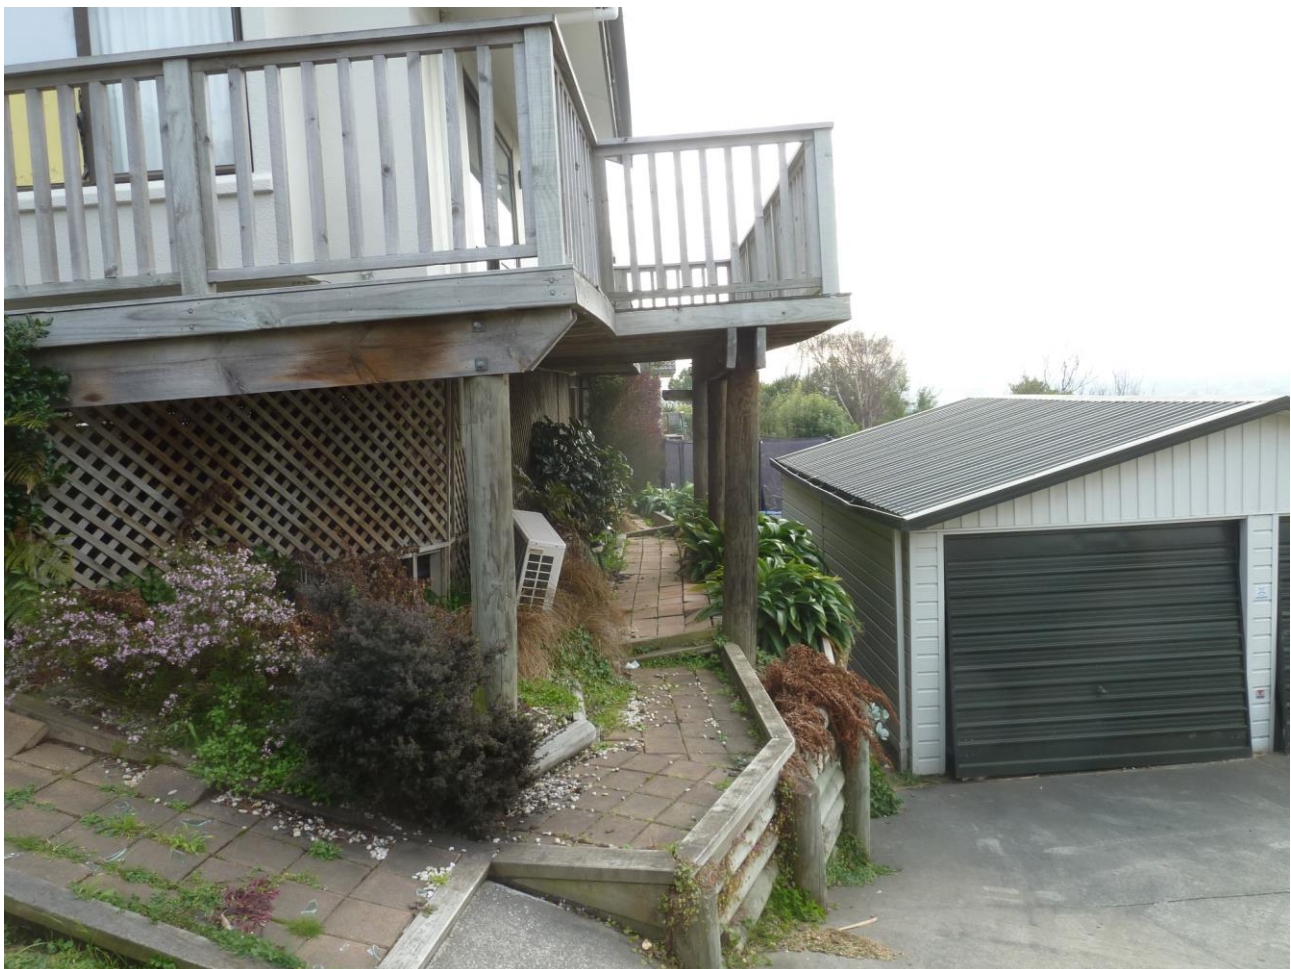
*Figure 1: Tilting pole structure*

Previous studies (Irvine and Thomas 2007, Beattie et al 2017, Thomas & McGowan 2011, Thomas and Shelton 2012 Thomas et al 2013, Brunsdon et al 2014, Horspool et al 2016, Drayton et al 2017,) have indicated that there are significant issues with the structural strength and stability of many existing house foundations and other light timber frame buildings on sloping sites. These structural issues may lead to consequential losses such as fire following earthquakes (Thomas and Irvine, 2007, Thomas 2017). This was confirmed after the Christchurch earthquakes, where the authors observed poor behaviour of some house foundations in the Christchurch hill suburbs when undertaking safety assessments in the declared state of civil emergency. Analysis of the data gathered in the BRANZ random survey of houses following the Christchurch earthquakes (Beattie et al., 2015, Thomas et al 2017) also confirmed that some house foundations on sloping sites demonstrated poor performance. Pile or poles rotate downslope as shown in figure 1, if their embedment length, footing diameter is too small, or the soil is too weak to take the imposed loads.

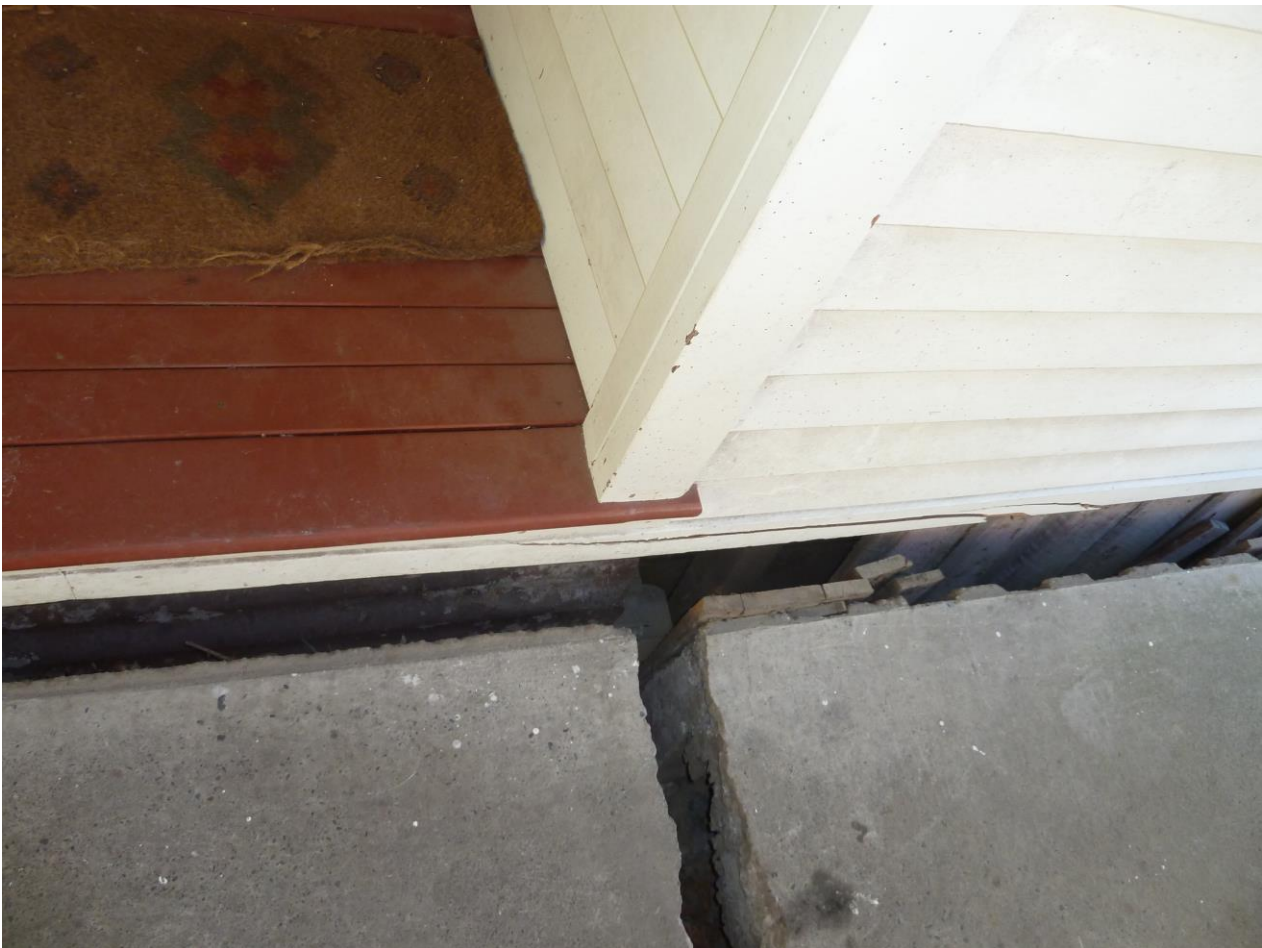
Foundation walls also rotated or slide downslope as shown in figure 2. In both types of foundations, as the foundation oscillates up and down-slope, there is more resistance to uphill motion as the soil is deeper on the uphill side and loose soil is more likely to fall into the gap left behind the foundation as it moves downslope, whereas as it moves upslope the loose surface soil is less likely to fall behind the foundation as it moves as some if it may have fallen downslope away from the foundation, and the soil height is simply less on the downslope side. After many cycles this is expected to result in the foundation rotating and/or sliding downslope as shown in figures one or two. If the rotation is sufficiently large, with the centre of load application outside the footing, then the weight of the structure above will cause the foundation to rotate further resulting in an uncontrollable progressive failure. The magnitude of this affect is highly dependent on the number of load cycles, so will be more parent in a long duration earthquake. This behaviour was observed to some extent in the Christchurch earthquake sequence of 2010-11, but no instance of catastrophic failure are known. Although the Christchurch earthquake of 22 February 2011 caused high levels of shaking, and definitive references for the duration of shaking are hard to find, its duration of shaking was short at about 10s, (Bradley et al 2017). In contrast the Kaikoura Earthquake on 14 November 2016 had a significant duration of about 25 seconds (Bradley et al 2017). This is significantly shorter than the duration of shaking expected from a large subduction zone earthquake (Bradley et al 2017).

*Figure 2: Downslope displacement of footing on uphill side*

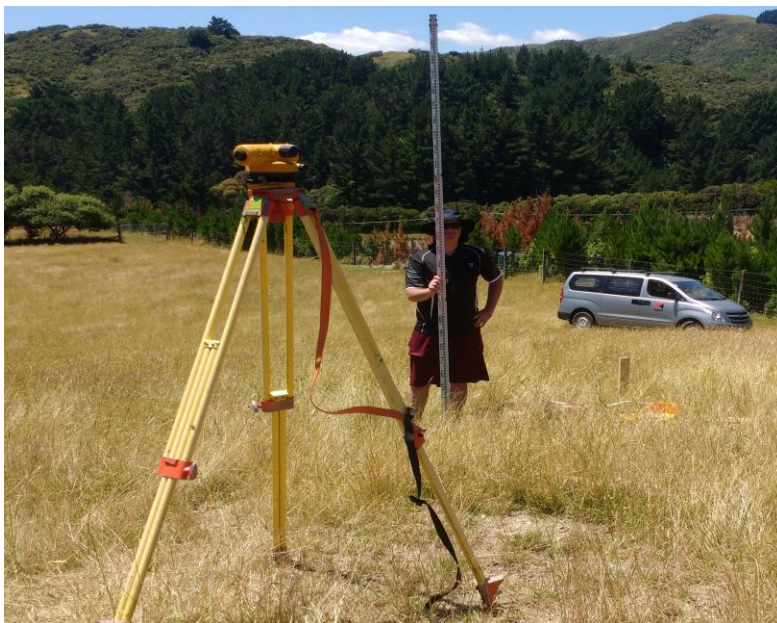
It is proposed to conduct full scale experiments on a series of four light timber framed house foundation types, with each of these installed on a sloping site. The tests will be carried out on a sloping site on a property close to BRANZ off Hayward's Hill Rd, Judgeford, Porirua on which to conduct the experimental work (figure 3 and 4). Scala penetrometer testing and post-hole augers will be undertaken at the site to establish the soil bearing properties and the description of the soil. The soil is expected to be representative of most hillside sites in the Wellington region.

Figure 3: Surveying hillside site and Figure 4. Site Plan
