NEW ZEALAND SOCIETY FOR EARTHQUAKE ENGINEERING  
**2019 Pacific Conference on  
Earthquake Engineering**  
TURNING HAZARD AWARENESS INTO RISK MITIGATION  
4 – 6 April | SkyCity, Auckland | New Zealand

# Structural behavior of a retrofitted reinforced concrete building under near-fault earthquake

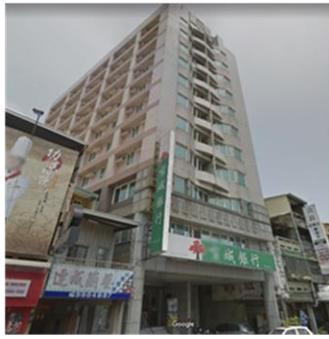
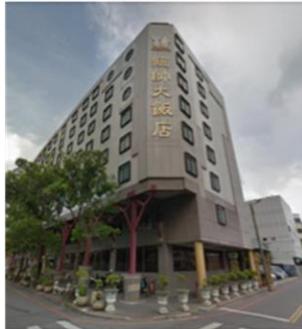
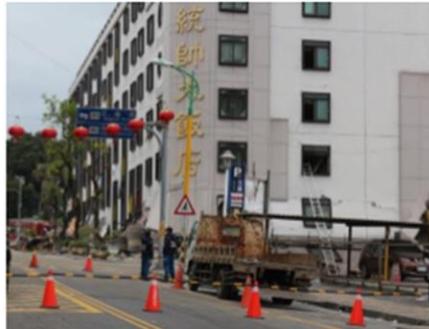
(a) Before earthquake  
(2016)

(b) After earthquake  
(2016)

(c) Before earthquake  
(2018)

(d) After earthquake  
(2018)

*Figure 2: The recent earthquake disaster in Taiwan.*

In addition, the similar situations also were observed in 2016 Meinong and 2018 Hualien earthquake. During the post-earthquake investigation, it found out there are several mid-to high-rise buildings were severely damaged even collapsed. Those collapsed buildings were found out with weak story problem, the story lateral stiffness is quite different from the adjacent story, as shown in Figure 2.
