Dunedin law courts – seismic strengthening and refurbishment

J.F. Finnegan & T. Holden

Aurecon New Zealand Ltd, Wellington

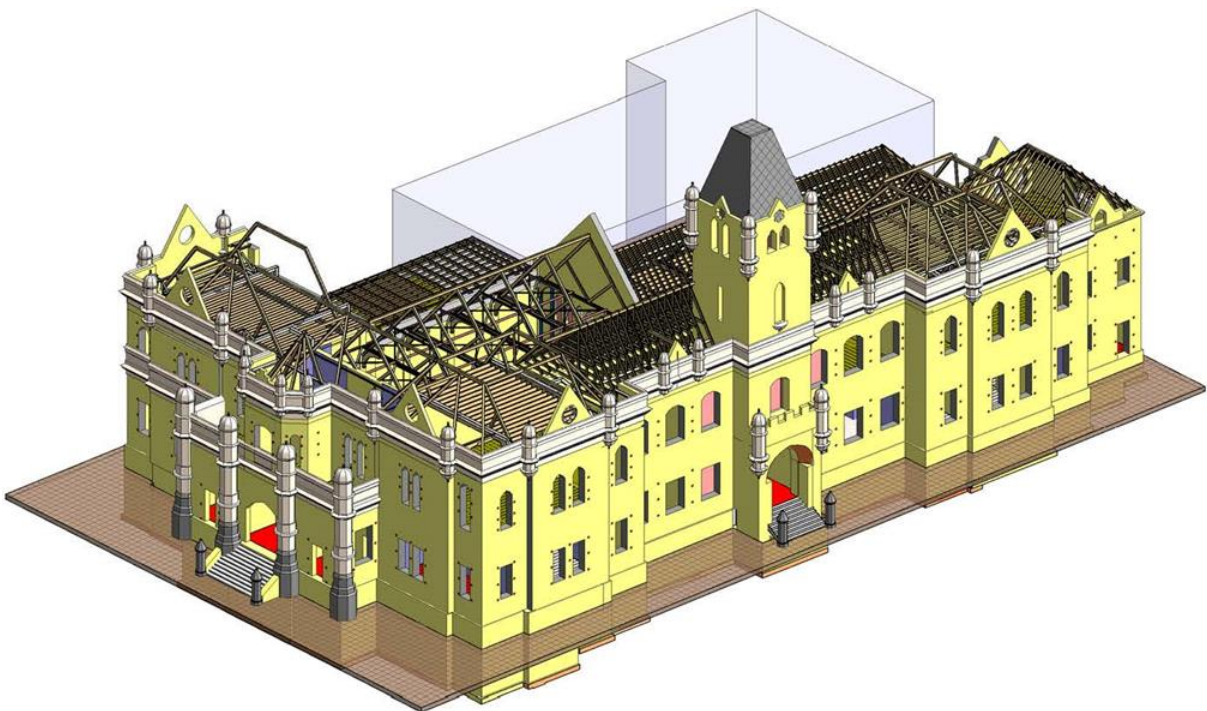
Figure 2: 3D REVIT model showing the general structural form of the Dunedin Law Courts.

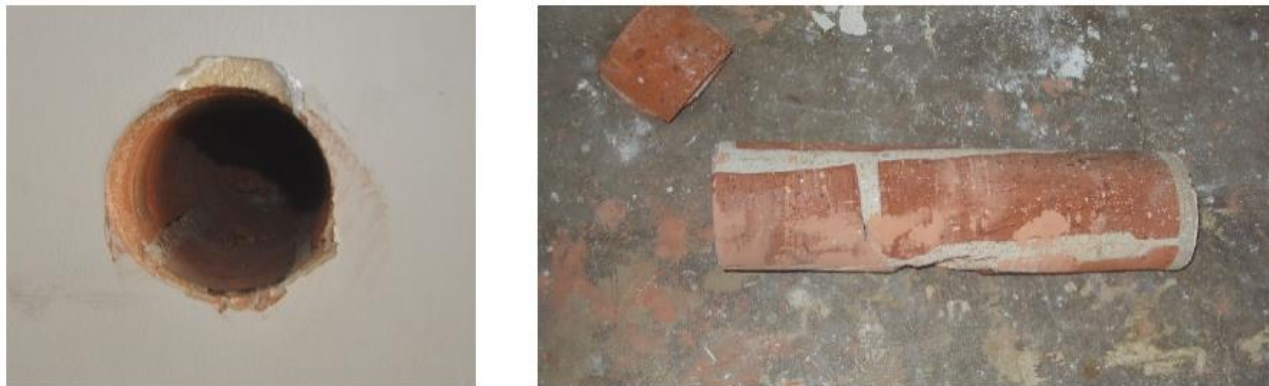
Figure 6: Photos of existing URM interior wall core samples, illustrating their solid construction with no internal cavity.

The in-plane and out-of-plane strength of the unreinforced block walls was calculated based on accurate in-situ material property values obtained by materials testing agency Opus. The strengths and allowable deformations were compared to the demands on the walls to verify which walls require strengthening and how much strengthening was required.

Where required, strengthening of walls in-plane included fibre-reinforced polymer (FRP) layers. The failure mode of the walls (either diagonal tension cracking, toe crushing, bed joint failure, or rocking) determined the performance requirements of the FRP. The exterior wall layers of brick and Breccia were not adequately tied together, and the floors and trusses frame into the interior skin only. New ties were required between the walls to effectively utilise the strength of both layers, particularly for out-of-plane loading. It has been

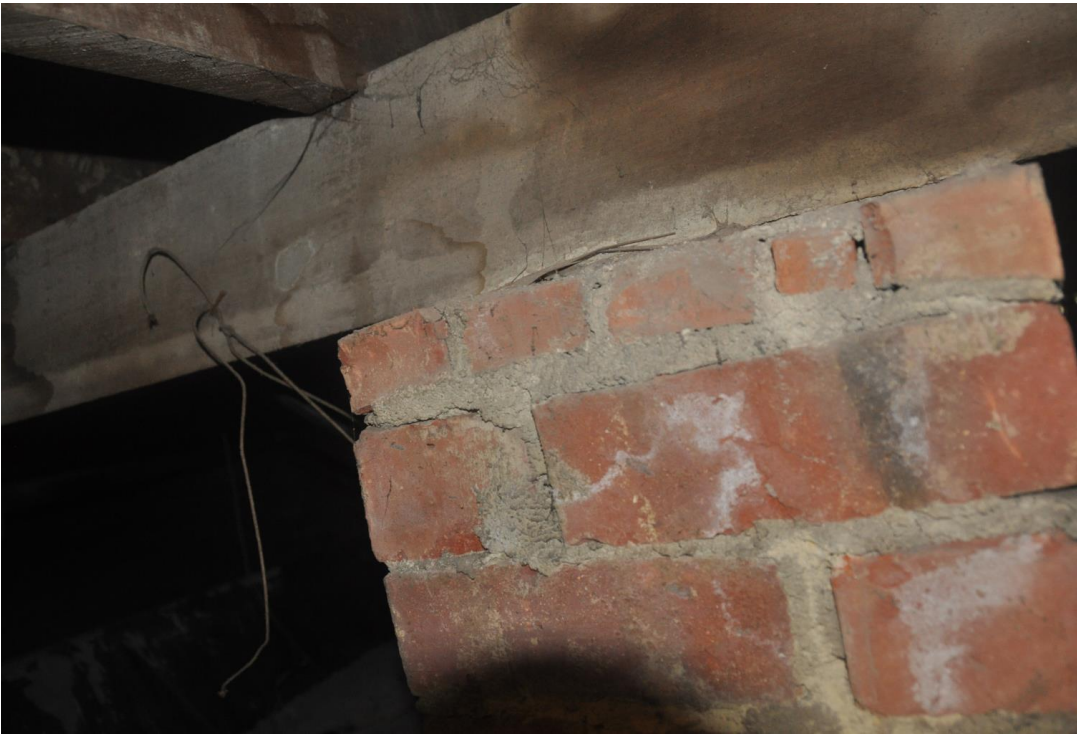
Figure 7: Photo of existing timber bearer on URM supporting pier. No tie or direct fixing is evident.

It is understood that the timber framed ground floor is susceptible to vertical movement and vibrations particularly in the main court rooms. Further investigation revealed several areas where the floor boards and gravity framing were not connected due to settlement and warping. The floor system was made true and level, and the subfloor was adequately connected to the framing, which resulted in a stiffer floor system, not suffering from vibration and creaking. It is also noted that the timber bearers at the ground floor were not tied to the isolated URM piers. The introduction of a plywood diaphragm helps restrain the bearers against the risk of losing their seating.

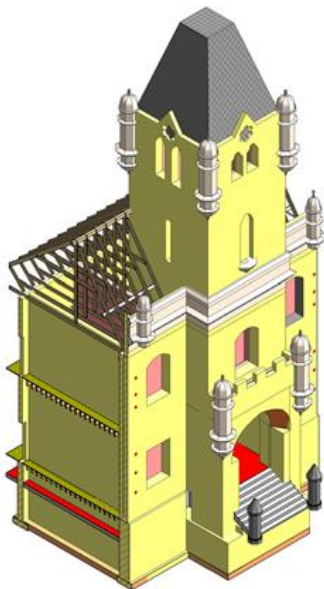
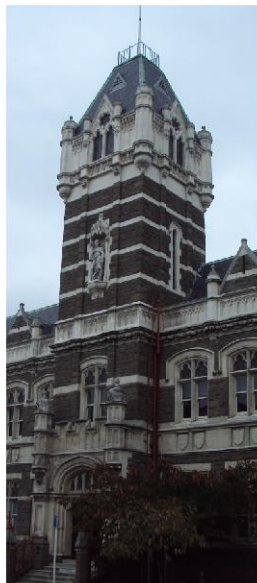
Figure 8: Photo and 3D REVIT illustration of tower structure

The tower at the northern end of the building has been assessed as being a high-risk element and prone to collapse in a seismic event. The tower had previously been strengthened using structural steel bracing members epoxy bolted to the inside walls. This bracing was considered to be inadequate for the seismic demands required to be resisted as part of the proposed strengthen works, and was removed, and the tower walls were strengthened with reinforced concrete to 100 per cent seismic loads. The new walls were both internal and external to the masonry walls, constructed both as shotcrete and as poured concrete. A large reinforced concrete raft slab was introduced to carry overturning and bending loads at the foundation level.

Geotechnical investigation determined that the soil bearing pressure caused by overturning of the tower will cause excessive vertical settlement, which in turn will cause unallowable separation of the gravity structure from the tower wall. Ground improvements below the tower were proposed by GeoSolve and were designed and specified by GeoSolve. The proposed scheme involved unreinforced jet piles, extending to a layer of soil with good bearing qualities, increasing the available bearing capacity under the tower.
