NEW ZEALAND SOCIETY FOR EARTHQUAKE ENGINEERING
**2019 Pacific Conference on
Earthquake Engineering**
TURNING HAZARD AWARENESS INTO RISK MITIGATION
4 – 6 April | SkyCity, Auckland | New Zealand

The University of Auckland Clock Tower East Wing: turning a heritage building into a modern teaching space

The Clock Tower East Wing is an iconic building for the University of Auckland of historical significance. It was originally constructed between 1923 and 1926 and is listed by Heritage New Zealand as a Historic Place Category 1.

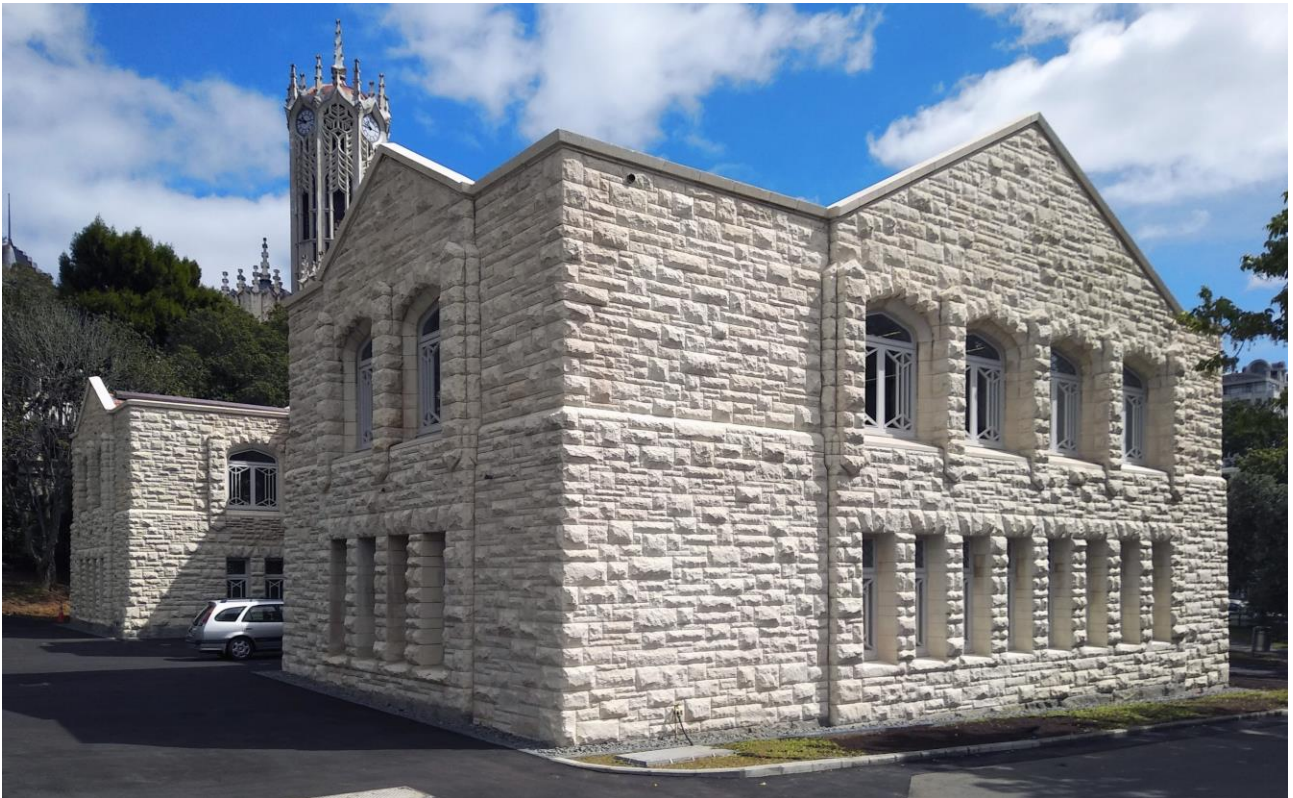
Figure 2: View of the East Wing building from South

The East Wing building (Fig. 2) is two storeys, has an approximate footprint of 535m² and longitudinal and transverse building lengths measuring 35.0m and 19.5m, respectively.

The structure comprises a timber-framed/trussed roof and a reinforced concrete first floor with hollow masonry units to form ribs in the profile of the slab that spans between the main concrete beams. The perimeter walls are reinforced concrete, clad in heavy limestone masonry, and are the primary lateral load resisting system for translational and torsional stability. The building is supported on shallow strip footings and pad thickenings under the main walls.

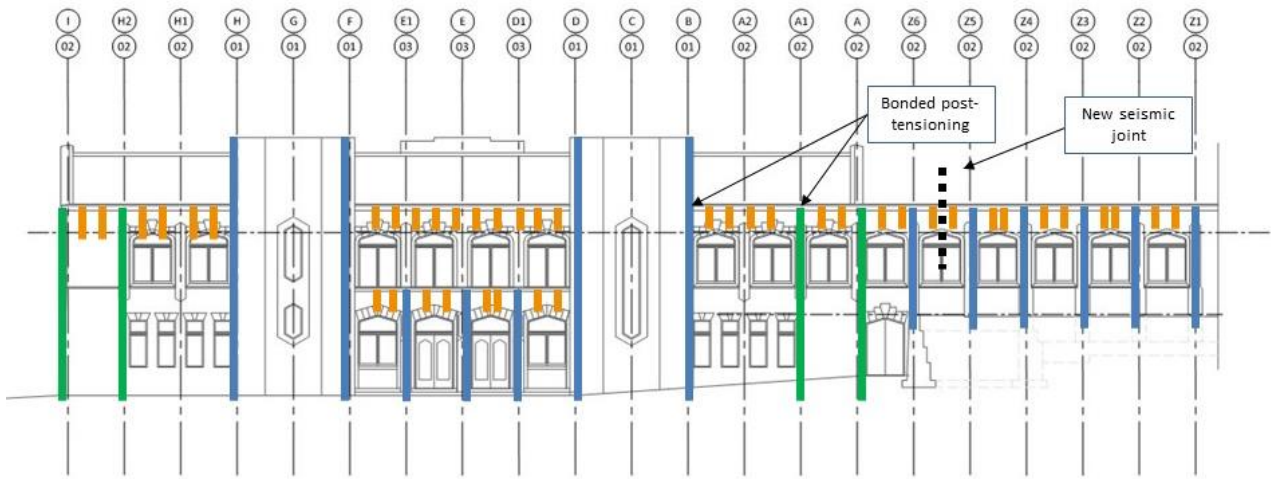
Figure 6: Strengthening with post-tensioned bars on the Southwest elevation

The objective of the strengthening with the post-tensioned bars (Fig. 6) was to increase the in-plane capacity of the existing reinforced concrete shear walls and cloister stone piers (Marteddu et al., 2018).

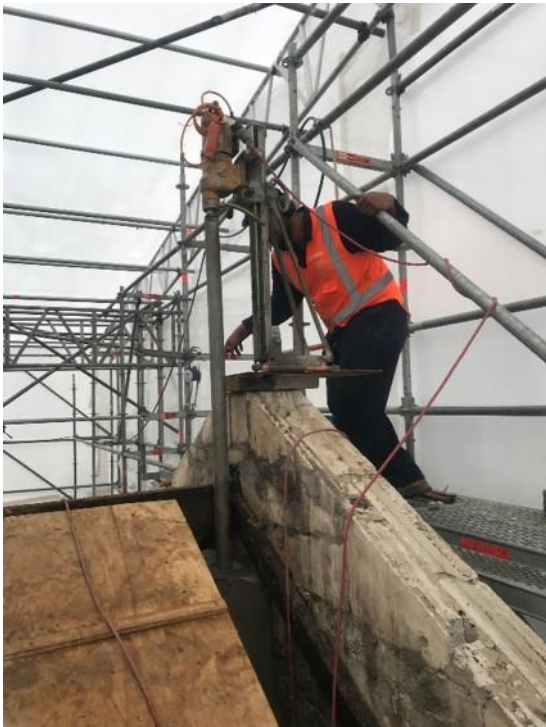
Figures 7 and 8: Rig set up for vertical drilling (left) and spiral reinforcing steel (right)

This was achieved through the core drilling of vertical holes down through the existing walls from the top of the parapet to the underside of the existing foundations, up to 12m deep (Fig. 7). The tight tolerance required on the verticality of the holes was achieved by using a longer than usual drilling mast and by securely anchoring this mast to the existing structure prior to commencing drilling. Drilling was carried out using a wet coring process due to restrictions on noise levels during University operating hours.

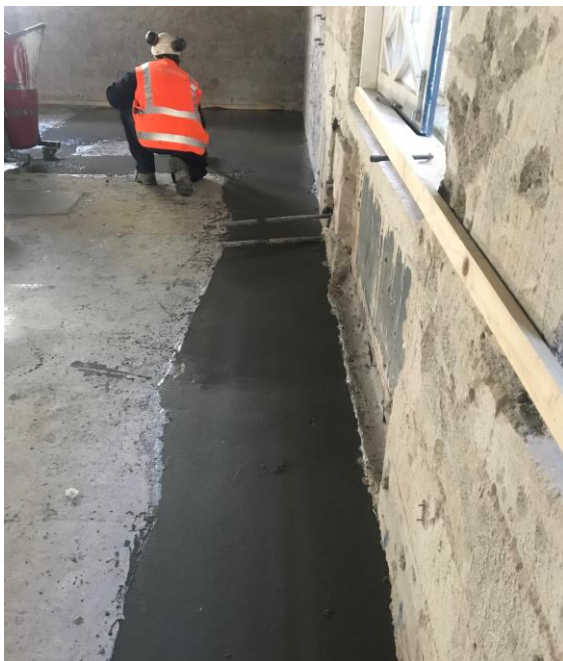
Figures 9 and 10: Substrate repair (left) and FRP on-site installation (right)

The strength of the existing substrate is an important factor in bond-critical applications of FRP systems (American Concrete Institute, 2008). Careful surface preparation is required to ensure that an adequate adhesive bond between the FRP system and the existing concrete floor is achieved. Prior to construction work, an extensive survey of the first-floor slab was carried out to map existing loose, spalled and cracked concrete, and the substrate was repaired (Fig. 9) to meet the system requirements (American Concrete Institute, 2008). As a result, approximately 8m³ of Sikafloor Level-30, a high performance cementitious, self-levelling and fast drying screed mixed with Sika Pea Metal aggregate was used to reinstate the topping slab to a thickness of 15 to 60mm.

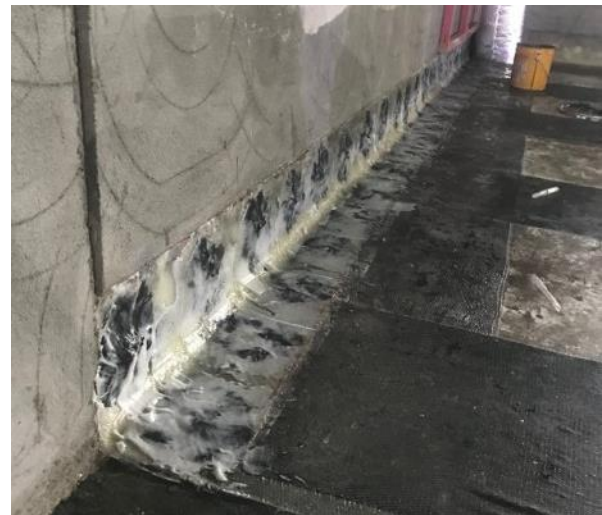
Figures 11 and 12: Perimeter skirting detail (left) FRP on-site installation to a fillet radius (right)

The connection of the floor to the perimeter walls was also strengthened using FRP strips. This was carried out using FRP curved to a fillet radius of 65-75mm at re-entrant corners around the slab/wall interface (Figures 11 and 12). This prevented stress concentrations and voids between the FRP system and the concrete. Unidirectional glass fibre fabric was installed using 230m² of SikaWrap Hex-100G strips and

900No. SikaWrap FX-50 C carbon fibre ropes anchored into the wall to enhance the floor to wall connection and ensure adequate shear transfer.
