# Bending stiffness and strength performance of different column splice connections

*F. Tork-Ladani, J.G. Chase & G.A. Macrae*

University of Canterbury, New Zealand.

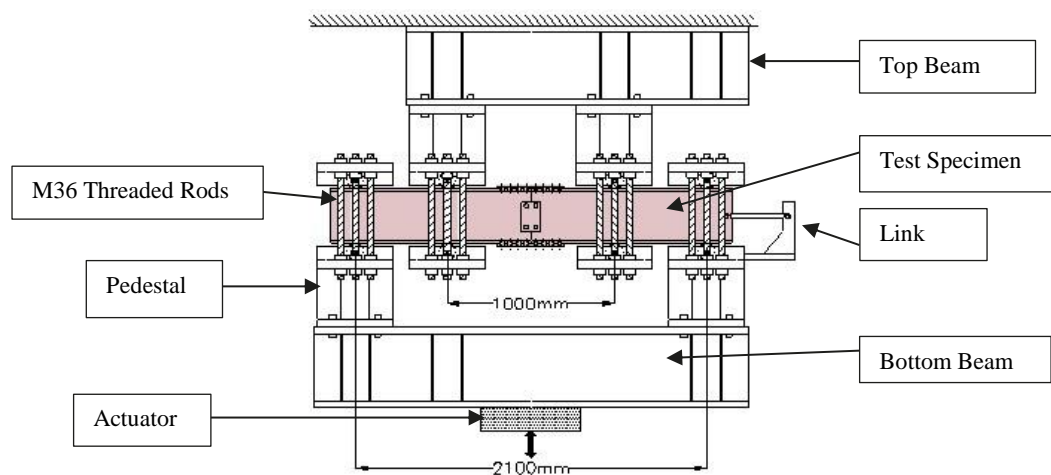
Figure 1: Test setup components

Figure 1 shows the moment test setup using the Dartec 10MN universal testing machine. Four columns, not shown in the figure, support the rigid roof of the Dartec, which can be adjusted at any height. A hydraulic actuator at the bottom of the machine applies vertical forces.

The top and bottom setup beams are attached to the Dartec by four 51mm bolts of high strength steel, AISI 4140. While the bottom beam can move up and down with the actuator, the top beam is fixed to the Dartec

roof and is stationary. Special connections were designed to facilitate the cyclic loading. The connections accommodate two rollers each side of the specimens at the loading and supporting points. The rollers are pinned to two plates with slotted holes. This design restrains the ends of the rollers from vertical movements, while providing freedom for the test specimen to move horizontally.

Three M36 Grade 10.9 threaded rods are located at each side of the specimen to clip the rollers to the specimen. The threaded rods are tightened sufficiently to keep the rollers on the specimen, avoiding pre-tensioning of threaded rods and restraining horizontal movement of the specimen. The connections are fixed to the top and bottom beams with rigid pedestals. Eight M24 high strength bolts connect the blocks to the setup beams.

When the actuator moves up, the end bottom rollers push up the specimen ends and the middle top rollers, apply downwards force on the specimen. When the actuator moves down, the forces are applied in the opposite direction through the opposite rollers. In this state, the threaded rods are engaged to transfer the forces. This setup provides constant moment between the loading points without a significant shear force. Although the right end rollers were restrained from rolling, it was observed the specimen could slip under heavy loads. Therefore, a link was provisioned to stop the slippage while allowing the end to rotate.

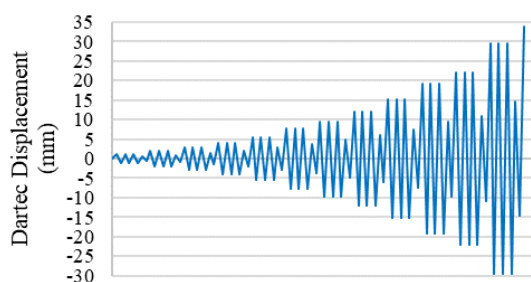
Figure 2: Loading regime applied to Dartec actuator

The loading in this study was controlled by the displacement of the actuator. This displacement is different from the displacement at the centre of the specimens. Since the bolts attaching the setup to the Dartec could not be post-tensioned due to the large diameter, the joints experienced some slack when the actuator is in tension. Therefore, the specimens themselves were subjected to smaller displacements in the direction corresponding to actuator tension. The loading regime slowly applied to the actuator in the experiments is shown in Figure 2. The range of motions was chosen to ensure yielding and failure in a well-incremented set of steps. No axial load was applied to the specimens during the moment tests.

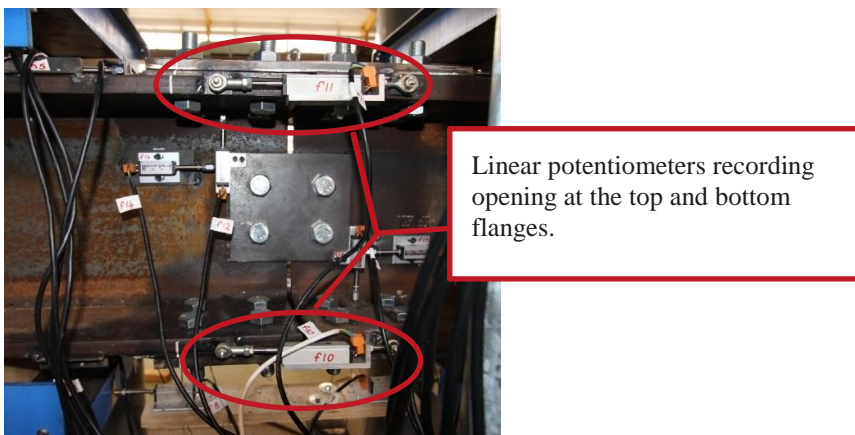
*Figure 3: Linear potentiometer measuring gap between the two sections*

Two linear potentiometers were attached horizontally to the top and bottom flanges to measure the gap between the spliced members as shown in Figure 3. The data provides the rotation at the splice joint at each load step. Other instrumentation devices seen in the photo are not the subject of this study.

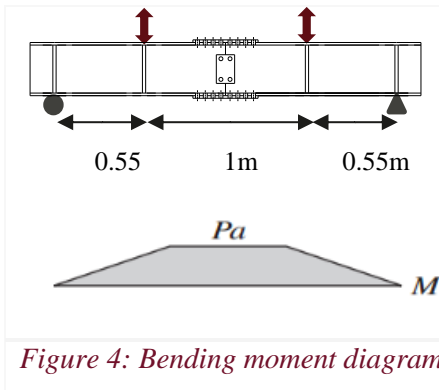
Figure 4: Bending moment diagram

Figure 4 shows the bending moment diagram resulting from the applied loads. The moment and rotation at the connection were calculated as shown in Figure 5. These calculations translate measurements into resulting loads and actions.

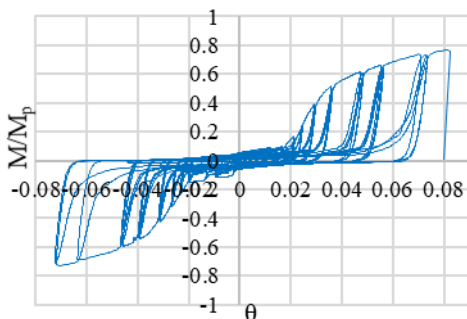
Figure 6: Hysteresis loop: moment ratio ( $M/M_p$ ) vs rotation  $\theta$

The hysteresis behaviour of the connection is shown in Figure 6. The connection developed ~76% of the nominal plastic moment capacity of the smaller section associated with ~8% rotation at the joint.

The expected slip at the connection mainly occurs on the tension side. If the bolts are centered in the 2mm oversized holes, the rotation anticipated before bolt bearing occurs is approximately  $4\text{mm}/327\text{mm} = 0.012$  or 1.2%, as there are two holes either side of the splice and 2mm oversized yielding 4mm motion. Figure 6 shows the actual rotation before load increased significantly was about 2%. After dismantling the specimen, the bolt threads were observed to have penetrated into the plates, as seen in Figure 7. The minor diameter of M20 bolts is approximately 3mm smaller than the nominal diameter. Therefore, the threads are 1.5mm high, and the rotation anticipated after bolt bearing occurs is approximately  $7\text{mm}/327\text{mm} = 0.021$  or 2.1%, which better matches the 2% value seen in the hysteresis loop of Figure 6.

The loops corresponding to the second and third cycles after the slippage show slackness and gapping due to hole elongation. The maximum elongation in the splice plates and the shear deformation in the bolts were approximately 4mm and 5mm, respectively. These values allows a  $2 \times 9\text{mm}/327\text{mm} = 0.055$  rotation after slippage. This latter result is consistent with the post-slippage displacement of about 6% seen in Figure 6.

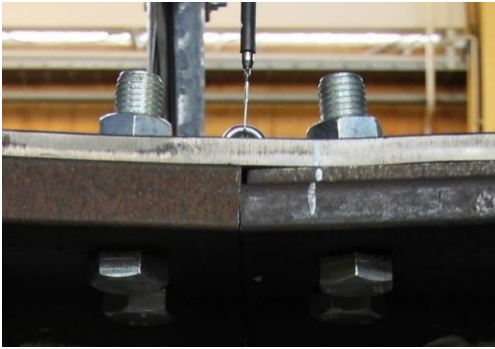
compression side puts tension on the bolts, this tension did not seem to adversely affect the splice flexural strength. Figure 8 illustrates bending of splice plates on the compression side.

*Figure 8: Bending in splice plate on compression side*      *Figure 9: Gap between connection plates*

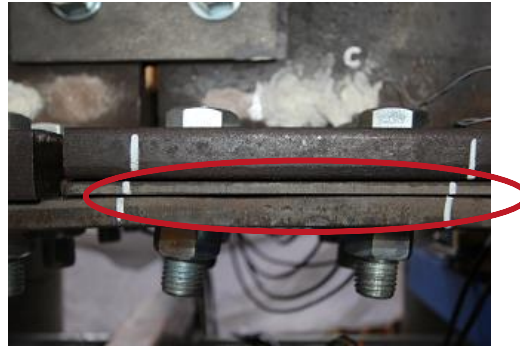
Figure 9 shows the separation of the splice plate and the filler plate close to connection's failure. The damage could be attributed to prying actions and piled up material at the bearing area of the bolts. Figure 10 shows damage in the flange splice plate. It is seen that all the holes yielded in bearing and the plate yielded along the inner row of the bolt holes. The resulting deformation allowed the inner bolts to tilt more. It is also clear that the hole ovalization is larger for the inner rows compared to the edge rows. Figure 11 shows the damage in the web holes. Although it is assumed web splices do not participate in transferring bending moment, they could damage in large rotations, which could potentially affect their shear performance.

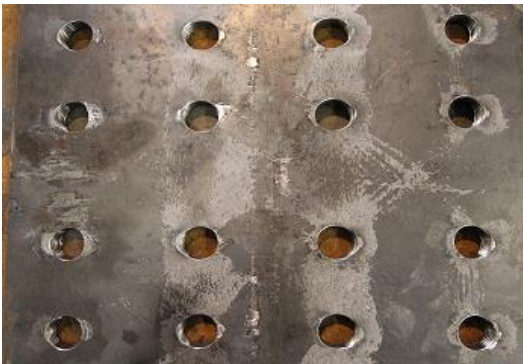
*Figure 10: Damage in flange splice plate*      *Figure 11: Elongation of holes in web*

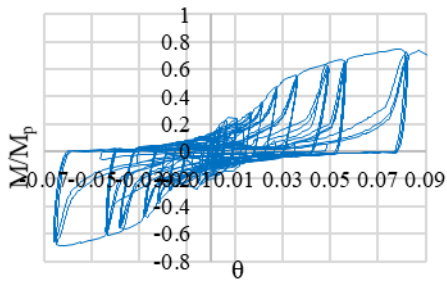
Figure 12: Hysteresis loop: moment ratio ( $M/M_p$ ) vs rotation  $\theta$

This test was conducted to study the effect of eliminating the web splices in Specimen #1 on flexural performance of the connection. Figure 12 shows the hysteresis behaviour of the connection. The ultimate strength is approximately  $0.73M_p$ , which is slightly less than that of Specimen #1. The small variation could be because of the small lever arm for the web splice bolts, small ratio of the number of bolts in the web to flanges and thin web and web splice plates in Specimen #1, which led to elongation of the holes. Specimen #2 is also more flexible at larger rotations than Specimen #1, which is likely to be as a result of the absence of web splice.

The bolts in Specimen #2 were tightened to obtain 145kN tension. Initially, the friction force in this case is about  $0.2M_p$ , which is very close to the estimated value.

The slip force is greater than that of Specimen #1 due to different surface preparations and higher tension in the bolts. However, the slip force dropped to less than  $0.1M_p$  in the larger displacement cycles. The connection rotational capacity is 0.084, which is 5% more than that of Specimen #1.

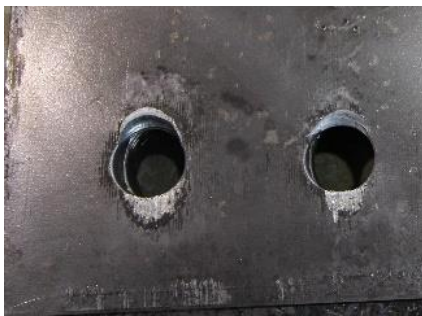
Figure 14: Abrasion and splitting of hole edges in filler plates

The failure mode was similar to that of Specimen #1. Figure 14 shows abrasion and splitting of the hole edge, which was also observed in Specimen #1. Figure 15 shows the gap at the spliced joint during the experiment at zero load as observed in Specimen #1. Figure 16 shows deformation in one of the bolts at failure. It can be seen the upper portion of the bolt has tilted. Similar deformation of bolts were observed in Specimen #1.

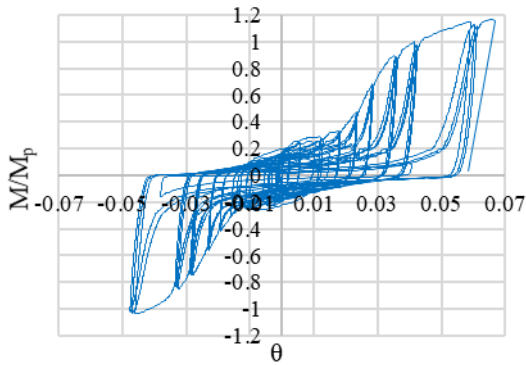
Figure 17: Hysteresis loop: moment ratio ( $M/M_p$ ) vs rotation  $\theta$

Specimen #3 was designed for higher strength than Specimen #1, to compare the overall performance of splices designed for different strengths. Figure 17 shows the hysteresis behaviour of the connection. The connection ultimate strength capacity is greater than  $M_p$  even though holes were present in the flanges. This overstrength could be attributed to strain hardening in the flanges and the contribution of the splice plates. The connection exhibits larger stiffness compared to Specimen #1. Initially, the friction force in this case is about  $0.22-0.28M_p$ , which is smaller than the estimated value.

The connection has smaller rotational capacity compared to the other two specimens possibly because the thicker (20mm) flange splice plate was stronger and had less bolt hole deformation under the forces imposed by the bolts. In addition, the bending stiffness of the flange plates are larger than for Specimen #1.

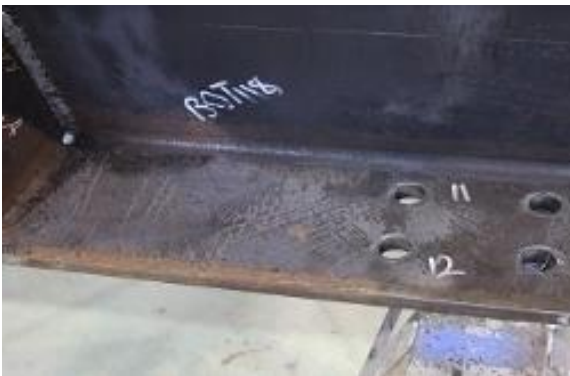
Figure 19: Damage in flange in smaller member

Figures 19 and 20 show damage in the smaller member. The column flanges and web are damaged more than in Specimen #1. The smaller member yielded adjacent to the splice joint. This behaviour could indicate that the splice joint was not the weakest bending point in the member. No significant elongation was observed at the holes in the flange splice plate. The failure mode was similar to that of Specimen #1.

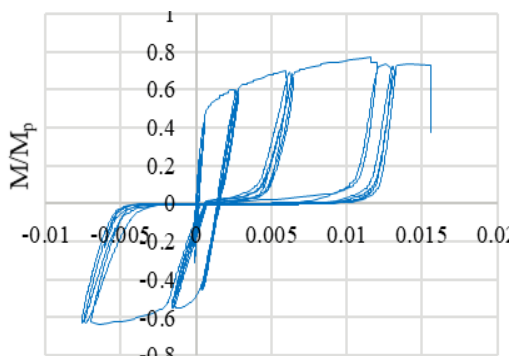
Figure 21: Hysteresis loop: moment ratio ( $M/M_p$ ) vs rotation  $\theta$

This test was conducted to study the difference in the flexural performance of lap bolted splice connections relative to end plate splice connections. The cyclic performance of the connection is shown in Figure 21. The rotational capacity of the specimen is considerably smaller than the lap splice connections. The elastic deformation is approximately 0.001 or 0.1%, which could be due to elastic elongation of bolts.

The ultimate deformation of the connection is approximately 1.56%, which is associated with approximately 6mm elongation in the farthest bolts assuming zero deformation in the end plates. The ultimate strength is approximately  $0.78M_p$  compared to the  $0.46\phi M_p$  calculated in Table 2. As expected, the failure occurred in the bolts.

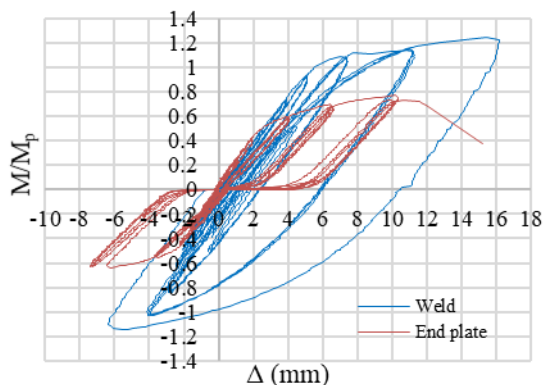
Figure 23: Hysteresis loop: moment ratio ( $M/M_p$ ) vs displacement  $\Delta$

This test was conducted to compare the behaviour of full penetration butt-welded splices with bolted splices. The loop shows displacement versus moment ratio at the connection. To compare the behaviour of the welded connection with bolted splice connections, the moment-displacement loop of Specimen #4 has also been presented in Figure 23.

Specimen #5 demonstrates elastoplastic performance. The test was stopped after plasticity in the smaller members due to restrictions of the test rig. No visual damage was observed in the weld after the experiment. The end plate connection performs similar to the rigid welded connection at small displacements.
