Experimental seismic testing of semi-reinforced stone masonry building in mud mortar

ABSTRACT

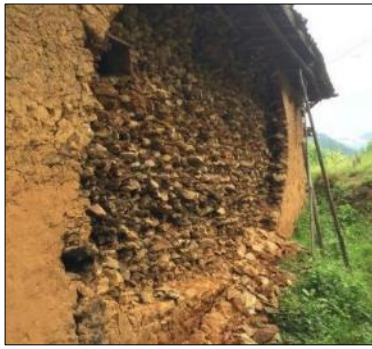
(a) Delamination and bulging of wall wythe, 2015 Gorkha earthquake, Nepal

Local and global failure modes of LSM buildings when subjected to earthquake induced loading is inherent in the building morphology. The LSM buildings typically suffer from a lack of bonding between masonry units and masonry veneers, and effective connection between orthogonal walls and various building components, such as lack of wall to diaphragm connections. These deficiencies commonly lead to delamination and mechanism failure (expulsion of irregular stones) due to a lack of connection between outer veneers and irregular stones (Dizhur, Dhakal, Bothara, & Ingham, 2015), (Gautam & Chaulagain, 2016), (Bothara & Hiçyılmaz, 2008), and slumping or overturning of walls under face loading. Figure 1 presents photographs of failure examples, which includes local and global failure modes that are typically suffered by LSM buildings.

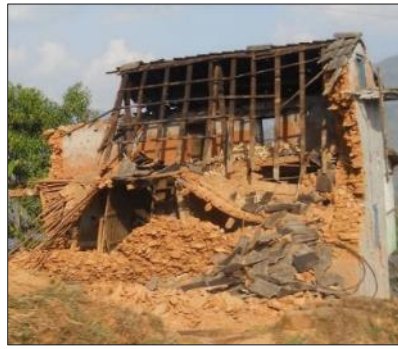
(b) Out-of-plane collapse of wall led to collapse of roof and floor, 2015 Gorkha earthquake, Nepal

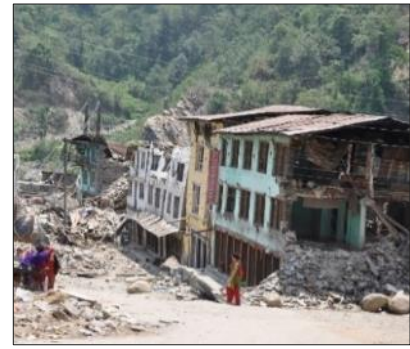
(c) Out of plane collapse of walls, destruction of top storey, 2015 Gorkha earthquake, Nepal

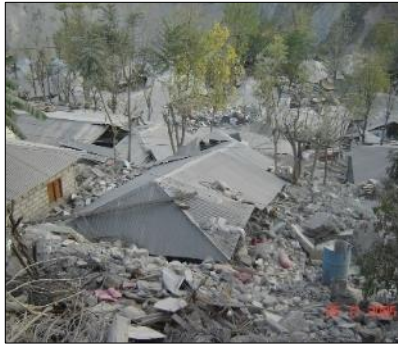
(d) Destruction of a village, during 2005 Kashmir earthquake, Pakistan

Figure 1: Typical failure modes of stone masonry building with weak mortar

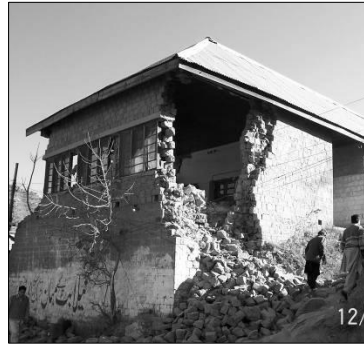
(e) In-plane wall and corner damage, 2005 Kashmir earthquake, Pakistan

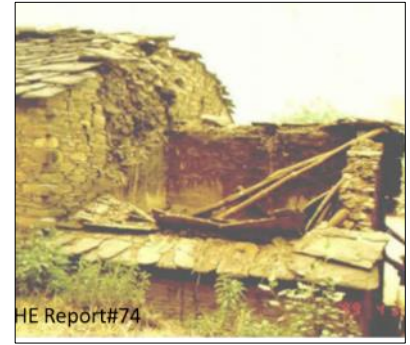
(f) Roof collapse due to absence of wall-roof connections, 1999 Chamoli earthquake, India
(Photo credit: WHE, Report # 74)

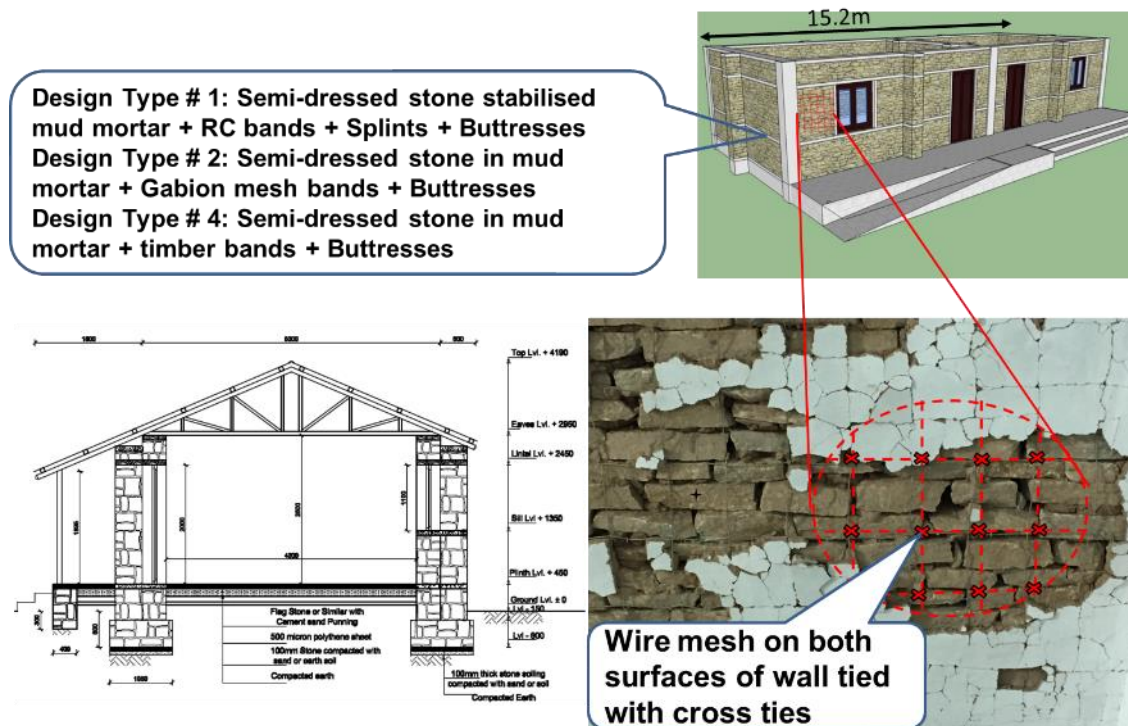
Figure 2: Prototype details of the proposed building (DT 1)

Following the recommendations of the aforementioned guidelines as well as observed and postulated damage to low strength masonry buildings, the following four Design Types (DT) were developed that utilise the abundantly available local construction materials, with only minimal use of imported materials. The Design Types were one-storey high with a light metal roof and have the same architectural features and sizes. A sample drawing of the proposed two-room prototype is presented in Figure 2 and details of the proposed building types are as follows:

- **DT 1 (SM_RC):** Semi-dressed stone masonry in cement stabilised mud mortar with RC band, splints and containment mesh on wall surfaces,
- **DT 2 (SM_Gabion):** Semi-dressed stone masonry in mud mortar with galvanized iron gabion bands and containment mesh on wall surfaces
- **DT 3 (CSEB_RC):** Cement stabilized earth brick (CSEB) in cement stabilized mud mortar with RCC bands and vertical bars.
- **DT 4 (SM_Timber):** Semi-dressed stone masonry in mud mortar with timber bands and containment mesh on wall surfaces.

As noted above, the developed Design Types of stone buildings in mud mortar were provided with gabion, timber or reinforced concrete (RC) bands. To basket and thereby prevent disintegrity of the stone masonry walls, galvanized steel mesh was proposed on both surfaces of the walls, which were tied together by cross links (cross ties) passing through the walls.

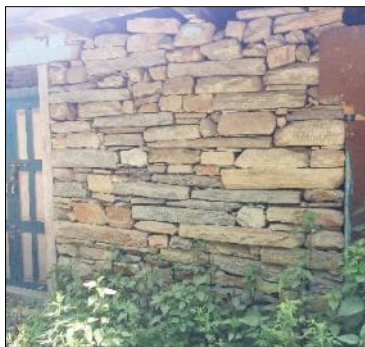
(a) Intermixing of double and single thickness stones

Figure 3: Variation in semi-dressed stone masonry walls within short stretches in the earthquake-affected areas of Nepal

Attempts were made to simulate the field conditions of the earthquake-affected areas of Nepal while constructing the model buildings and test specimens. To simulate the field conditions, quality control of the construction materials and labourer skills was kept to a minimum, resulting in a large variation in the test results. Two issues were noted during the stone preparations processes: (i) because stone is a natural material, the shapes and sizes and dressability of the stones depends largely on the mineralogy and bedding plane orientation of the stones, which are highly variable even in a short geographical stretch (Figure 3), (ii) the stone masons are habitually used to working with the stones available in the areas of their work, and hence find it difficult to replicate stone masonry from other areas. These two issues made it extremely difficult to accurately replicate stone masonry for testing that was similar to that found in Nepal. All the model buildings were covered with mud plastered and whitewashed, in order to facilitate crack identification during testing. Refer to Figure 4 for photographs of the building models under construction.

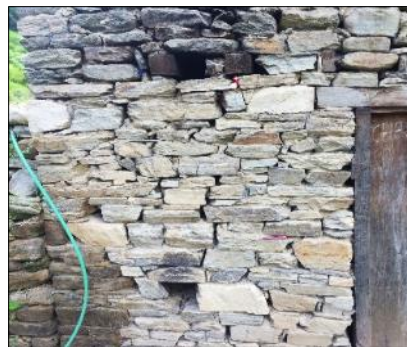
(b) Relatively shorter but thicker stones

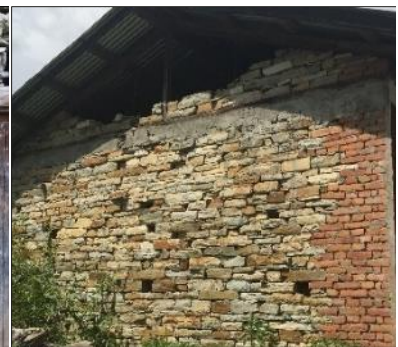
(c) More clearly defined bedding planes, sharp edges of stones

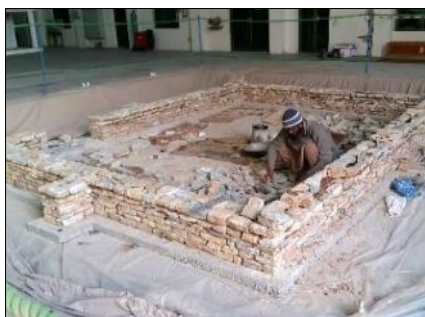
(a) Model building under construction (DT 1)

Figure 4: Snapshots of model buildings (2/3rd scale) construction

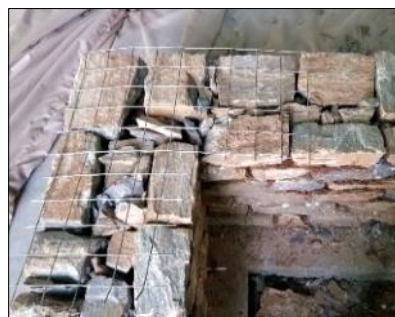
(b) Close-up view of stone wall (wire mesh on the wall is stitch) (DT 2)

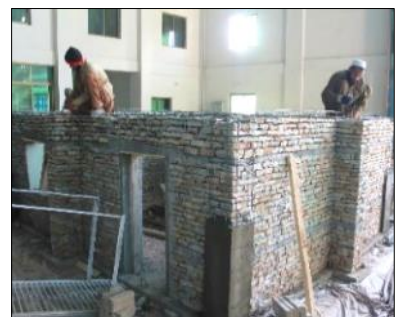
(c) RC band and splints under construction (DT 1)

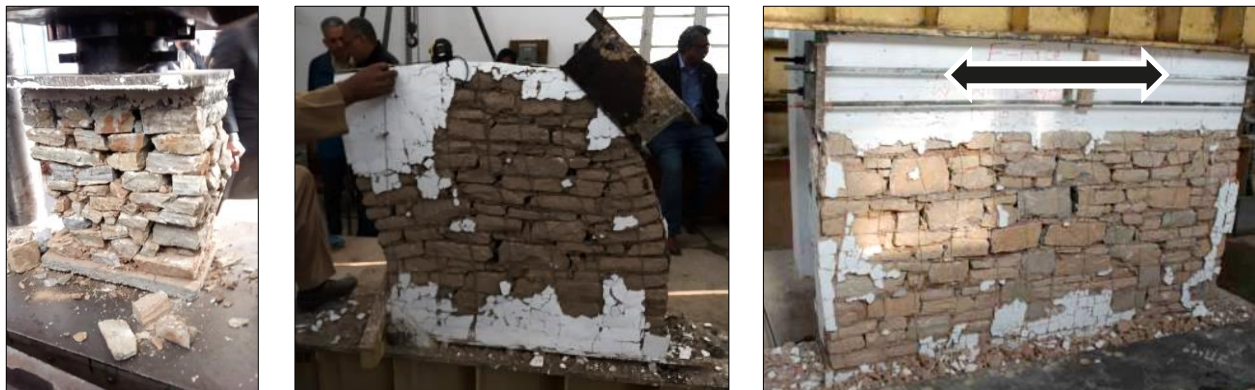
Figure 5: Testing of subassemblies

A comprehensive material and subassembly testing programme was designed to characterise construction materials and masonry. The material tests included mortar cube and stone cylinder compression tests, and tensile tests of galvanised wires and reinforcing bars. Subassembly tests included compression tests of masonry prisms, diagonal compression tests of wallettes and in-plane quasi-static cyclic testing of masonry piers (Figure 5). The stone masonry subassemblies were constructed in both stabilised and unstabilised mud mortar with and without surface containment. The non-standard nature of the construction materials and a lack of quality control during construction of the test specimens led to a large variation in the test results of the materials and subassemblies.

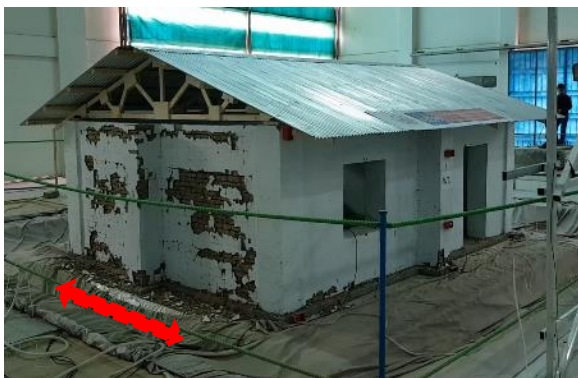
(a) One of the 2/3rd scale model buildings (DT 1)

Figure 6: Testing of the model buildings on the shake table during (testing in transverse direction). Accelerometers were installed inside the red boxes

All the model buildings were primarily shaken in the transverse direction considering the high vulnerability of the long walls (refer Figure 6) when subjected to face loading. In addition to transverse shaking, the 1/3rd scale DT 2 model buildings were also tested in the longitudinal direction after shaking these models in the transverse direction after repair. The model buildings were subjected to gradually increasing intensity (i.e. PGA) of shaking up to 1.0g.

Accelerometers and linear potentiometers were employed at the eaves and lintel levels and at the base of the buttresses in both out-of-plane and in-plane walls to capture the response of the model buildings during dynamic excitation. Accelerometers were also installed on the shake tables to acquire the response of the shake table to input signals. Potentiometers were employed to measure model displacement with respect to the table platform and the intensity of out-of-plane rocking at the base of the buttress to the wall.

The 2/3rd scale model buildings were tested on a 60-ton shake table, and were subjected to sinusoidal base excitation of varying frequency and base imposed displacement to produce moderate-to-strong acceleration base excitation, to push the structure from an elastic to an inelastic state in a progressive manner. The input frequencies were varied between 2 Hz and 12 Hz and the base target displacements were selected based on the pseudo-relationship, varying from 1.5 mm to maximum displacement, calculated to not exceed the base acceleration of more than 1.0g, which is the maximum acceleration limit of the seismic simulator. Taking into account different combinations of input frequency and base target displacement, a total of up to 27 runs were carried out. As all the model buildings survived shaking of 1.0g PGA before concluding the shake table tests, the models were subjected to long duration shaking close to a PGA of 1.0g at their resonance frequency to understand degradation of the models. Some variations were made to the test sequence to best-suit the situation, where required.

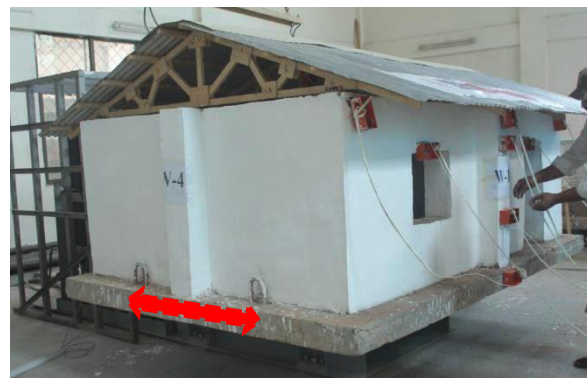
(b) One of the 1/3rd scale model buildings (DT 4)

The 1/3rd scale model buildings were tested on an 8-ton shake table. These models were tested under earthquake acceleration records, which comprised of the base excitations for the transverse shaking, which included: (i) acceleration time history of the Northridge (USA) earthquake of 17 January 1994 record at 090 CDMG STATION 24278 (Main Shaking) (Figure 7a); (ii) KIRT_NS. The KIRT-EW time history was recorded at Kirtipur, Kathmandu on a rock site from the 25 April 2015 Gorkha earthquake and was used as a supplementary test. To meet the objective requirement of verification of compliance of the proposed design to the applicable seismic Standards, the acceleration time history was matched to the code specified design acceleration spectrum of the Indian Seismic Standard (IS, 1993) (refer Figure 7b). To meet the scaling requirements, the

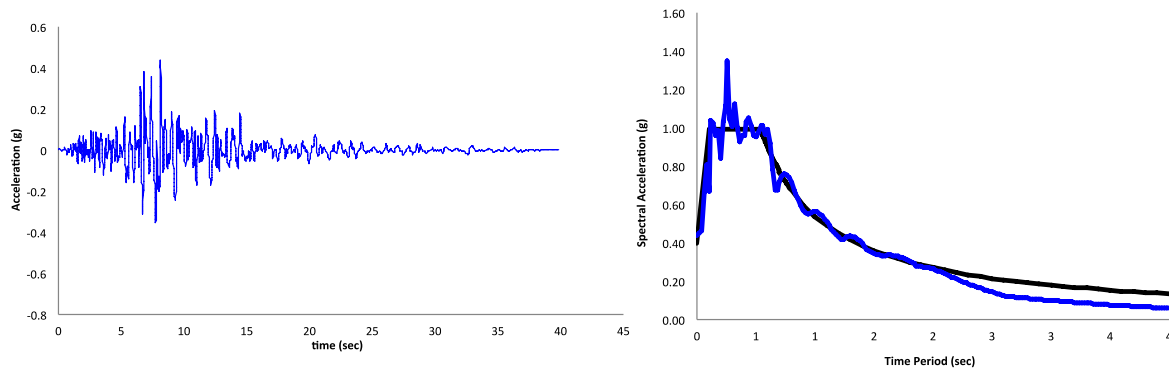
(a) Matched time history of Northridge (USA) earthquake of 17 January 1994 recorded at Station : 090 CDMG STATION 24278
The Northridge (USA) earthquake of January 17, 1994.

(b) Matching of acceleration record spectrum and code specified design spectrum (the design spectra includes Importance factor = 1.5 and Load factor = 1.5)

Figure 7: Main shaking time history and spectra matching

acceleration time history frequency was increased by a Scale factor^{0.5} = $3^{0.5} = 1.73$ in the present case. Shaking of the shale table was progressively increased from 5% to 240% to understand the behaviour of the model under design level forces and extreme level forces that may be expected in very rare earthquakes. Tests were also conducted on 1/3rd scale model buildings after removing 50% of the containment mesh of one of the in-plane walls and 100% of the containment mesh of another in-plane wall to gauge the sensitivity of the containment mesh to the seismic resiliency of the building. Some variation in shaking sequence were made as required. After completion of main tests, the models were subjected to artificially elongated long duration shaking to understand degradation of the models.

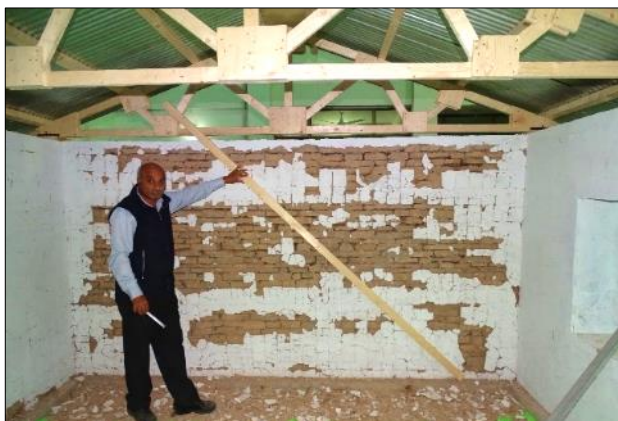
(a) Spalling of plaster and sliding of stones, interior face of 2/3rd scale model (DT 1)

Under extreme shaking, all the model buildings showed significant sliding and rocking of stones in the in-plane wall panels and induced lateral displacement. The containment wires prevented the development of large cracks and dislodging of stone. Further to this, containment wires ensured integrity of walls which allowed re-centering of the building subjected to reverse cycle loading, and the wall panels were observed to be without significant residual permanent deformations. Tremendous energy dissipation capacity has been observed in the model, which was due to well-distributed cracks within all of the walls, as well as horizontal sliding and rocking of stones at multiple locations in the in-plane wall panels.

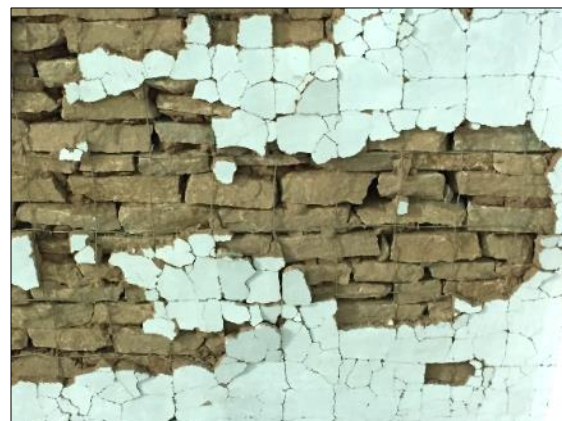
(b) Close-up view of wall, note wide cracks due to sliding of stones, exterior face of 2/3rd model (DT 1)

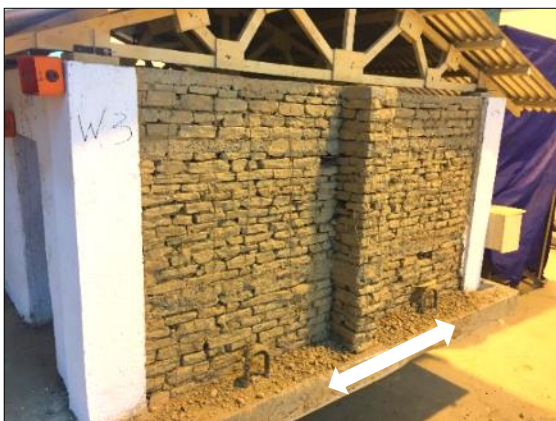
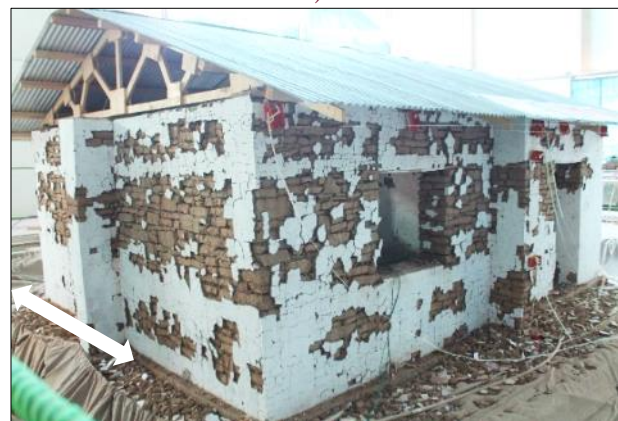
(c) Partial removal of containment mesh, note holes in the wall as result of falling of stones (1/3rd scale, DT 1)

To investigate sensitivity of stability of the walls to the containment mesh, the 1/3rd scale model buildings of DT 1 and DT 2 were also tested after removing 50% and 100% of the containment mesh from the in-plane walls. Once the containment mesh was fully removed from the in-plane walls, the dislodging and falling of the stones off the wall started, and degradation of the wall was rapid. However, the partial containment mesh was still able to contain the masonry units in the in-plane wall. Figure 8 presents a few of the photographs of models under testing.

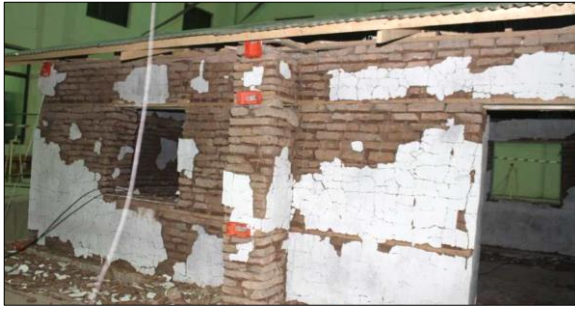
(e) Out-of-plane movement face-loaded wall (DT 4)

gabion bands flexed more violently than did the face loaded walls of the building with RC bands, indicating a dominant out-of-plane mechanism of these building types. This observation indicates that the difference in stiffness of the bands constructed of different materials ensured different levels of building integrity, thus, influencing the hierarchy of damage. In the case of buildings with timber bands, sliding of bands was observed whereas separation of bands and masonry was observed in the case of the model building with RC bands. Neither sliding nor separation was observed between bands and adjoining stones in the buildings with gabion bands, most likely because of the same material properties of the walls and bands tying the walls.

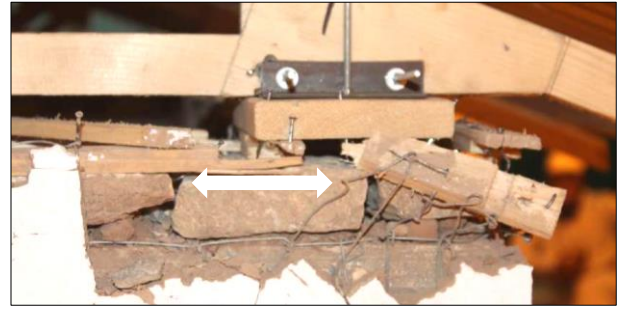
(f) Breaking of timber band (DT 4)

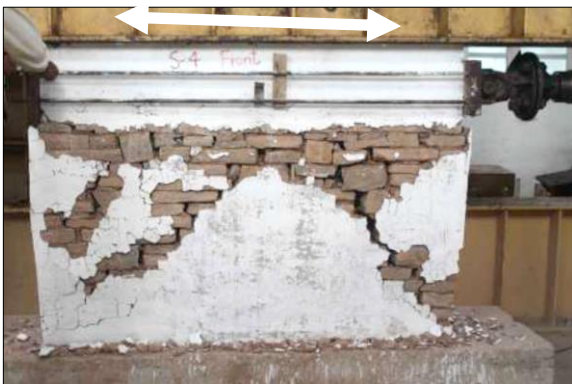
(a) Testing of wall pier without containment mesh under shear

Figure 9 presents force-displacement plots of wall piers with and without surface containment mesh. From the plots, it is obvious that the containment mesh was able to increase force and deformation capacity of the piers, which was also observed with multiple stone sliding planes, resulting in distributed damage over the whole pier. Also, it can be confirmed from the stable and fat hysteretic response of walls that the models with containmnet exhibit significant energy dissipation, which is an essential parameter for controlling seismic demands (forces and defoamtions) and limiting structural damages under earthquake induced lateral vibrations.

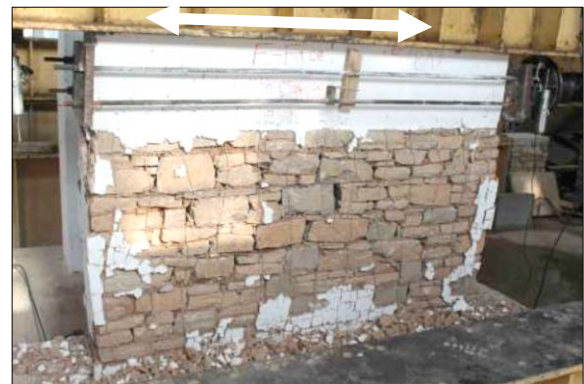
(b) Testing of wall pier with containment mesh under shear

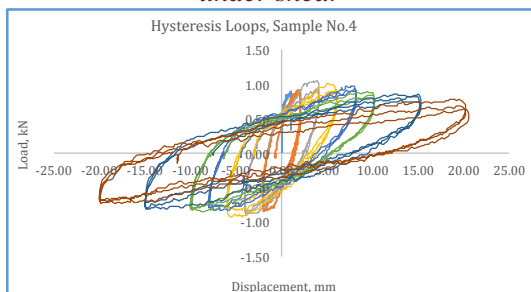
(c) Force-displacement plot of wall pier without containment mesh under in-plane lateral load

Figure 9: Force-displacement hysteretic loops of the wall piers buildings (arrow shows direction of push-pull)

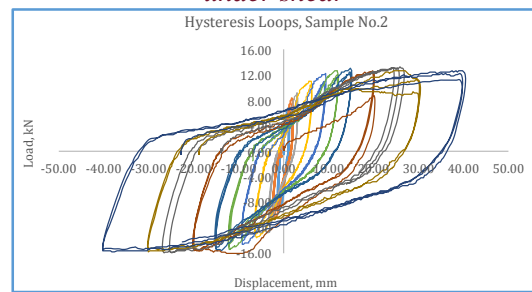
(d) Force-displacement plot of wall pier with containment mesh under in-plane lateral load

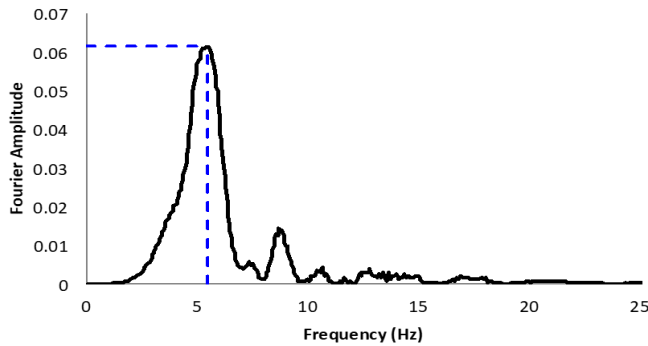
Figure 10: PSD developed for free vibration acceleration response of 2/3rd model for out-of-plane response

Free vibration tests data were analysed for measurement of fundamental frequency of models. The uncracked fundamental period of model was measured using the data from free vibration test runs. The time history response of acceleration recorded at the eave level was obtained and analysed in SeismoSignal for base line correction and filtering. Fourier amplitude of acceleration was correlated with the frequency to obtain the power spectral density (PSD). Figure 10 presents the PSD obtained for 2/3rd model for out-of-plane responding wall for TD 2. It is interesting to note that the fundamental period of the in-plane and out-of-plane walls were very different in the case of the models with timber and gabion, whereas the same was very close with the RC bands. To understand the behaviour, the data is being further analysed.
