NEW ZEALAND SOCIETY FOR EARTHQUAKE ENGINEERING  
**2019 Pacific Conference on  
Earthquake Engineering**  
TURNING HAZARD AWARENESS INTO RISK MITIGATION  
4 – 6 April | SkyCity, Auckland | New Zealand

# Hybrid fence design for rockfall protection above the coastal highway in Kaikoura, New Zealand

*Paper 77*

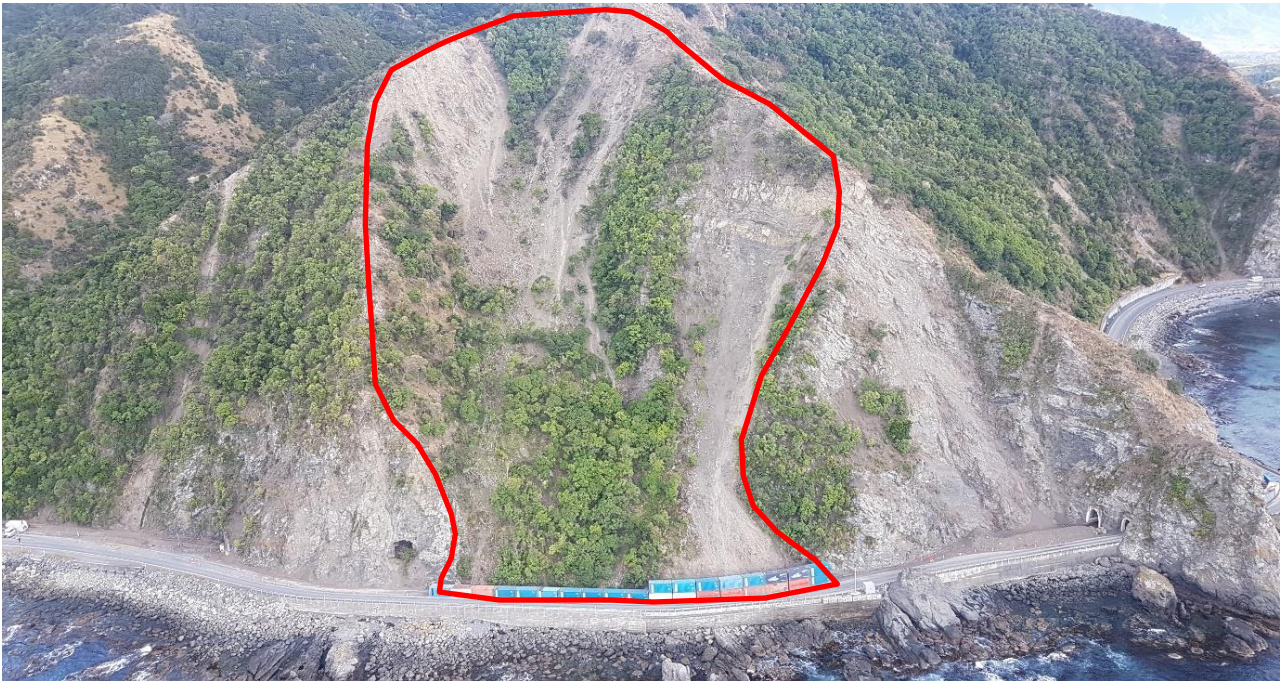
*Figure 1: Earthquake damaged slopes above the coastal transport corridor, the approximate site location of SR18/19 is outlined in red*

At SR18/19, earthquake shaking ground damage effects on the hillslopes included denuding of soil slopes, tension cracking and dilation of rock outcrops, all of which have increased the potential for future rockfall onto the transportation corridor, see Figure 1.

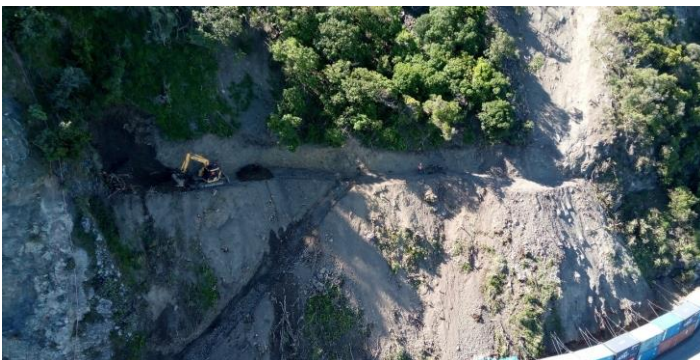
*Figure 4: The bench and access ramp enable for improved access for the fence installation*

To provide temporary access and a suitable construction area, a narrow 2.5 m width bench was constructed at the proposed fence location (Figure 4). Installing a bench on the slope initially provided a clear working platform on which to construct the hybrid fence, which enabled access without the need of daily helicopter transportation. The bench also enabled the use of excavators for installing the plinth foundations, reducing the construction time which was critical to road reopening.

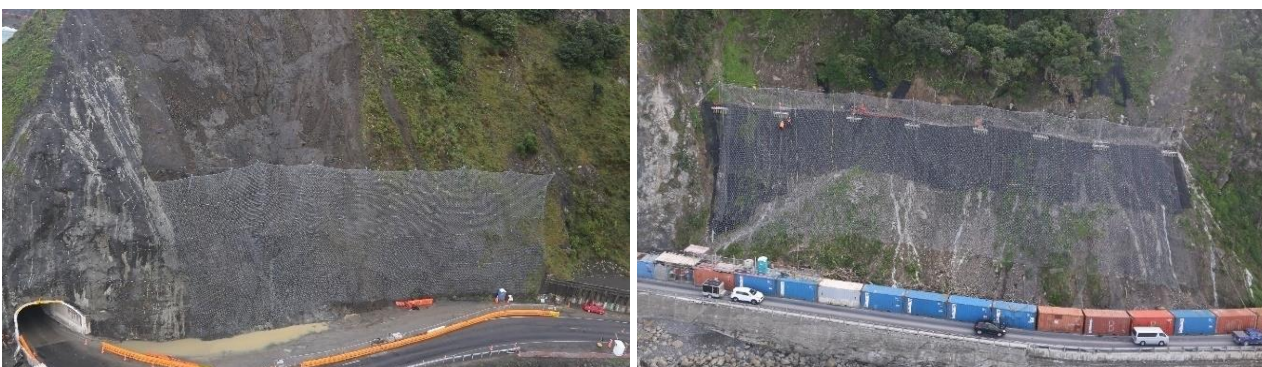
*Figure 5: (Left) SR14, installed across a planar slope (Right) SR18/19, constrained by complex topography*

Prior to the construction of the hybrid fence at SR18/19, a similar hybrid fence had begun to be installed at a nearby site (SR14). The partially completed installation of the hybrid fence at SR14 provided the basis of the construction assumptions for the hybrid fence at SR18/19. However, at SR14 the slope is simple and planar allowing the hybrid fence to be extended across the full extent of the identified hazard, whereas the fence at SR18/19 is limited by the complex topography and constrained to the narrow gully, as shown in Figure 5.

As can be seen in Figure 5 and 6 above, the toe of the slope was obscured throughout the design and construction by the row of temporary protection containers. This presented a challenge for the tie in detail of the attenuator tail.

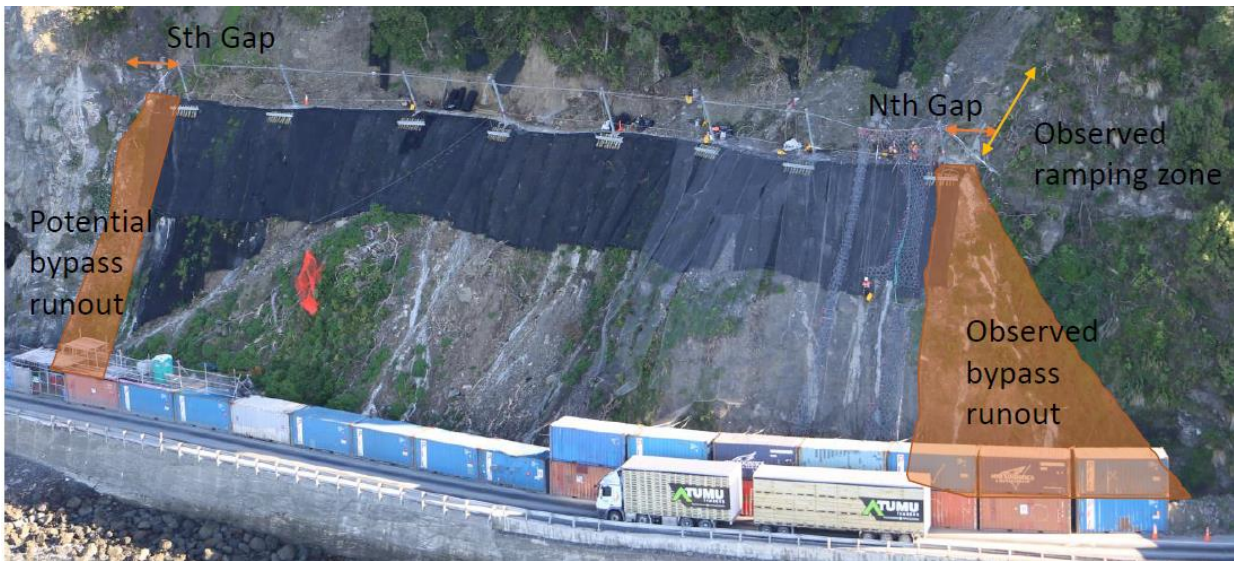
*Figure 6: The mapped hazards resulting from the gaps at the edges of the hybrid fence at SR18/19*

To ensure the maximum coverage of the hazard at SR18/19, the hybrid fence was designed to be installed across the full width of the gully with the border posts installed at the furthest possible extents on the installed bench. During the installation of the ring-net panels it became apparent that, even with the end posts at their furthest possible location, the linear fence installed at the narrowest point of the widening gully resulted in sizable gaps existing between the draped ring net panels and the ground. These gaps were observed on the northern and southern edges and mapped by the site team, see Figure 6.

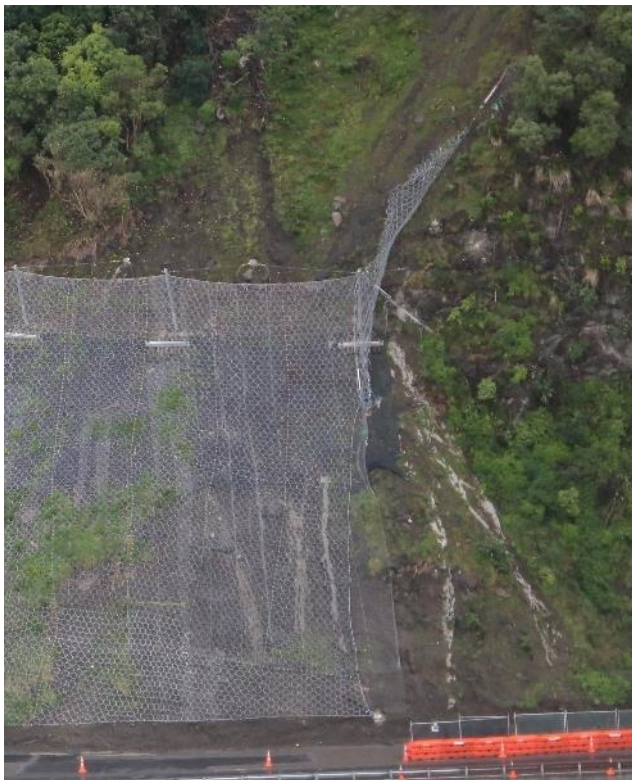
*Figure 7: An example of the initial drawings of the close out detail*

The design intent of the close out attachments is to act as a funnel, diverting rockfall paths directly into the catchment area of the hybrid fence, reducing the possibility of material bypassing the fence, see Figure 7. These additions enabled the linear fence to fit better within the topography of the narrow gully.
