NEW ZEALAND SOCIETY FOR EARTHQUAKE ENGINEERING
**2019 Pacific Conference on
Earthquake Engineering**
TURNING HAZARD AWARENESS INTO RISK MITIGATION
4 – 6 April | SkyCity, Auckland | New Zealand

Design of a large scale rockfall protection bund for coastal transport corridor recovery following the 2016 Kaikōura earthquake

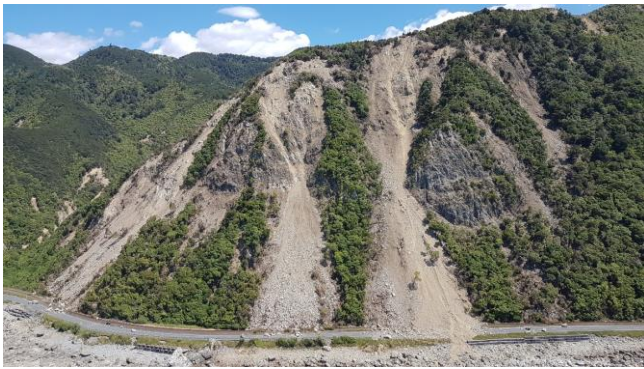
Figure 1: Slip P7 after the Kaikōura earthquake

The crest of the uppermost source area is 250m above the road corridor below, and the length of corridor directly affected by the rockfall hazard is approximately 650 m. The overall area consists of discontinuous bluffs (particularly on the upper third of site) which are highly fractured/dilated and

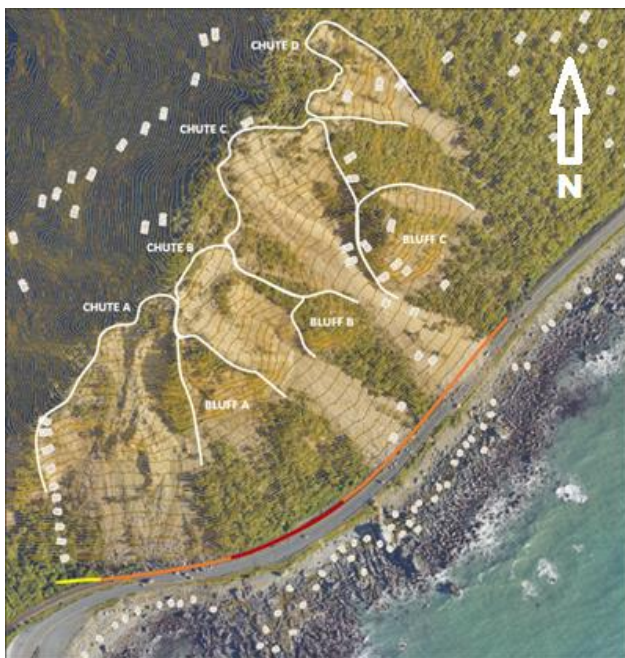
Figure 2: P7 zones and temporary protection. White = zone outlines, yellow = earth bund, orange = double stacked containers, red = single stacked containers

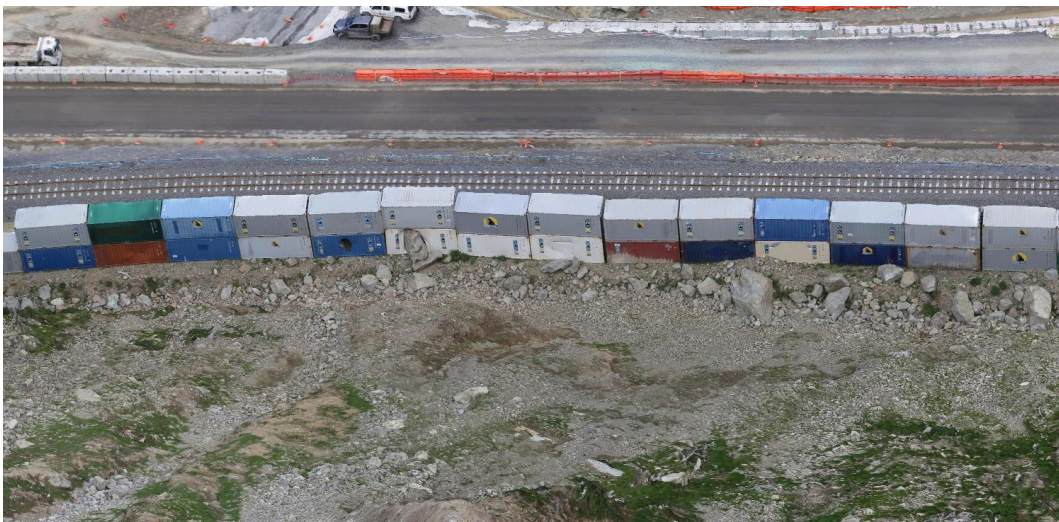
Figure 3: Boulder impacts at container wall following rock blasting

After initial sluicing and scaling had been completed, the nature of the rockfall hazard meant temporary protection measures were required to ensure the safety of the site staff travelling past the slope toe. Across the majority of site, this involved constructing a double stacked wall of shipping containers, ballasted with slip debris. Through the period these shipping containers were in place, they were subjected to numerous impacts, particularly as a result of the large rock blasts upslope which mobilised numerous large boulders (Figure 3). Through analysis of video footage of these blasts, and the impact locations on the containers, it was possible to develop a greater understanding of the behaviour of oversized falling rocks at this site.

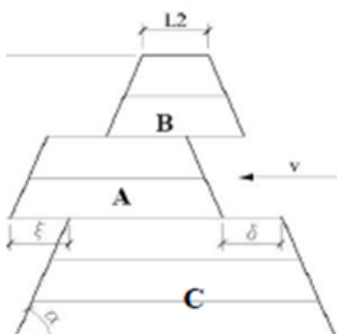
Figure 7: Simplified cross section of the embankment geometry after rock impact (Ronco et al., 2009)

The Ultimate Limit State of the bund is determined by evaluating the static stability of the structure after impact deformation. The projection of Block A centre of mass has to be inside the front support of Block C or the projection of the Block B centre of mass has to stay in equilibrium with Block A (Figure 7).

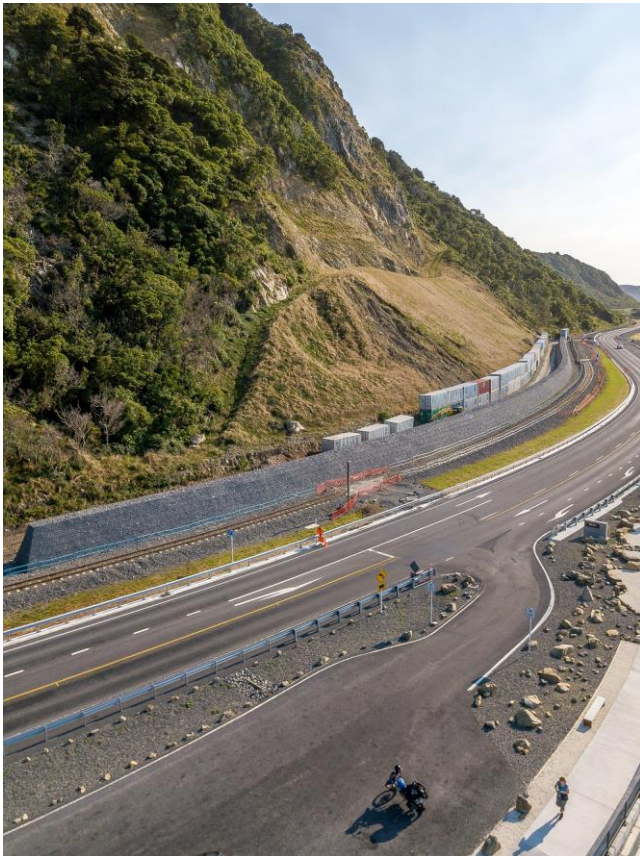
Figure 8: Partially completed bund beneath Chute B before removal of temporary protection
