# Kennedy Building – Strengthening of a four-storey URM heritage façade in a prominent Wellington location

*S. Chung, F. Vessey & C. Ashby*

WSP Opus, Wellington.

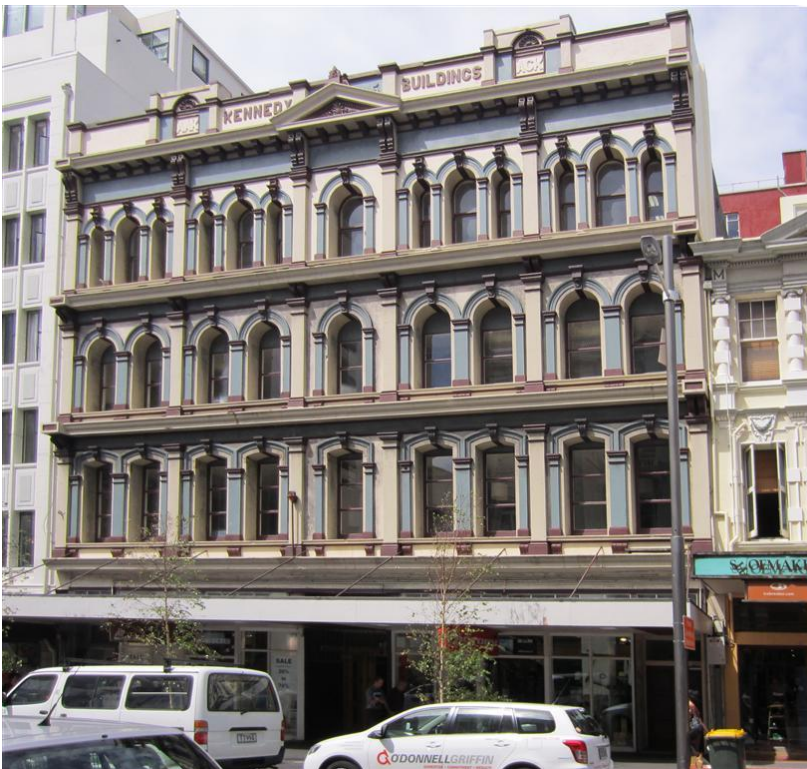
Figure 2: Exterior View of Kennedy Building

Today, the building forms part of the Cuba Street Heritage Area and is one of four key prominent Edwardian buildings on the block between Manners Street and Wakefield Street in the Wellington CBD. Cuba Street is a prominent pedestrian thoroughfare in Wellington lined with cafes and retail shops. It is home to icons such as the bucket fountain and hosts the annual Cuba Street Carnival. This end of the street is known as Lower Cuba Street, and although cars have access to the street for parking, the area is highly pedestrianised and is frequently closed to traffic for markets and events. The building is enclosed on the north, east and south by adjacent buildings which are of similar height. The west façade faces Cuba Street (Fig. 2).

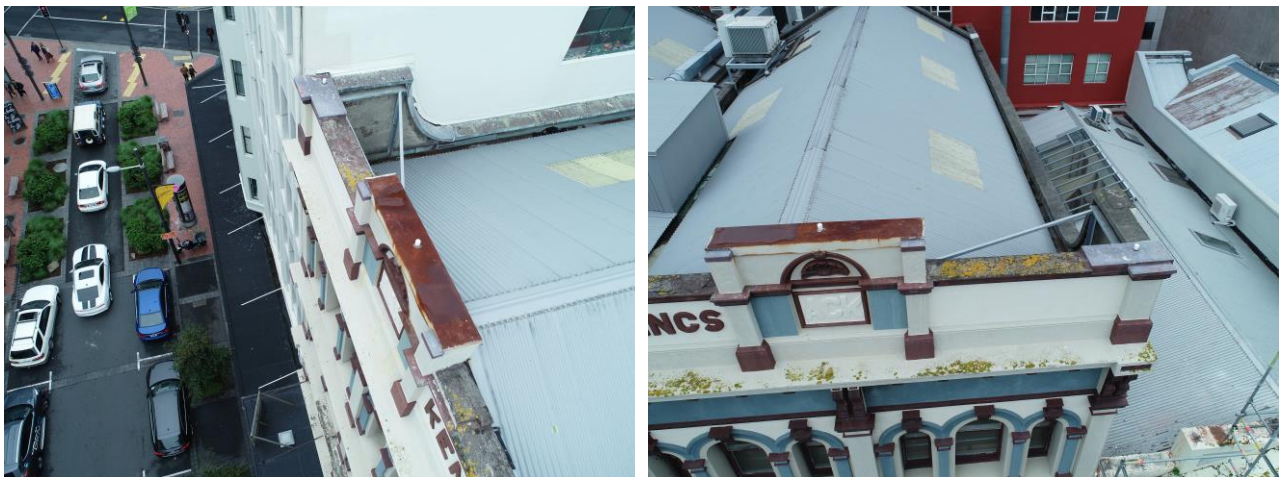
*Figures 5 and 6: Images of the roof and parapet from the drone survey*

A site visit involving the building owner, contractors, and consultants, confirmed the need for intrusive investigations to finalise the detail of the design and confirm contractor methodology. This included access to the ceiling voids and to the roof area to inspect the parapet. For urgency and safety reasons, a drone survey of the façade, parapet and roof was undertaken. The information gained from the photos, videos and 3D model of the façade and parapet was used to establish the extent of the strengthening and the weather tightness remediation at the connection between the roof and parapet (Figs. 5 and 6). The data gathered during this exercise was invaluable during the detailed design phase as much of the concept was based off assumptions and dimensions taken from the original drawings.

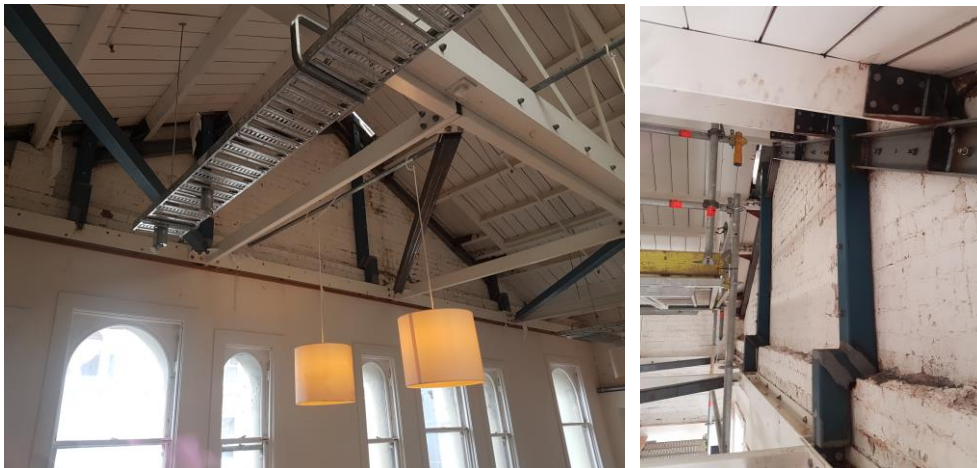
*Figure 9 and 10: Steel Installation on Level 3*

The Level 3 installation of the truss was straight forward as it was an open area which allowed contractors to work above and below the truss line. The outer frame and interior struts were installed first as these dimensions could easily be ascertained from site measure. A template was made for the diagonals to ensure that these elements could fit in place with the steel that has been installed in place. Due to the visual impact of the connections on this level, there was little room for error.

The visible strengthening on the third level is incorporated into the existing fabric. The materiality of the strengthening works is different to the original, but with consideration given to colour, texture, composition, dimensions and detailing, the strengthening elements are successfully blended with the existing structure (Figs. 9 and 10).
