Case study of TVNZ Refurbishment - Specific Design of Seismic Restraints for Non-Structural Elements

John Newall, Paul Campbell, Tom Parker, Kristian Jensen

WSP Opus, New Zealand (Auckland).

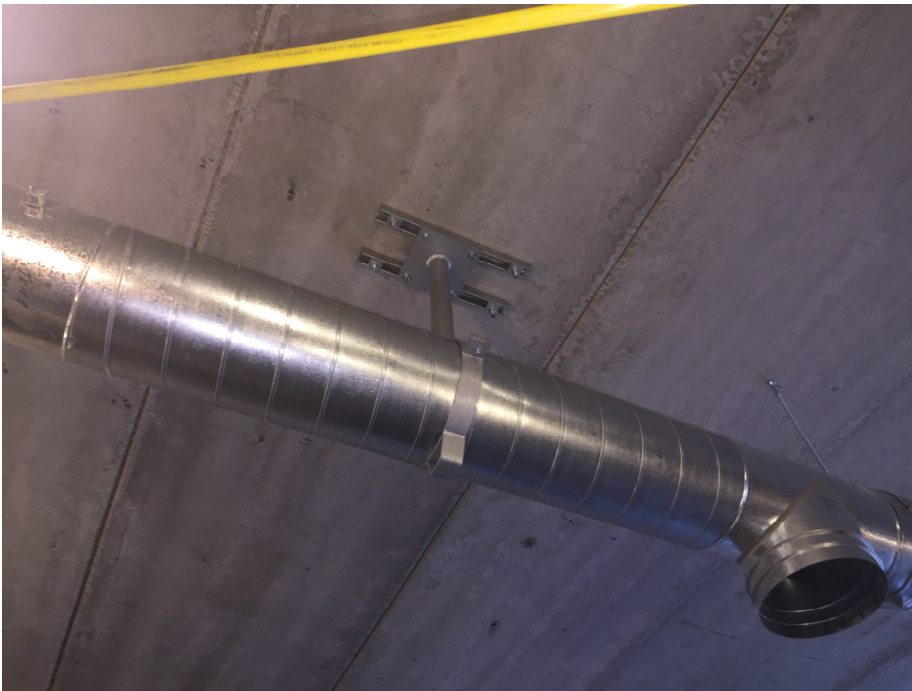
Figure 1: Cantilever post detail where Arch didn't want braces

style were discouraged. This meant that our solution had to be sympathetic to the architectural constraints and we needed to employ solutions such as inverted portal frames or one-off cantilever hangers. This also meant that we had to ‘bundle’ services to make efficient use of the inverted portal frames.

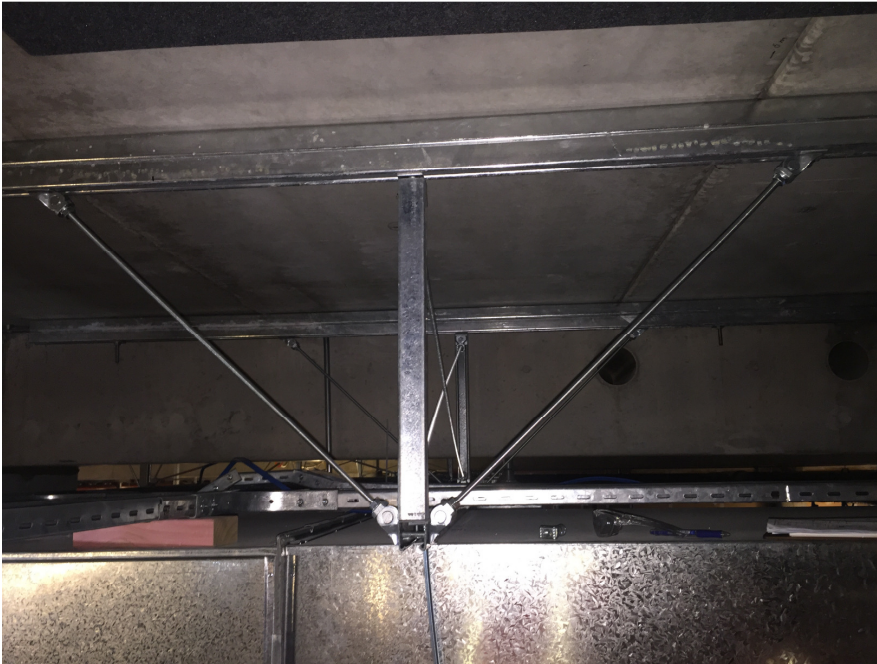
Figure 4: Simple configuration on unistrut lengths off underside of slab, to allow for some positional tolerance

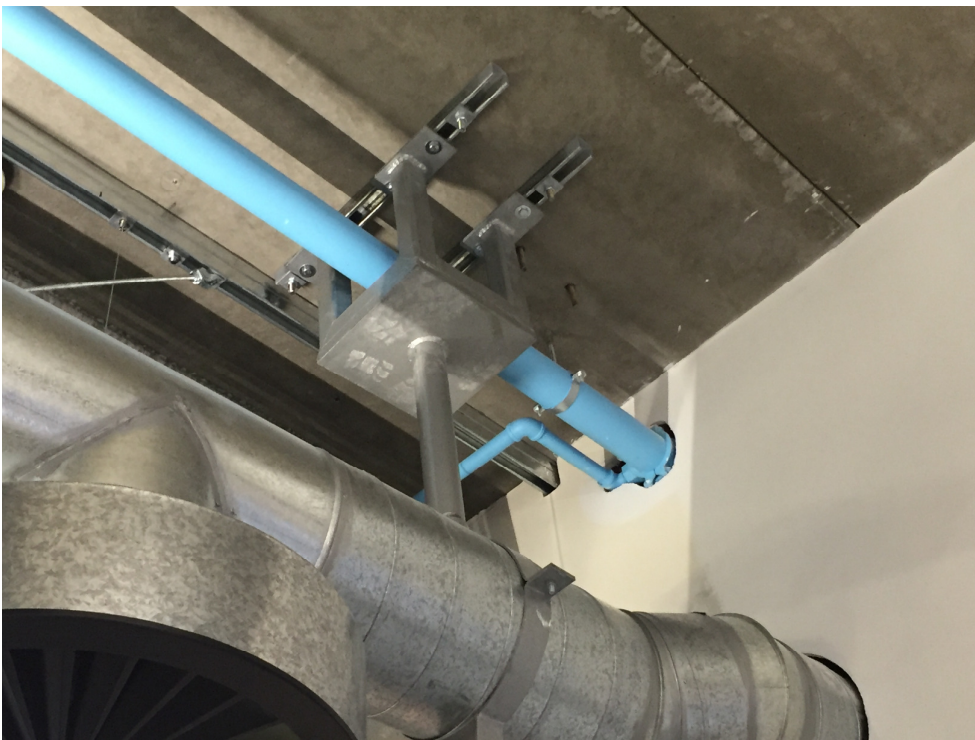
Figure 7: Specific solution for area where services clashed and could not be moved

Bespoke items were designed and documented individually. Typically, these items included those services identified as requiring a higher architectural finish, services in the “back of house” plant areas where larger plant items are located and those services that required specific acoustic treatment.

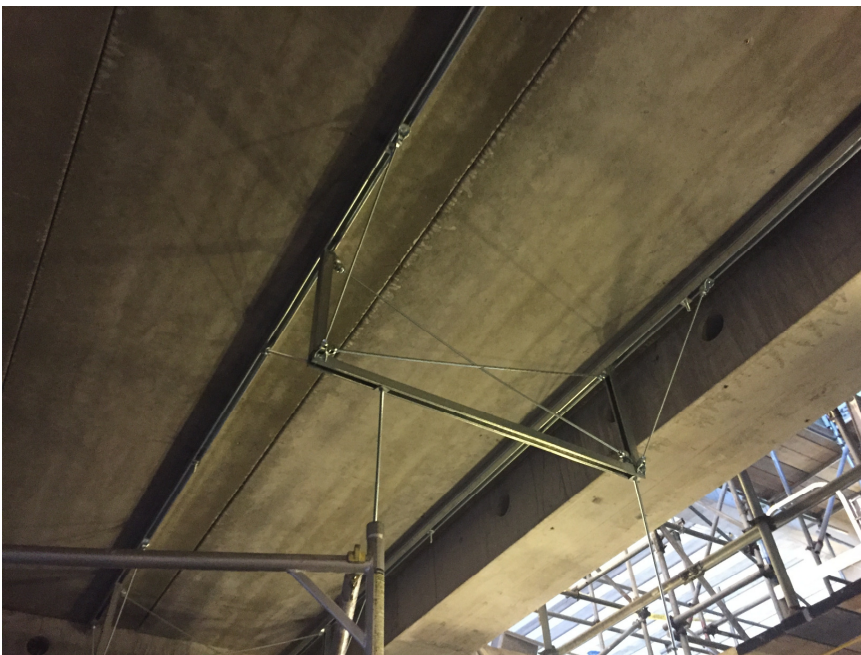
Figure 8: Simple configuration on unistrut lengths off underside of slab, to allow for some positional tolerance

- Fixing to the underside of hollow core floors required special attention where there are limited options for seismically rated anchors on the market. Most fixing types can adequately resist relatively low gravity loads but we could not satisfy ourselves of their suitability for cyclic, lateral loads. The solution adopted was that of Stage 1, where a chemical anchor was fixed into the slab topping from below. A short section of Unistrut provided some flexibility in position.

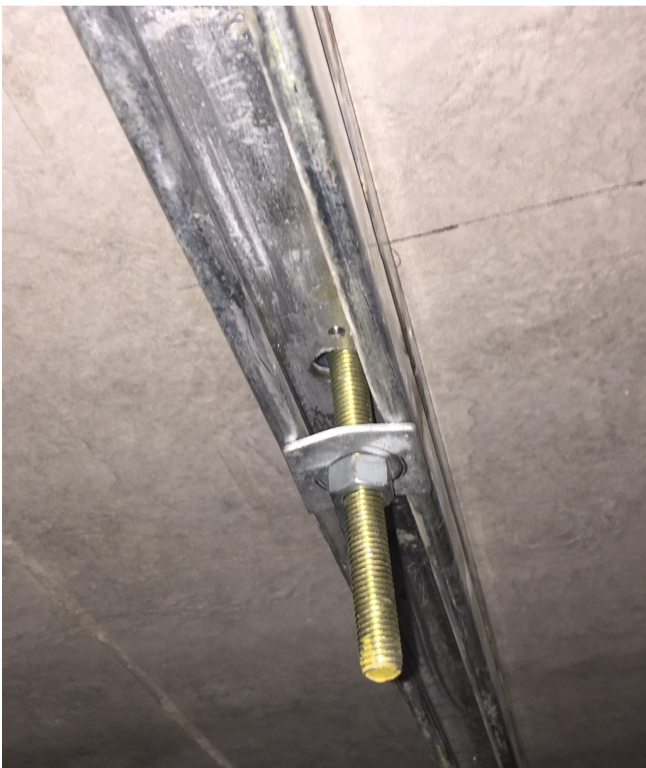
Figure 9: Wrong sized washer that got bent during installation

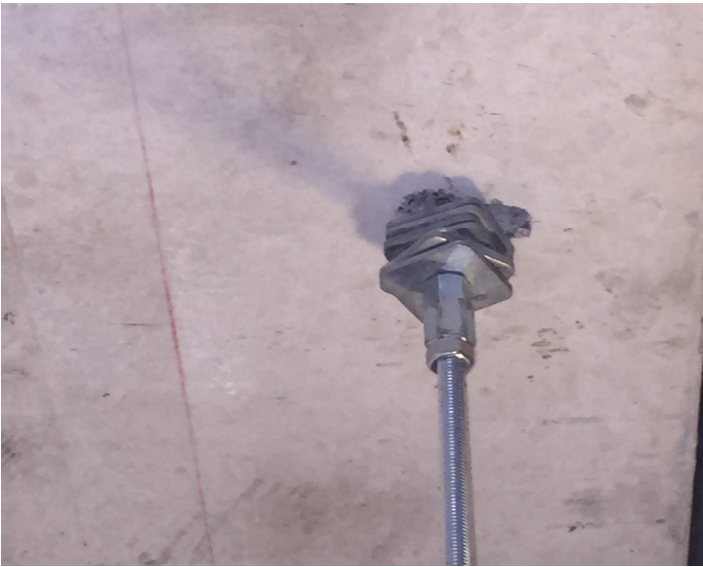
Figure 11: Poor installation. If in doubt, chuck in more washers

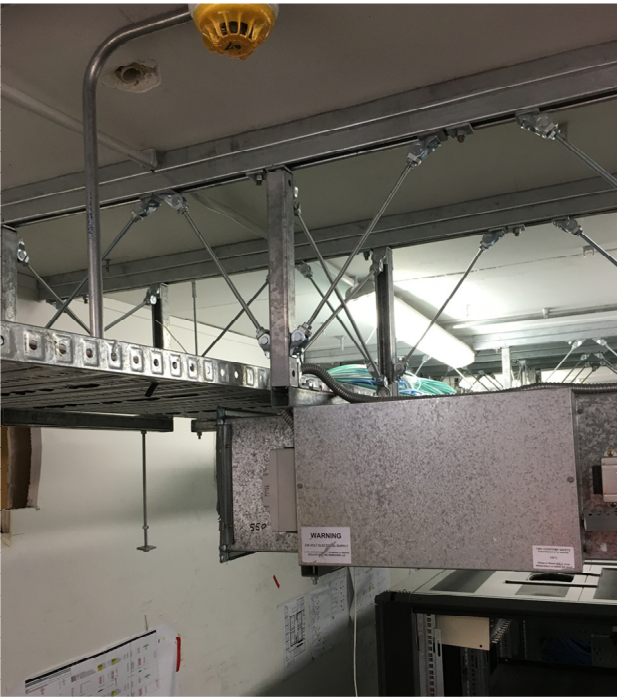
Figure 12: Standard Solution

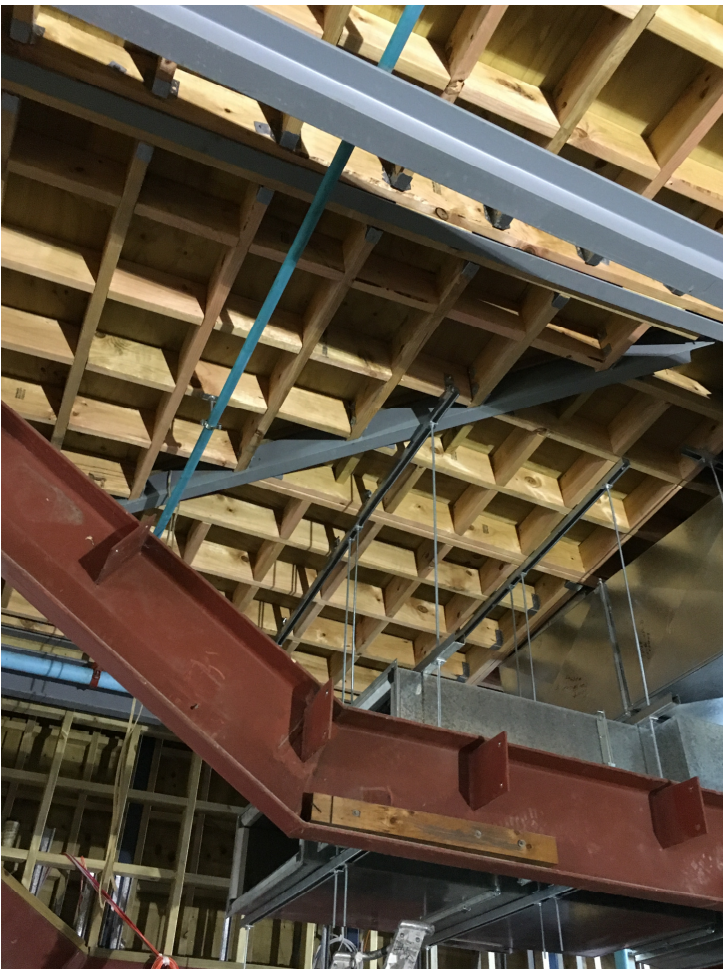
Figure 13: Gravity system of light weight structure with braces to be installed
