2019 Pacific Conference on Earthquake Engineering

Implications of seismic design detailing on the fire performance of Post-Tensioned Timber frames

P. Horne, A. Palermo, A. Abu & P. Moss

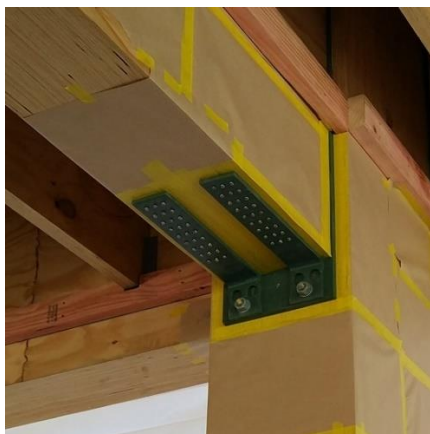
Figure 3: A beam-column connection using angle dissipaters

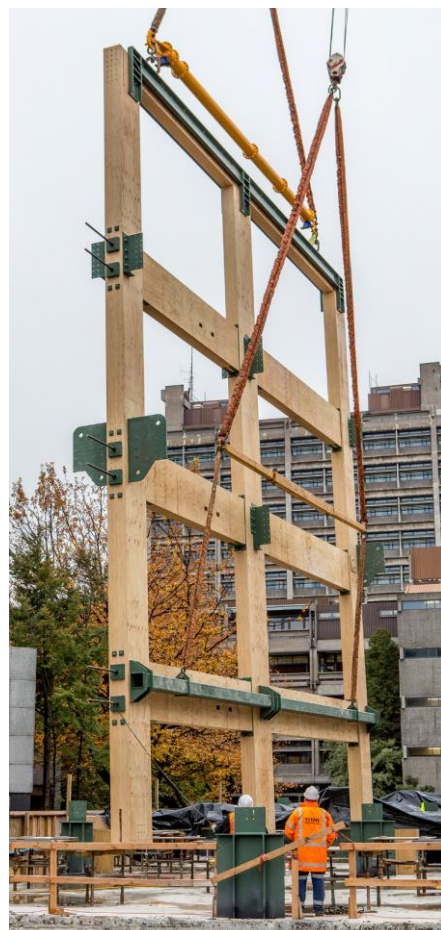
Figure 2: A post-tension timber frame being erected (courtesy of University of Canterbury)

Several Post-Tensioned Timber frame buildings have been built in New Zealand including Trimble (Brown et al., 2014), Merrit, St Elmo Courts and Beatrice Tinsley (Kirstein et al., 2018) buildings. An example of a post-tensioned timber frame and connection are presented in Figure 2 and Figure 3. Except for one building, which has a two-way frame and concrete columns, these buildings use post-tensioned frames in one direction. Most use grouted necked steel bars as dissipaters and use five to seven size 15 mm strands for tendons; reduced section steel angles and steel bars have not been used to the same extent. A variety of shear keys are used from stiffened steel angles or plates to SHS dowels. Typically, steel plates reinforced with screws or steel pipe are used to prevent crushing perpendicular to the grain of the column. Only one building has a heel-toe joint at the beam-column interface.

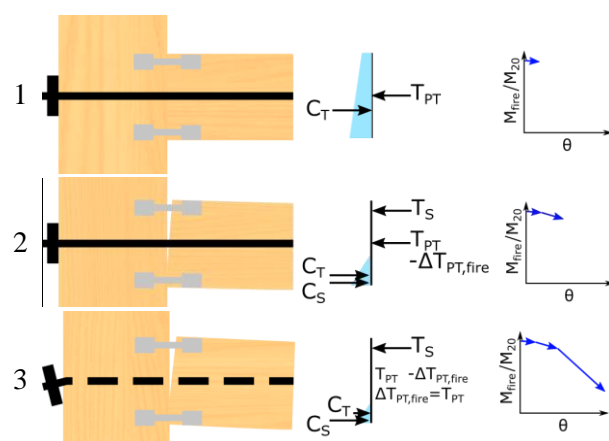
Figure 5: Stages of moment resistance

The evolution of moment resistance as the connection is exposed to fire can be described in three stages (Figure 5). (1) In the first minutes of exposure, the moment demand is less than the decompression moment. (2) As the tendon force decreases, the decompression moment is exceeded and a gap opens and the dissipaters are engaged to provide additional resistance. (3) As tendon force decreases to zero, connection rotations increase to maintain dissipater moment resistance. The moment capacity of the connection will eventually be exceeded when dissipaters will not be able to provide sufficient moment resistance.

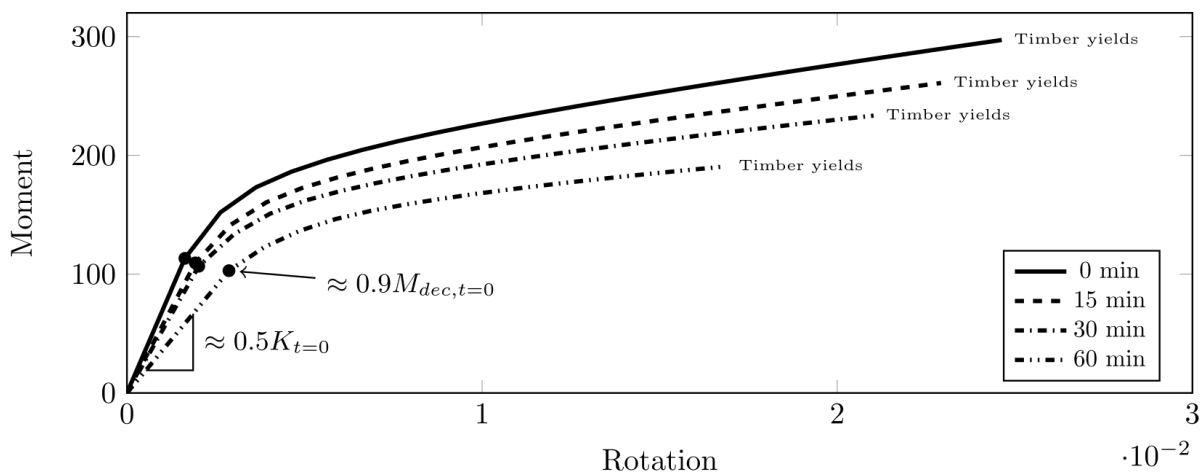
Figure 7: Moment-Rotation of a post-tensioned beam column connection under standard fire exposure

The resulting moment-rotation relationship for the connection after various exposures to the standard fire is presented in Figure 7. After 60 minutes the decompression moment has decreased by approximately 10%, whereas the stiffness has decreased by almost half.

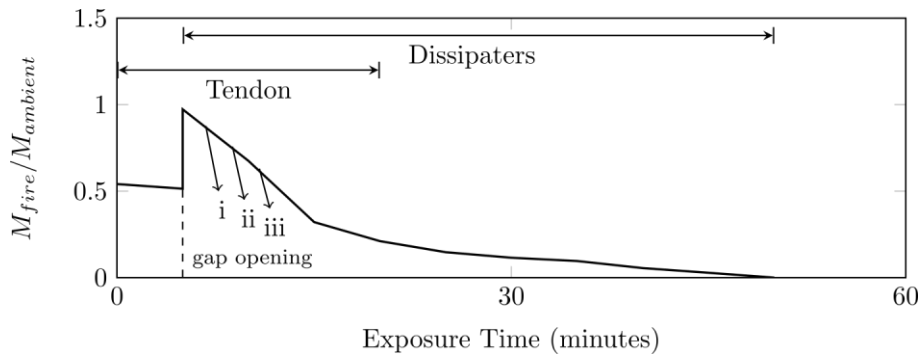
Figure 12: Estimated moment capacities of Connection 2 subject to standard fire exposure

The estimated moment capacity of this connection is shown in Figure 12. The gap between the beam and column face directly exposes the tendon to the fire and allows charring on all faces of the column and the end of the beam. The beam surface that bears on the shear keys is exposed to the fire. As this surface chars, a downwards displacement must occur to maintain bearing on the shear key. This vertical displacement will induce additional deformations in the connection and create secondary effects reducing moment capacity (shown as i, Figure 13a). The closely spaced rivets, will create superimposed thermal fields in the timber, reducing embedment strength and stiffness, and locally accelerating charring, reducing the load transfer mechanism from the beam to the dissipater (shown as ii, Figure 13b). The jacket plates which were tight at ambient develop slack as the column surface recedes due to charring, resulting in increased deformations to maintain the moment resistance (shown as iii, Figure 13b).
