2003 Pacific Conference on **Earthquake Engineering**

Preliminary results from the testing of a precast hollowcore floor slab building

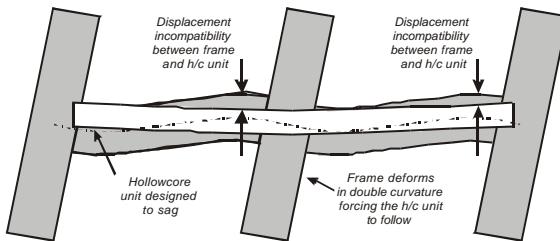
Figure 9. Displacement compatibility between the frame and the hollowcore floor units.

A hollowcore floor unit is designed to act as a simply supported one-way floor system. The first unit placed adjacent to the perimeter frame does not act in this manner as it is adequately tied not only at its ends but also along its entire length. This leads to the unit being displaced in a quasi-two way manner as the hollowcore unit is forced to undergo the displaced shape of the perimeter beam. This displacement incompatibility between the double curvature of the perimeter beam and the simply supported hollowcore unit causes the hollowcore unit to fail (Figure 8). Since the hollowcore unit has no redundancy in its design the unit fails through web splitting and the bottom half of the hollowcore unit drops.

If the unit was not tied along its length, in other words the hollowcore unit was not forced to undergo the displaced shape of the perimeter beam, then the unit would most probably perform better. If the unit is then detached from the perimeter beam then there are problems with the transfer of the inertia forces from the diaphragm to the perimeter moment resisting frame. This area requires a lot of additional attention.

Changing the way in which the first hollowcore unit is connected to the adjacent perimeter beam should allow the unit to perform in the manner in which it was intended by design—that is, a one-way slab. Two different connection details are proposed. The first involves a timber infill that allows a more flexible interface (Figure 10(a)). Damage is expected within this infilled section leaving the first hollowcore unit undamaged. The second is a detail that would need to be used if the bottom of the hollowcore unit is left exposed for an architectural finish (Figure 10(b)). This requires the unit to be butted against the perimeter beam. Placing some polystyrene against the edge of the first hollowcore unit and applying a bond release agent to the top of the first hollowcore unit, so that the topping does not bond to the unit, should allow the hollowcore unit to be de-bonded from the perimeter beam and permit the differential movement between the beam and slab as depicted in Figure 9.
