Retrofit to improve earthquake performance of bridge abutment slopes

P. Brabhakaran, J. Duxfield, S. Arumugam

Opus International Consultants, New Zealand.

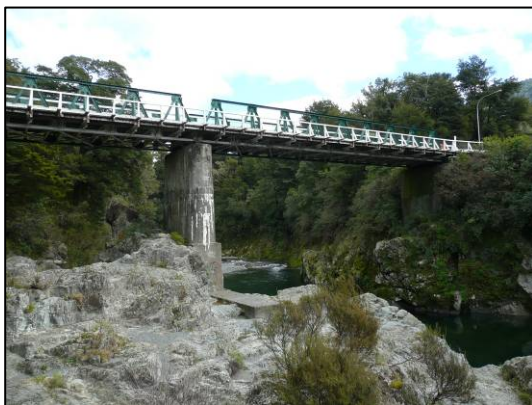
Figure 2. SH 6 Pelorus Bridge

The Nelson abutment and central pier of the bridge are founded on indurated sandstone bedrock, while the Blenheim abutment is founded on outwash gravels underlain by bedrock at shallow depth. It was assessed that the unfavourably oriented defects in the jointed rock mass at the Nelson abutment are likely to lead to planar rock slope failure under strong earthquake shaking, with a return period as low as 50 years. The cast in situ concrete abutment walls were also vulnerable to large displacements in 250 to 300 year return period earthquake shaking.

Rock anchors were chosen as the most economic method to retrofit both abutment walls as well as the rock bluff below the Nelson abutment, given the presence of good bedrock at shallow depth. Both concrete abutments were strengthened using a concrete overlay, and anchored back using rock anchors comprising double corrosion protected 32 mm diameter 1030 MPa Macalloy bars grouted into 150 mm diameter holes, see Figure 3. The wing walls were also tied back using anchors between opposite wing walls on each abutment. The rock blocks in the bluff below the Nelson abutment were rock bolted using double corrosion protected 25 mm 500 MPa Reid bars grouted into 130 mm diameter holes. The Macalloy and Reid bars were chosen because of their ductile post-yield behaviour.

With the anchors in place, the abutments and underlying rock are secured against movement or failure in 0.36g peak ground accelerations with a 1000 year return period. The anchors were designed using capacity design principles to ensure ductile failure by yielding of the anchor bars under seismic overload, rather than failure in a brittle manner by either rock-grout bond or grout-bar bond failure. This was achieved by providing greater strength reduction factors for these more brittle failure mechanisms, and the ductile elongation of the bars accommodating some displacement, and allowing associated reduction in earth pressures on the walls.

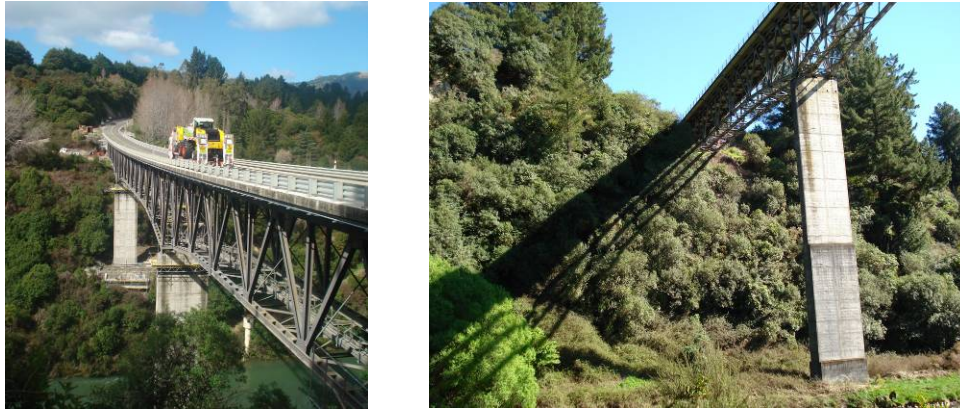
Figure 4. SH 5 Mohaka Bridge

The southern abutment slope was underlain by fill and weak alluvium deposits, with potential for large displacements of up to 450 mm in a 500 year return period event (0.41g peak ground acceleration). Such displacements had the potential to cause significant damage to the four slender reinforced concrete 400 mm octagonal driven piles supporting the southern land span Abutment F and the bearings, and possibly lead to collapse in larger events.

A number of options including drainage, stone columns, H-piles and soil nails were considered. Soil nails were chosen as the most economical and practical solution to reduce the amount of slope displacement and hence damage to the bridge foundations. Stone columns and H piles would be difficult to install given the limited head room below the bridge, and the presence of raked piles.

However, given the variable poor alluvial ground conditions, ordinary soil nails would not give adequate capacity and would give large displacements. The soil nails were *post-grouted* at 300 to 500 psi grout pressures through nodes in a post-grout tube grouted in during the initial grouting of the double corrosion protected bar assembly into the holes. This *post-grouting* technique for soil nails was originally developed for the Wellington Inner City Bypass project (Brabhaharan, 2007), and was adapted to suit this site. Soil nail pull-out tests were carried out to confirm design parameters and their suitability to give an adequate level of earthquake performance. The post-grouted soil nails reduced earthquake induced displacements of the abutment slope in a 1000 year earthquake, to less than 50 mm, which can be tolerated by the existing sub-structure.

Pier D of the bridge was also protected with rock bolts installed to stabilise the steep slope below its foundations.

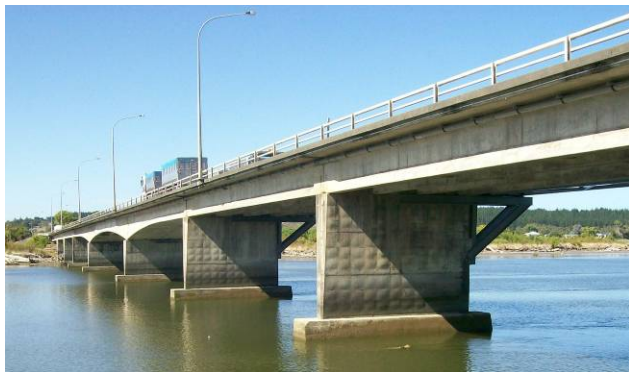
Figure 8. Cobham Bridge across the Wanganui River

A detailed description of the bridge, seismic assessment and retrofit is presented by Brabhaharan et al (2009). Geology of the area is alluvium comprising sand and silt of Holocene Age, deposited in an estuarine environment. The Cobham Bridge site has the potential for liquefaction, and consequent lateral spreading. Liquefaction will almost certainly lead to slope failure, and lateral spreading of the embankments, either during earthquake shaking or in the hours afterwards while the pore water pressures in the liquefied soils remain high. The abutment structure is expected to fail under large forces from the embankment fill.

A novel triangular shaped area of ground improvement behind each abutment, using stone columns and wick drains (see Figure 9) was adopted to protect the abutment while allowing lateral spreading or failure of the approach embankment slope away from the abutment. This design philosophy recognises that provided that the structure is protected from failure, the approach embankment could be relatively quickly reinstated by earth moving machinery after a major earthquake. This approach optimised the area of ground improvement, leading to a cost effective solution.

A new construction approach was adopted, comprising drilled and compacted stone columns. Holes were drilled to 600 mm diameter with casing providing temporary support. A central steel probe was lowered into the hole, clean 5 mm to 50 mm size aggregate was poured into the hole in stages, as the casing and probe were withdrawn, with compaction by concurrent vibration. This enabled implementation on an active highway without causing failure of the embankment during construction. Areas in front of abutments were improved by trench drains to facilitate porewater pressure dissipation and avoid liquefaction, and replacement of liquefiable sands with dense gravels, see Figure 9.
