# Damage assessment, analysis and modelling of bridges in non-liquefiable soil during Canterbury earthquakes

2012 NZSEE  
Conference

A. Palermo & M. Brando

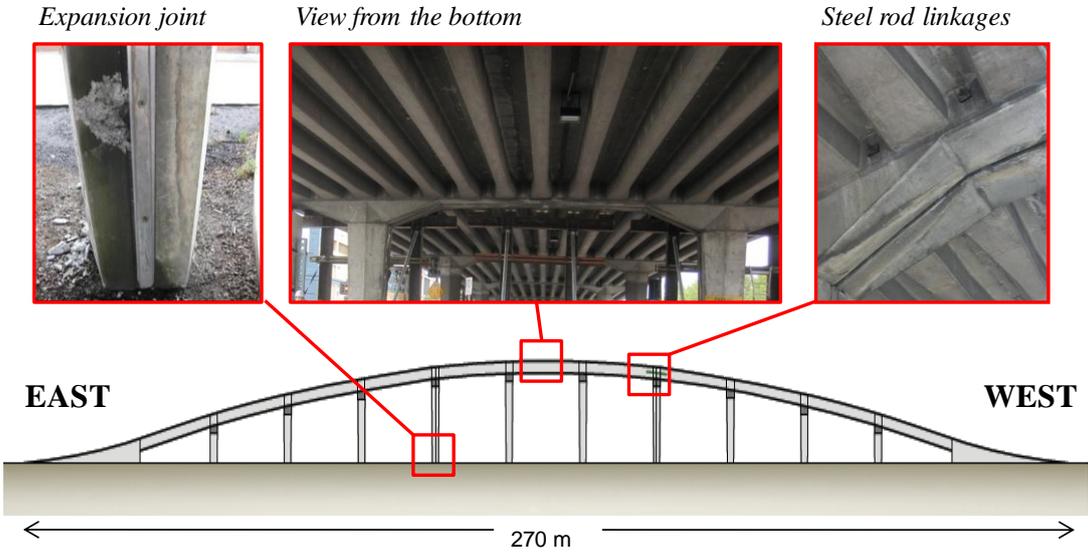
itself is one of the four avenues that encase the CBD, allowing traffic to flow around the CBD. Built in 1964, the reinforced concrete T-beam superstructure is supported by two-column bents. The bridge is founded on 406 mm diameter octagonal reinforced concrete piles. The structure was constructed in three sections, separated by expansion joints (Figure 4).

Figure 4. Moorhouse Avenue Overpass. Sketch of the bridge elevation with location of the expansion joints and steel rod linkages (Palermo et al. 2011).

During the February earthquake, piers were significantly damaged with shear cracking and buckling of longitudinal rebars. The bridge sustained damage to one column near the North-East approach where a deck expansion joint was located. The insertion of steel rod linkages in the deck at the expansion joint at the only West side of the bridge caused irregularity in the bridge structure (Figure 4). In fact, because of the West and central part of the linked bridge, the pier at the East expansion joint suffered extensive displacement demand. The slenderness of the pier affected the vertical load carrying capacity of the structure along with the lateral capacity. The columns had also widely spaced transverse reinforcement, making the structure susceptible to a brittle failure mechanism (Figure 5a).

Observations after the Christchurch event indicated that the damaged columns had started to buckle putting the central span at risk of collapse. Due to the higher displacement demand in the West-Central part of the bridge, the deck pounded against South-West abutment of the bridge causing extensive spalling and bar buckling (Figure 5b). Strengthening works were erected around the failed pier. These consisted of two built up square block concrete columns with timber blocking to prop the bridge while further works were undertaken. A multi-span structural steel frame was designed and constructed spanning between the two failed columns, as a temporary solution to prevent the collapse of the damaged section. This solution did not provide any additional lateral stability and therefore the overbridge was not reopened to vehicle traffic until March 31, 2011, when the final repair solution consisting of dual cross-bracing units at each of the weakest piers was constructed (Figure 5c).

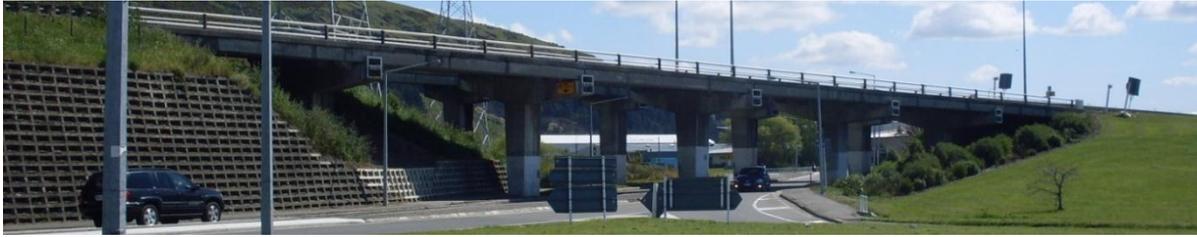
Figure 7. Overall view of Port Hills Road Overpass [Courtesy of OPUS].

During the Christchurch earthquake, flexural cracking developed in the lower halves of the piers of both bridges except those adjacent to the abutments. In fact, despite the presence of the linkage rods increased the deck diaphragm action, this was not enough to control the higher displacement demand occurring in the central piers. Soil gapping at ground level occurred at the faces of most of the pier stems with separation cracks up to 15 mm wide. Spalling occurred at the base of the central pier, and the longitudinal bars started to buckle (Figure 8a). The damage increased during the June 13, 2011 aftershock. The nominal 10 mm gaps between the new shear keys and the abutment face at the South-East abutment closed up with no clearance on two of the four keys.
