Network protection without compromise – Deconstruction of 91 Hereford Street for Telecom

D.M. McGuigan & C. Hill

Aurecon New Zealand Ltd, Wellington & Christchurch.

2014 NZSEE
Conference

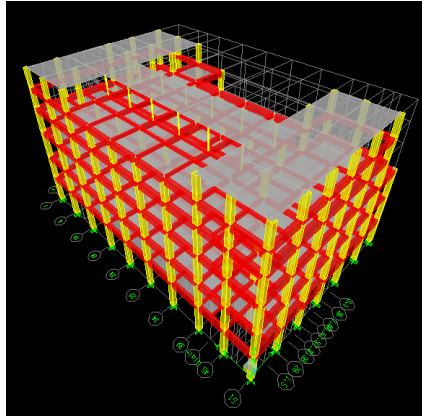
Figure 3. Image of ETABS model developed to analyse the building

To give a better degree of accuracy of the building's seismic capacity a detailed seismic analysis was undertaken. This included developing a three dimensional model to simulate the building's response to earthquake actions using ETABS software. Member capacities for the primary structural frames acting as moment resisting frames were computed. These sections, in particular the column members, were complex due to their compound nature of having several separate sections encased within concrete. A nominal 10% enhancement of the section capacity was incorporated to allow for the beneficial effects of the concrete encasement. Figure 3 provides an image of the ETABS model developed to analyse the building.

The assessment confirmed that the primary structural frames could be considered very resilient in terms of their seismic capacities. Analysis of the results indicated that the building exceeded an 80% NBS capacity when considered as an Importance Level 2 building. The key deficiency of the building was the brittle nature of the facades.
