A novel approach to rehabilitation of a church in Fendalton, Christchurch

S.J. Neill & A.S. Beer

Beca Ltd, New Zealand.

2014 NZSEE
Conference

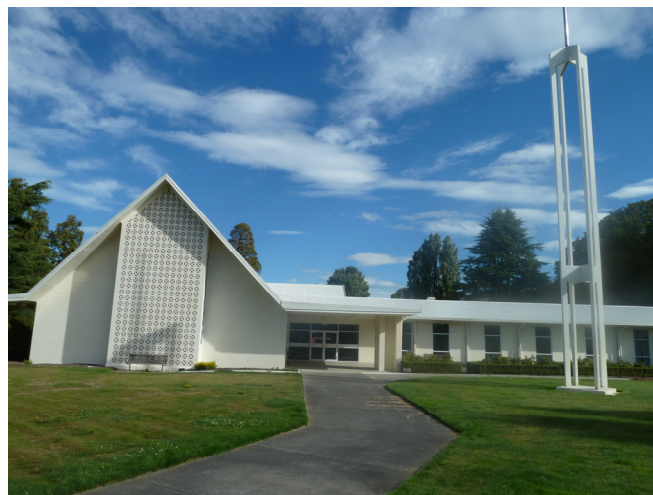
Figure 1. The front view of the church in Fendalton.

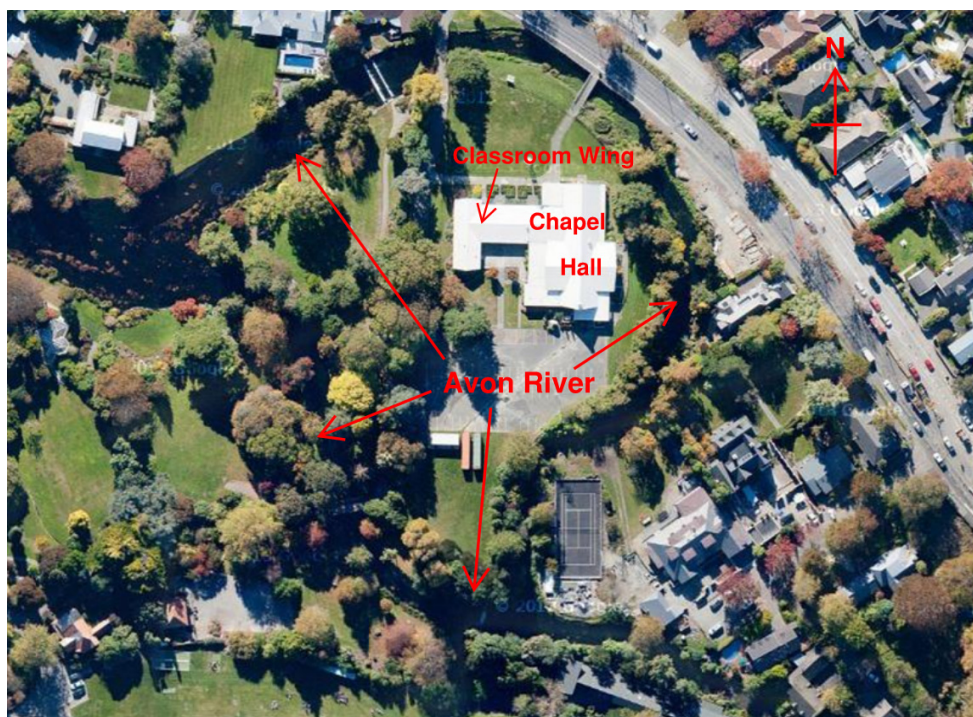
Figure 2. The site of the church in Fendalton.

The unique site in Fendalton, Christchurch is completely surrounded by the Avon River (as shown in Figure 2). The shallow soil in the area largely comprises alluvial deposits from the river that have built up over time. The relatively soft sandy/gravelly soil extends to a depth of at least 15m. Due to the close proximity of the river and Christchurch being of largely flat terrain, the water table is only approximately 1.5m below ground at the location of the building. Saturated loosely compacted sandy soils of this type are of course susceptible to liquefaction during an earthquake.
