Post-Seismic Capacity of Damaged and Repaired Reinforced Concrete Plastic Hinges Extracted from a Real Building

2017 NZSEE
Conference

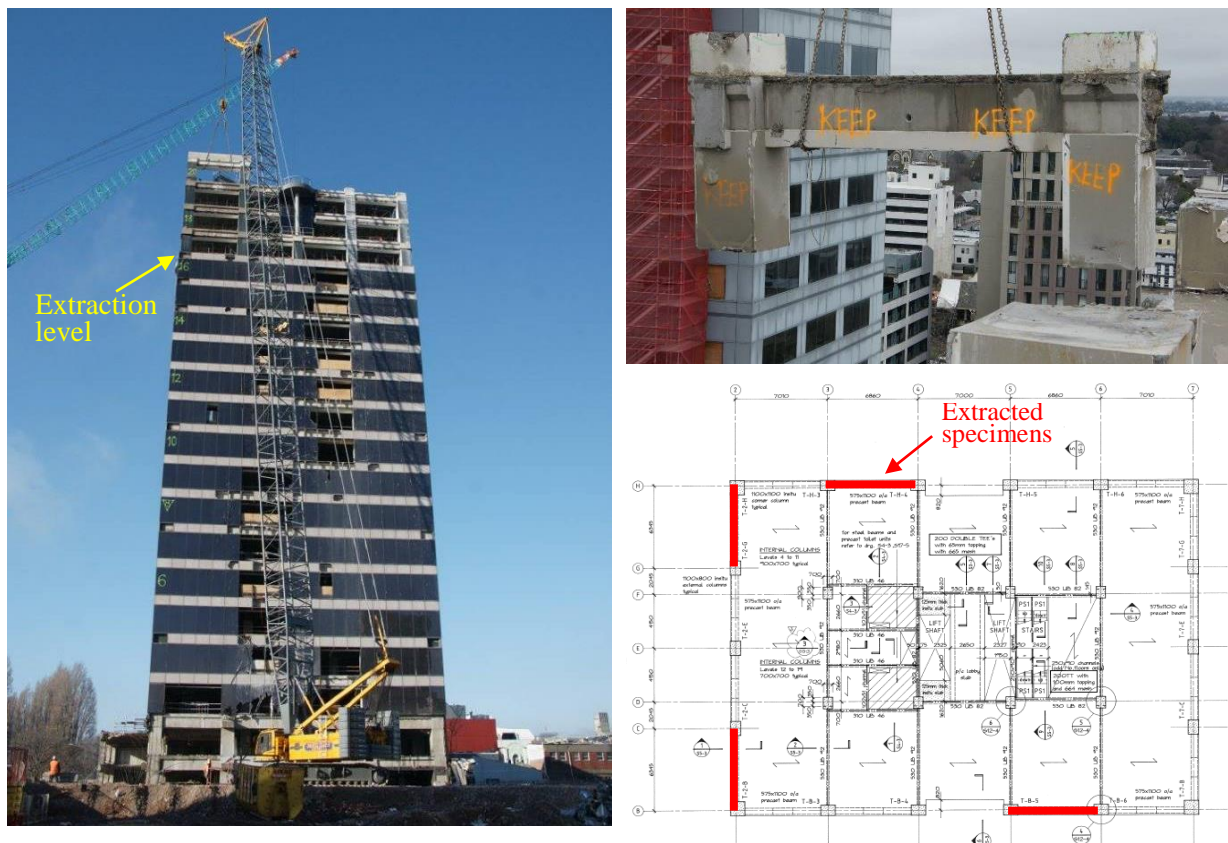
Figure 1. Elevation of the PwC building during the deconstruction process (left); extraction of one of the “H frames” (upper-right); typical floor plan view at the upper levels (lower-right), red lines indicate locations where the specimens were taken out of the 16th floor level.

During the CES, the building appeared to behave as expected, with the beams developing plastic hinges at both ends along the full height of the structure, with a general trend of diminishing level of damage along the elevation. The columns or joints did not show any sign of damage. The building experienced more damaged in the EW direction, consistent with the direction of the strongest components recorded in the surrounding area. Maximum observed residual cracks varied between 0.8 mm and 20 mm wide in the EW direction, and between 0.4 mm and 8 mm in the NS direction.

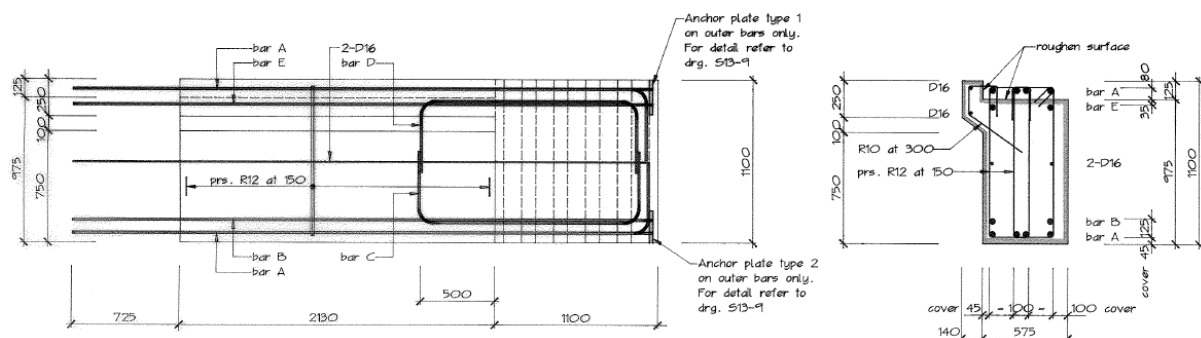
Figure 3. Typical section and elevation view of beams tested (Holmes Consulting Group, 1988).

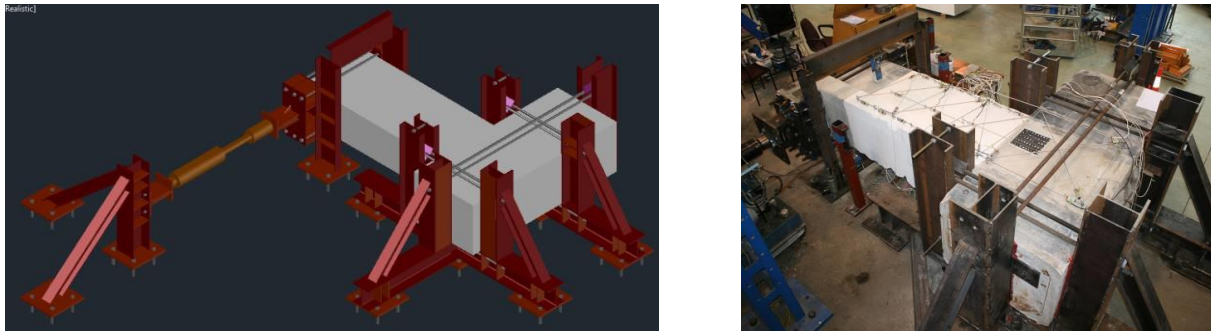
As shown in Figure 4, the reaction frame used for the tests consisted of steel braced frames anchored to the RC strong floor. The beam-column joint was placed horizontally on top of steel beams and clamped to the braced frames with steel channels and post-tensioned Macalloy bars. The beam-end was vertically supported on Teflon pads. A steel frame with a roller prevented the beam-end to uplift due to any accidental eccentricity that might occur at the actuator-to-beam connection. No axial and gravity loads were applied at the column (in addition to the resultant force from the post-tensioned bars) and beam, respectively.

Figure 4. 3D CAD view of the reaction frame (left); specimen 1 during the tests (right).

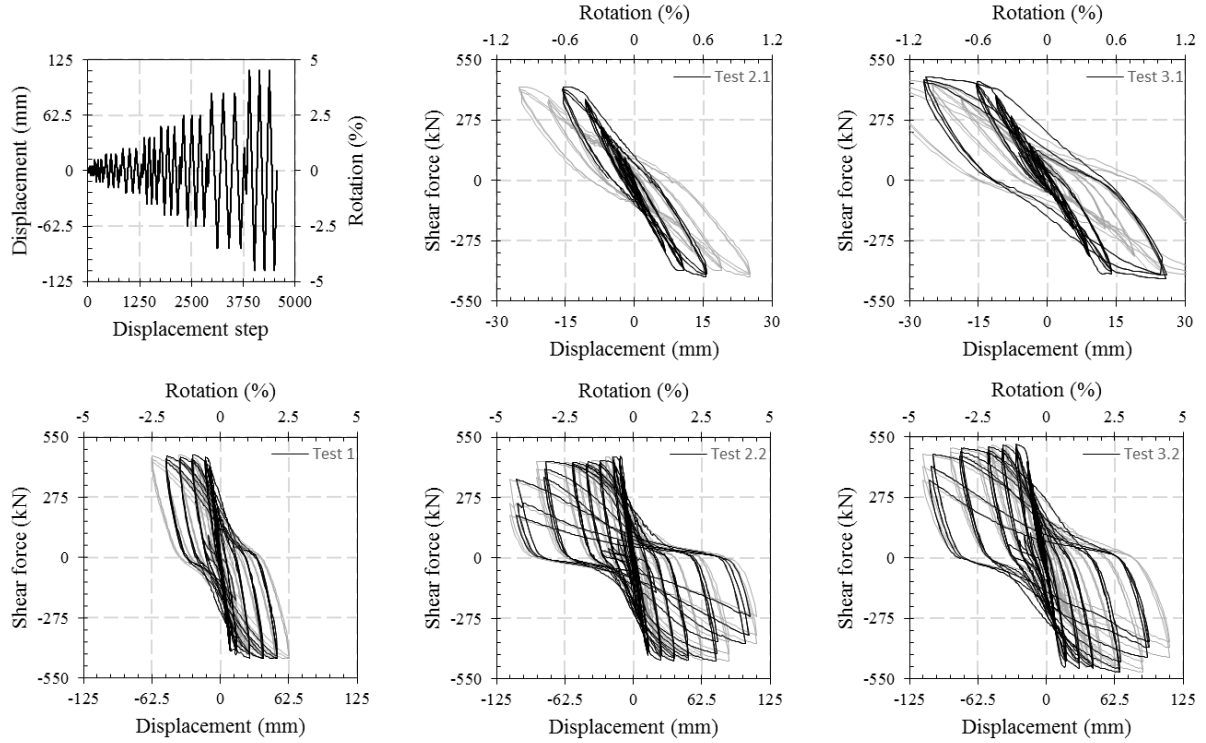
In Figure 10, solid grey lines represent force-displacement curves measured in “total” displacement units, whereas solid black lines are in “effective” displacement units (i.e., the “total” applied displacement minus the equivalent lateral displacement at the beam end due to rigid body translation and rotation). The onset of nonlinearity occurs at about 0.5% “effective” beam rotation. Rotation ductility demands of around 1.20 and 2.10 were achieved at the end of Tests 2.1 and 3.1, respectively.

in strength during the last 3 cycles in both repaired configurations (Tests 2.2 and 3.2). Higher pinching behaviour, due to cracks opening and closing and more likely due to bond-slip degradation, was observed in the repaired configurations, in particular for Test 2.2.

When considering Test 3.2, the relocation of cracks outside the plastic hinge relocation detail led to higher shear forces for the same displacement demand and a more stable hysteresis loop with less pinching. Overall, the effective displacement (capacity) achieved in the test was lower than in other tests.

Figure 10. Applied loading protocol (upper-left), and force-displacement curves.

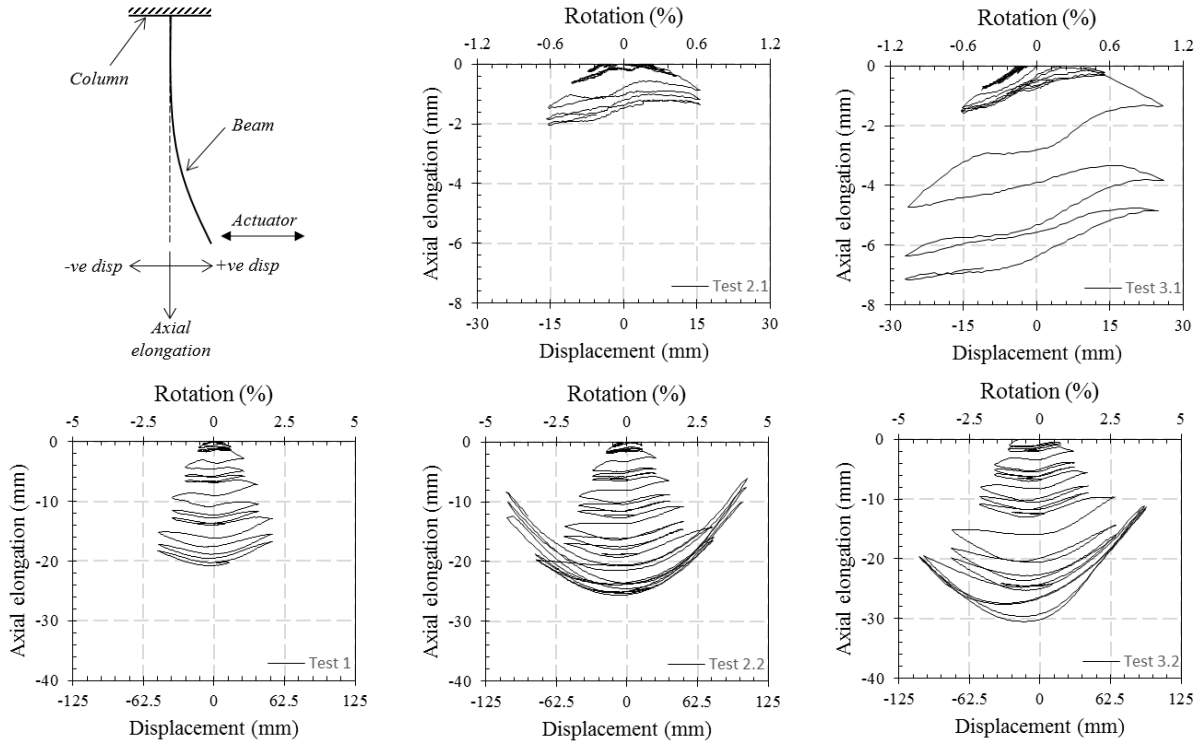
Figure 11 shows the axial beam elongation for all the tests. It can be noted that the beam elongation is permanent and cumulative. Maximum elongations in Tests 2.1 and 2.2 were 2 mm and 7.2 mm, respectively, equivalent to 0.08% and 0.29% increase in beam length. These beam elongations were consistent with the maximum cracks widths observed at the end of the tests. Maximum elongations in Tests 1, 2.2 and 3.2 were 21mm, 26mm, and 30mm, equivalent to 0.85%, 1.05%, and 1.20% increase in beam length, respectively. It is worth noting that the testing apparatus allowed for free beam elongation without any restraint action from the floor diaphragm as in fact would occur in the real building. Therefore, while the results are important to develop a better understanding of the behaviour of a “free” subassemblies, the beam elongation results are not fully representative of what we would have observed following the earthquakes.

Figure 11. Displacement sign convention (upper-left), and beam elongation curves.

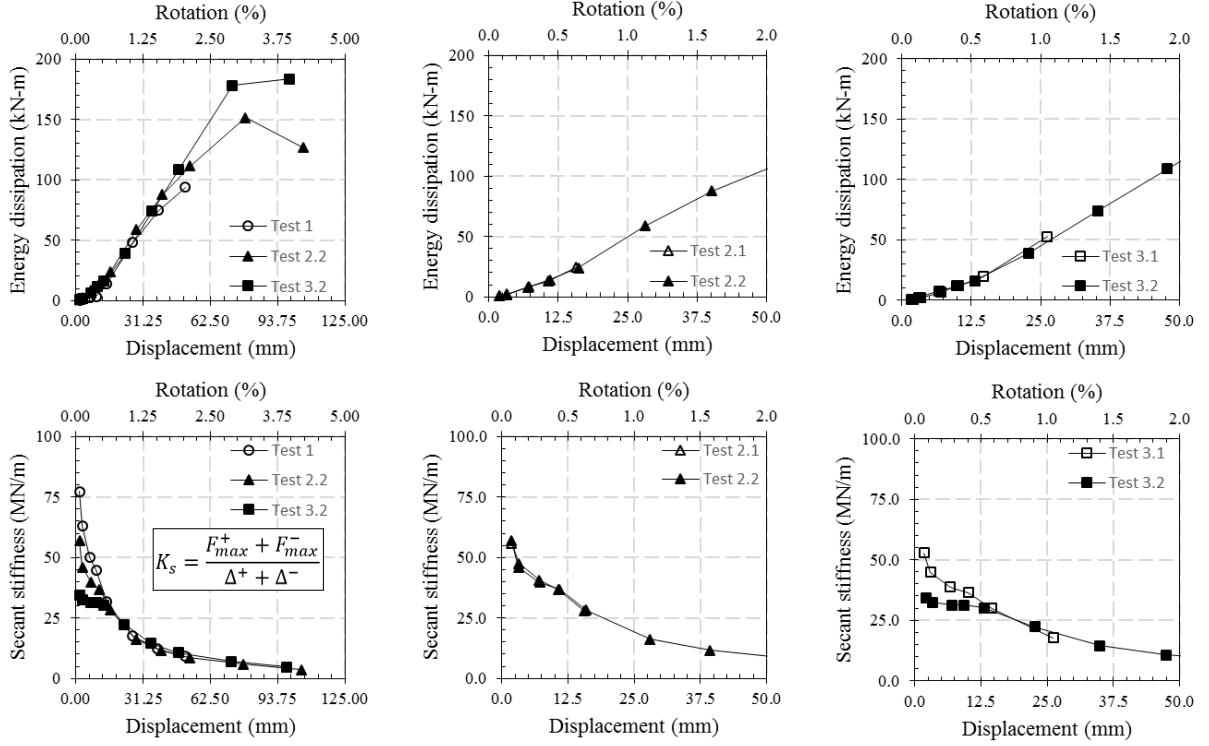
Figure 12 (top) shows cumulative energy dissipation computed as the sum of the area enclosed within the force-displacement curves, computed in “effective” displacement units. As shown in the figures, more energy is dissipated in Test 3.2 than in Test 2.2 (and arguably more than in Test 1 if we can infer that following the trend in the graph). This can be attributed to the less pinching as a result of more damage relocation (flexural type, outside the plastic hinge relocation detail). In general, reasonably good energy dissipation at both low (SLS) and high (ULS) rotation levels was achieved in the repaired specimens when compared with the slightly damaged specimen (Test 1).

As shown in the figures, there is a reduction of stiffness in the repaired specimens (both Test 2.2 and 3.2) at low rotation levels (below to the onset of nonlinearity, approximately) when compared with the slightly damaged specimen (Test 1). There is a better stiffness recovering (at low rotation levels) in Test 2.2 than in 3.2, possibly because of its lower damage condition prior to the repairs. The secant stiffness of Test 2.2 is also closer to the one obtained in Test 1, and the same in Test 2.1. In general, the secant stiffness does not seem to be significantly affected at high (ULS) rotation levels when compared with Test 1.

Figure 12. Energy dissipation (top) and secant stiffness degradation at 1st cycles (bottom) characteristics.

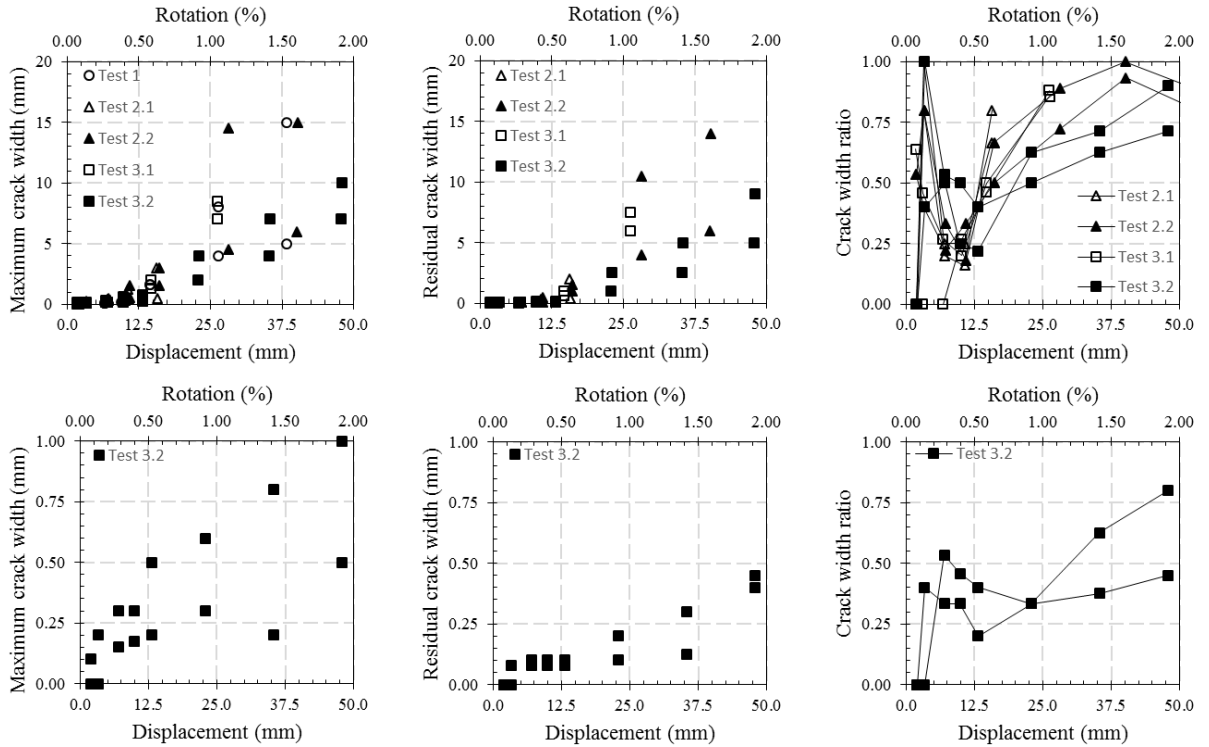
Figure 13 shows maximum and (static) residual crack widths measured during the tests. The top figures correspond to the most critical crack(s) observed within the plastic hinge relocation detail (i.e., shear-flexural cracks); the bottom ones correspond to flexural cracks observed outside the plastic hinge relocation detail during the Test 3.2. The maximum crack widths are measured at peak force, whilst the residual crack widths at zero force. Worth reminding that these residual cracks are “static” ones. The dynamics effects during the earthquake, as well as any axial load contribution, i.e. slab engagement effect resisting to the beam elongation, would further reduce them, thus increasing the maximum/residual ratio (Christopoulos et al., 2003; Pampanin et al., 2003).

Crack width ratios computed as the residual crack width upon the maximum residual crack width are also shown in the figure. It is evident how the crack width ratios are rotation (i.e. drift) dependant, showing a change of slope from negative to positive at rotations near or at the onset of nonlinearity. The negative slopes below the onset of nonlinearity are due to the fact that at low rotation levels the residual cracks are very small and almost constant (hairline-to-0.1 mm in width), regardless of the increase of the maximum crack widths as the rotation level increases. This is in line with recent post-earthquake observations (Pampanin et al., 2012; SESOC, 2011) where hairline-minor residual crack width, particularly when axial load effects contribute to the closure of the cracks, could in fact hide non-negligible, if not significant, damage, including tensile fracture of the bars, especially in lightly reinforced shear walls.

Figure 13. Maximum and residual cracks, and crack width ratios within (top) and outside (bottom) the plastic hinge relocation detail.
