The Mibar Building - an Architect's and Engineer's perspective on the seismic strengthening of a heritage building

M. Geddes, F. Vessey & C. Ashby

WSP Opus, Wellington.

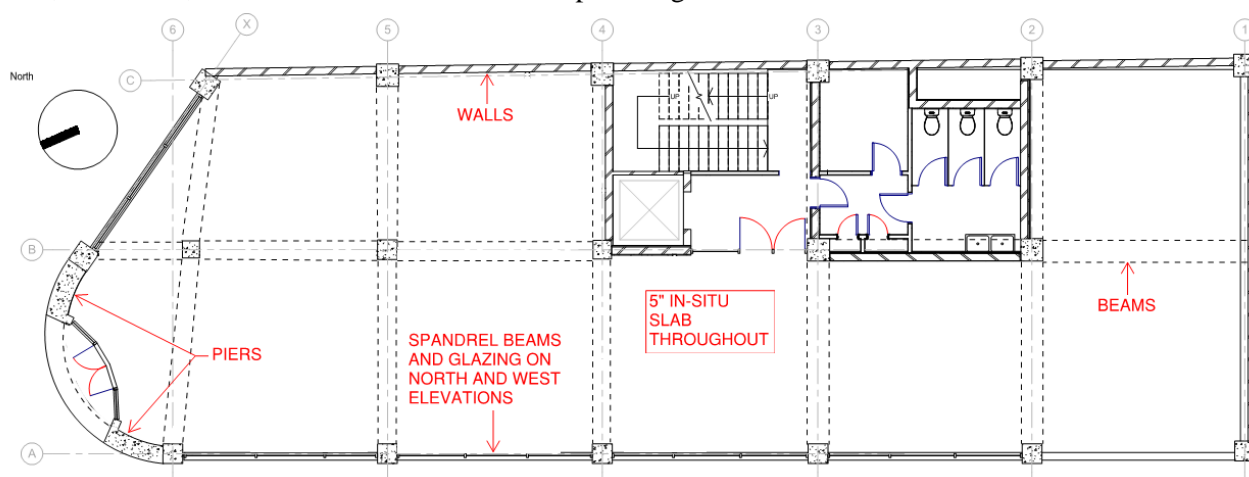
Figure 5: Typical Floor Plan

Structon Group designed this in-situ reinforced concrete building and the later addition of a lightweight steel framed penthouse. Lateral loads are resisted by shear walls with some contribution from moment frames. The wall elements (external walls and shear core) are concentrated in the east and south of the building creating a plan stiffness eccentricity and associated torsional effects. There are moment frames on the north and west elevations, and on internal gridlines. A typical floor plan is shown below (Fig. 5).

The strengthening has removed the critical weakness at the ground floor on the curved north elevation, where the beam and columns had the potential to fail in shear and compromise gravity load paths. As seen in Fig. 6 the work was confined to this relatively small portion of the building. By targeting this weakness the building's inherent strength provided by the numerous shear walls (Fig. 5) is able to be better utilised.
