NEW ZEALAND SOCIETY FOR EARTHQUAKE ENGINEERING  
**2019 Pacific Conference on  
Earthquake Engineering**  
TURNING HAZARD AWARENESS INTO RISK MITIGATION  
4 – 6 April | SkyCity, Auckland | New Zealand

# Lessons learned and need for appropriate philosophy for the design of stone column ground improvement under seismic scenarios

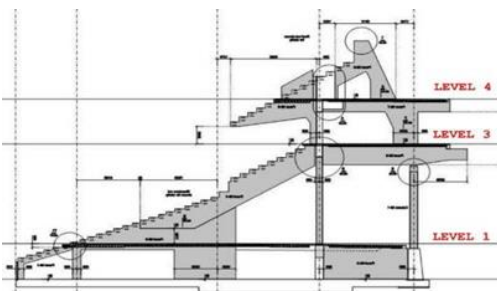
Figure 2: East-West section through Deans Stand

This ground improvement was constructed only beneath the footprint of the main part of the Deans Stand structure. It comprised vibro-replacement stone columns extending to a depth of approximately 9m below ground and concentrated in bands centred under the structural grids. Stone columns were notionally 900mm diameter, constructed on a variable sized (up to 2.7m) triangular grid. The minimum area replacement ratio was approximately 10%. Heavier structural loads were concentrated on defined rows of stone columns. The stone columns are stiffer than the ground around them, so they carry a large proportion of the gravity load from the overlying structure. They improve shallow bearing capacity and reduce settlement under static loads. The liquefiable ground below the stand was only treated to partial depth, with the intention of creating a non-liquefying crust or soil raft. A raft slab was not provided at ground level; instead, flexible pavement was constructed between the radial and circumferential ground beams.
