NEW ZEALAND SOCIETY FOR EARTHQUAKE ENGINEERING  
**2019 Pacific Conference on  
Earthquake Engineering**  
TURNING HAZARD AWARENESS INTO RISK MITIGATION  
4 – 6 April | SkyCity, Auckland | New Zealand

# A conspectus of wine storage tank damage data following the 2013 and 2016 New Zealand earthquakes

*M. Yazdanian, J.M. Ingham & D. Dizhur*

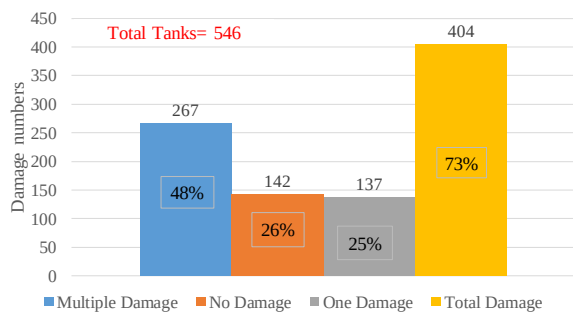
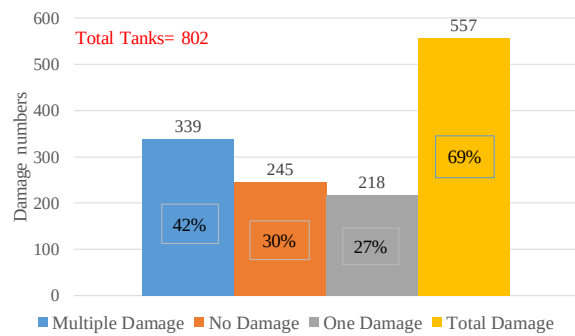
(a) Damage percentage to flat-based tanks (2013 earthquakes)

Typical damage examples of flat-based tanks and percentage of their damage type in the tank inventory can be seen in Figure 2. Figure 3a,b shows that although wineries sustained typically lower PGA in the 2013 earthquake, flat-based tanks sustained slightly more damage in the 2013 earthquakes (73%, 404 out of 546 tanks), compared with the 2016 earthquake (69%, 557 out of 802 tanks). Following the substantial losses during the 2013 earthquakes, wineries started to account for earthquake resilience in their short-term and

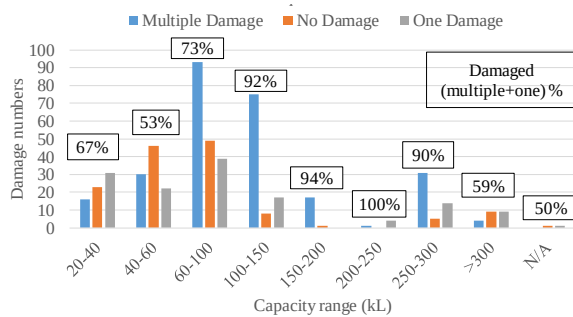
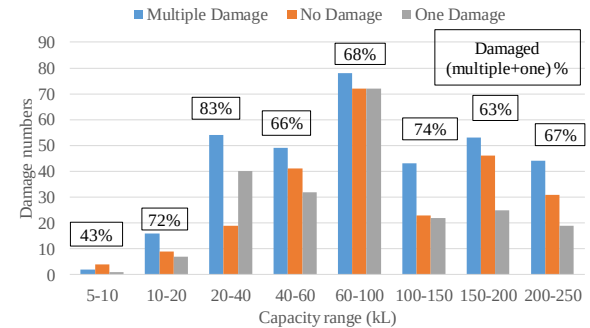
(c) Damage percentage to flat-based tanks based on capacity range (2013 earthquakes)

Tank capacity was a parameter that had a significant influence on the extent of damage to wine flat-based tanks (see Figure 3c,d). In the 2016 earthquake, inspected wine tanks with a volume between 20-40 kL sustained the largest damage among all ranges of capacities. During the site inspection following the 2016 earthquakes, it was identified that wineries placed emphasis on strengthening of larger capacity wine tanks, leaving smaller wine tanks mostly un-anchored or with outdated anchorage systems (see Figure 4). In the 2013 earthquakes, there was a substantial decline in the percentage of damaged tanks with capacity of larger than 300 kL (59%, 13 out of 22 tanks) and tanks with capacity range of between 150 kL and 300 kL (see Figure 3c). Such large capacity tanks (above 300 kL) were typically used for water storage and sustained minor (tank base shell) or no damage due to having a low height to radius aspect ratio and continued their operation following the earthquakes (see Figure 5).

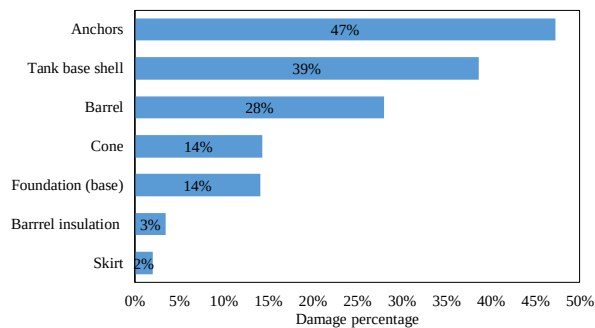
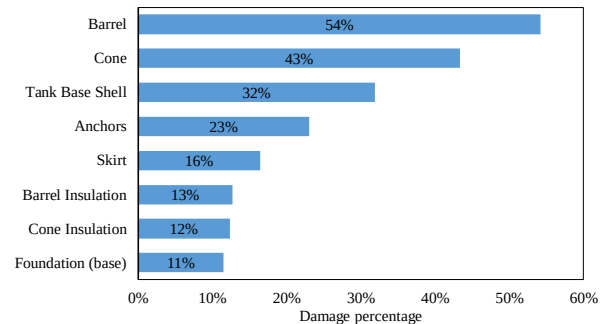
(e) Percentage of damage to different parts of flat-based tanks (2013 earthquakes)

In-field damage assessment following the 2013 earthquakes revealed that anchor (47%) and tank base shell (39%) parts of flat-based wine tanks sustained the largest percentage of damage, while damage to the anchors and tank base shell reduced to 23% and 32%. In the 2016 earthquake, damage to the barrel (54%) and cone (43%) parts of the tanks stood as the most significant reasons that caused damage to the flat-based wine tanks (see Figure 3e,f).

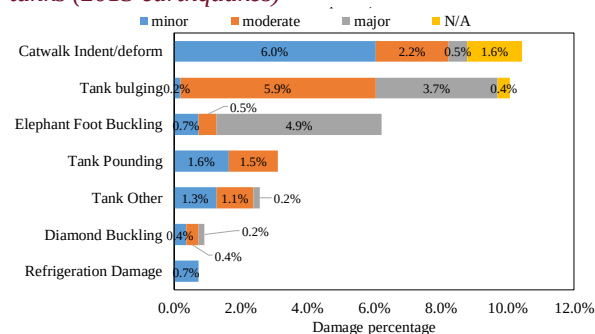
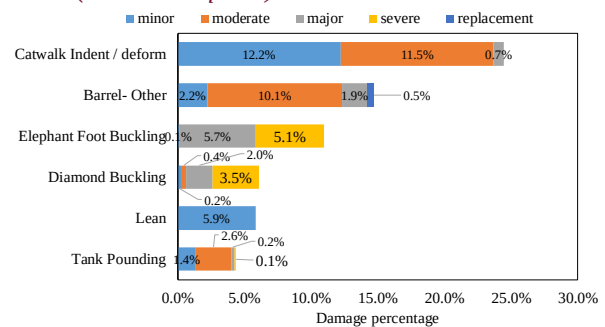
(g) Percentage of different failure modes that caused damage to barrel parts of flat-based tanks (2013 earthquakes)

In the 2016 earthquake, elephant-foot buckling (11%) and diamond shaped buckling (6.1%) caused the highest percentage of severe (section replacement) damage to the barrel (Yazdanian et al. 2018), where above 90% of the buckled tanks required remedial works (see Figure 3g). Elephant-foot buckling (see Figure 2i) generally occurs in tanks that are mostly fully filled, is an elastic-plastic type of instability (NZSEE 2009), (Sobhan, Rofooei, and Attari 2017), (Spritzer and Guzey 2017), , and can be described as an outward bulge of the tank shell. Diamond shaped buckling (see Figure 2h) is a type of elastic instability (NZSEE 2009), (Sobhan, Rofooei, and Attari 2017), (Spritzer and Guzey 2017). Sobhan et al. (2017) stated that elephant-foot buckling of the steel tank wall is caused by the interaction of both circumferential tensile stress close to the yield strength and by axial compressive stress exceeding the critical stress, whilst diamond shaped buckling is caused by severe axial compressive stresses. A vast majority of the anchors with earthquake related damage (94%) in the 2016 earthquake required replacement (see Figure 3i,j).

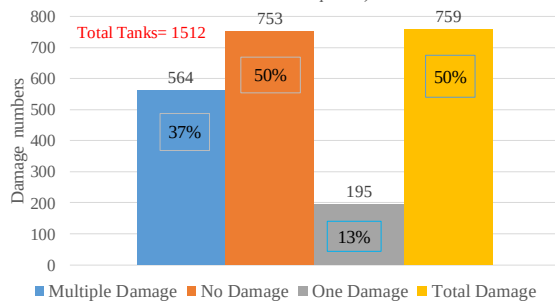
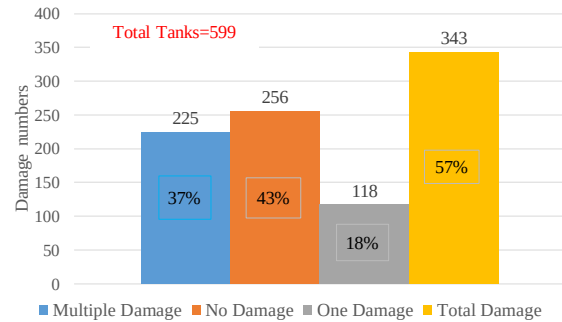
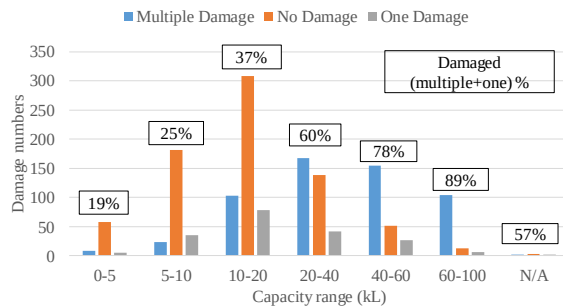
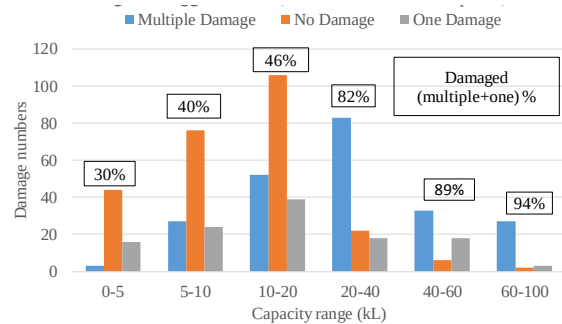
(a) Damage percentage to legged tanks (2013 earthquakes)

Examples of typical damage to legged wine tanks and percentage of each damage type for all legged tanks in the inventory can be seen in Figure 6. In the 2013 earthquakes, 50% (756 tanks) of the 1512-legged tanks in the inventory sustained damage (see Figure 7a). Out of 599-legged wine tanks that were inspected following the 2016 earthquake, 57% (341 out of 599 tanks) sustained damage (see Figure 7b). The effect of tank capacity was more severe for the legged wine tanks compared with the flat-based wine tanks, where in the 2013 and 2016 earthquakes, percentage of damaged legged wine tanks increased with increasing tank capacity (see Figure 7c,d).

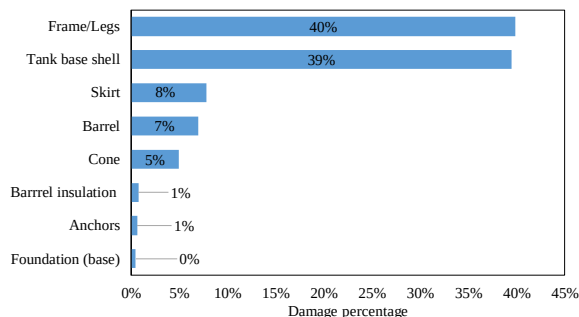
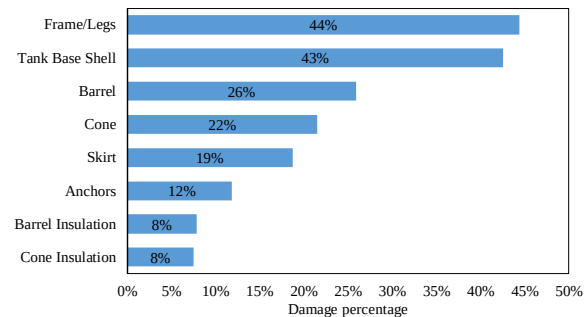
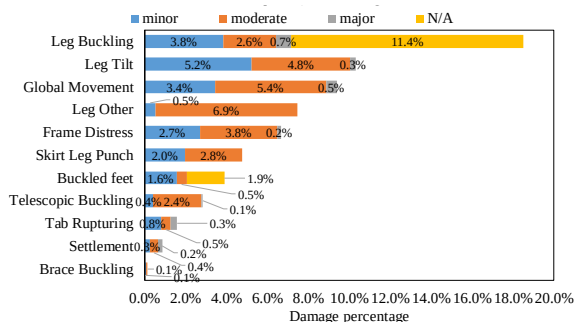
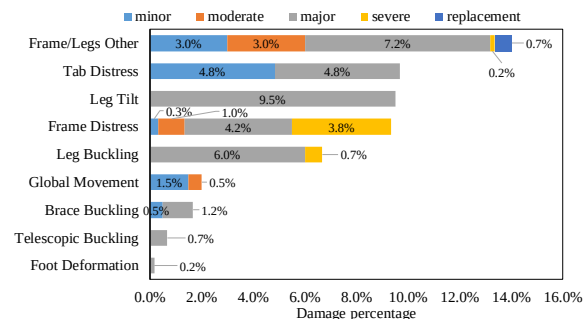
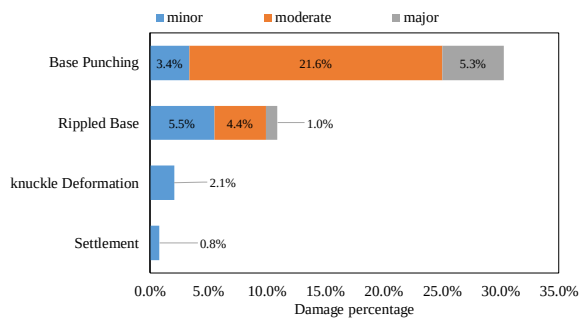
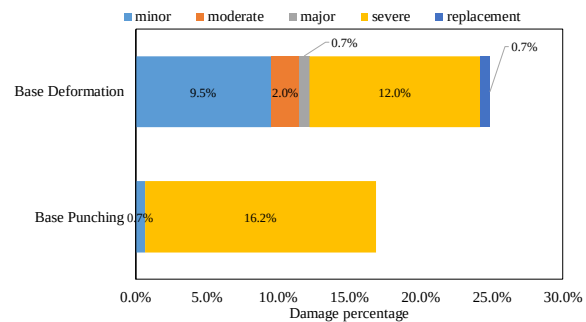
(e) Percentage of damage to different parts of legged tanks (2013 earthquakes)

Damage to the frame/legs of legged wine tanks had the highest percentage among the tank elements in the 2013 (40%) and 2016 (44%) earthquakes (see Figure 7g,h). The second most damaged parts of the legged wine tanks were the tank base shell, with 39% in 2013 and 43% in the 2016 earthquake, where almost 68% of the tanks with base shell related damage required section replacement (see Figure 7j). Rippled base, knuckle deformation (see Figure 6m,n), and settlement (see Figure 6 f) in the 2013 earthquake (see Figure 7i) was summarised to base deformation in 2016 (see Figure 7j).
