NEW ZEALAND SOCIETY FOR EARTHQUAKE ENGINEERING  
**2019 Pacific Conference on  
Earthquake Engineering**  
TURNING HAZARD AWARENESS INTO RISK MITIGATION  
4 – 6 April | SkyCity, Auckland | New Zealand

# Post-earthquake recovery phase of winery facilities. A case study in the Marlborough area

*G. Loporcaro, A. Palermo, W.J. Campbell & D.C. Hyndman*

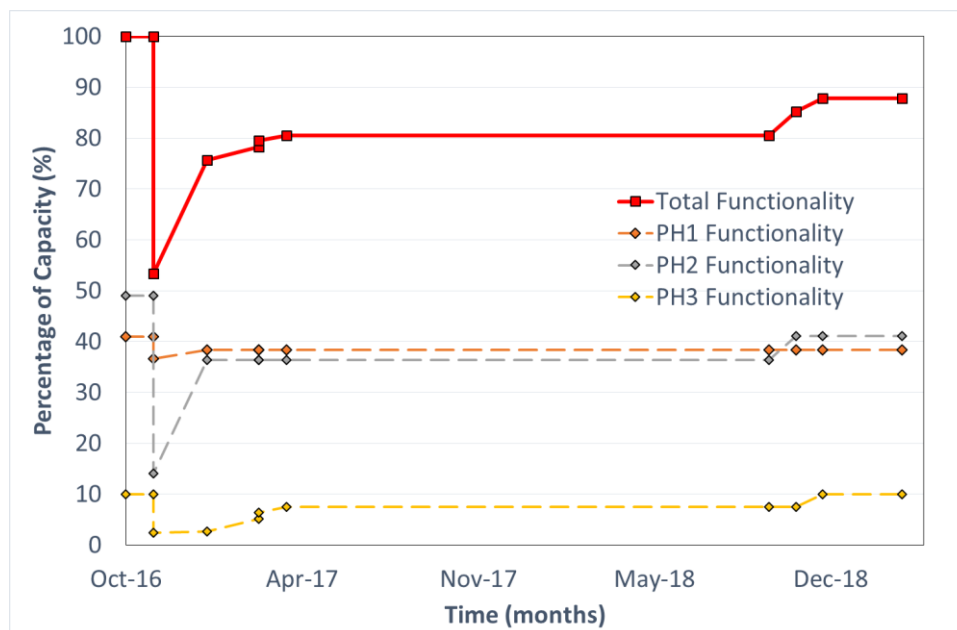
The empirical functionality curve shows that there was a rapid recovery in the first four months after the earthquake. However, there has been very little improvement in capacity since. This is because the bulk of the repairs done were short term repairs designed to recover capacity for the 2017 harvest with more permanent repairs to be designed after the harvest period. At this stage, the winery is aiming to be at 90% PFC by the 2019 harvest. This means that after two years the winery has been able to recover 34% of its capacity of the initial 47% wine capacity loss.

*Figure 5: Empirical functionality curve developed for the case study*

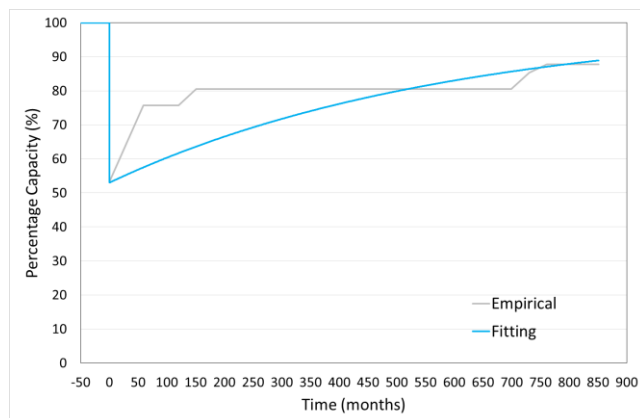
Given the nature of the repairs, the exponential model proposed by Cimellaro et al. (2010) seemed to be the best fit to the empirical curves. Results showed that the analytical expression underestimates by almost 20% the recovery transition to 90% capacity (Figure 6). This model does not take in account the delay caused by the insurance litigations. The recovery function is best represented by a series of exponential functions for each repair phase: an initial exponential relationship that corresponds to the initial temporary works carried out to respond to an immediate/short-term emergency; a plateau, which is the negotiation period with the insurance; and a final exponential relationship corresponding to the permanent works.

Figure 6: Analytical fitting of the empirical recovery function

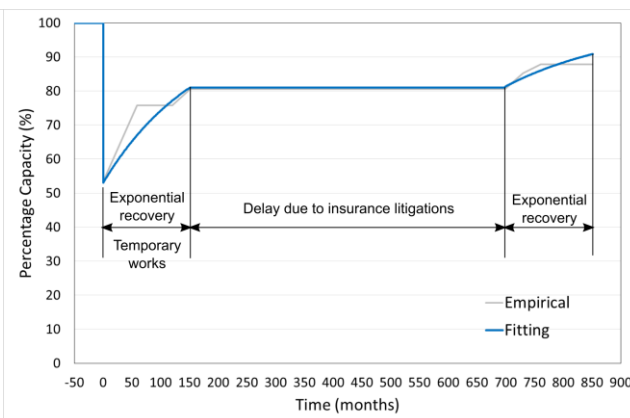
Figure 7: Analytical fitting of the empirical recovery function

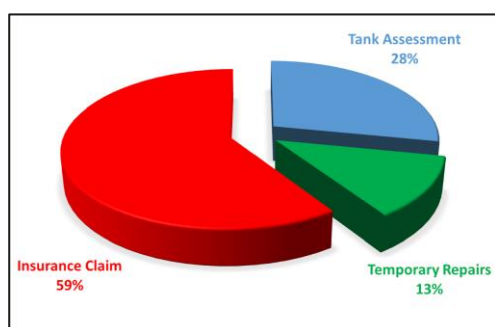
There are many factors behind the progress of the recovery. The recovering time attributed to each of them is shown in Figure 8 as a percentage of the total time since the earthquake. A large percentage, 59%, of the delay was caused by the insurance claim litigation (this mostly corresponds to the flat section in Figure 5). Tank assessment and design of repairs was the second contributor to the recovery time (28%). On the other hand, temporary works only took 18% of the total recovery time. Delays during repairing were also caused by the accessibility to tanks in the middle of groupings. It was not practical to get equipment in between the tanks in order to be repaired. This means that the majority of the damaged tanks in the middle of groupings of undamaged tanks have yet to be repaired.

Figure 8: The amount of time each recovery factor took as a percentage of the total time.
