PERFORMANCE OF ENGINEERED TIMBER STRUCTURES IN THE CANTERBURY EARTHQUAKES

Andrew Buchanan¹, David Carradine² and Justin Jordan³

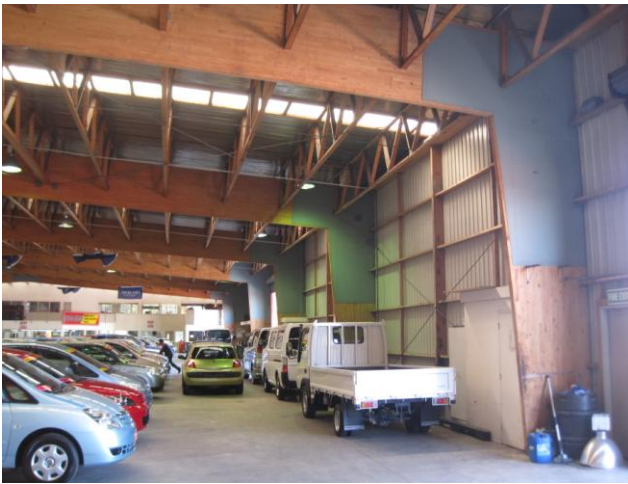
Figure 1(a) shows an industrial building constructed of glue laminated portal frames with nailed steel plates as moment resisting connections and deep timber trusses spanning between the frames. Some shear cracking was observed in columns of two of the frames, as seen in Figure 1(c) and

(a) Overall structure showing glulam portal frames and truss purlins.

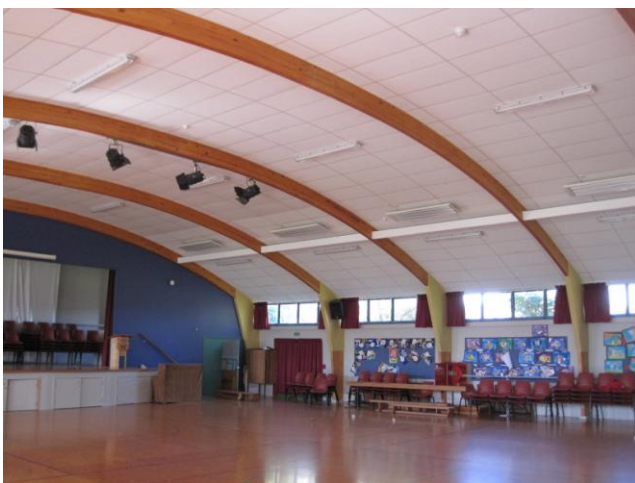
Many school halls in the Christchurch region have glulam portal frames. Most had no damage at all. The only damage observed during inspections of many of these buildings was caused by minor lateral movement of foundations, as shown in Figures 2 and 3. The damage in Figure 2 was caused by the 2010 earthquake. Figures 3(a), 3(b) and 3(c) are all the same school building, where the only damage was the minor foundation movement shown in Figure 3(c). A similar school hall suffered no structural damage despite the displacement of ceiling tiles shown in Figure 3(d).

(a) No damage to curved portal frames.

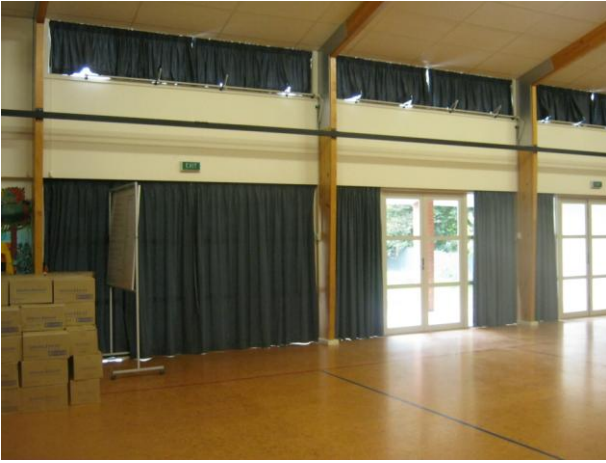
(a) School hall portal frames.

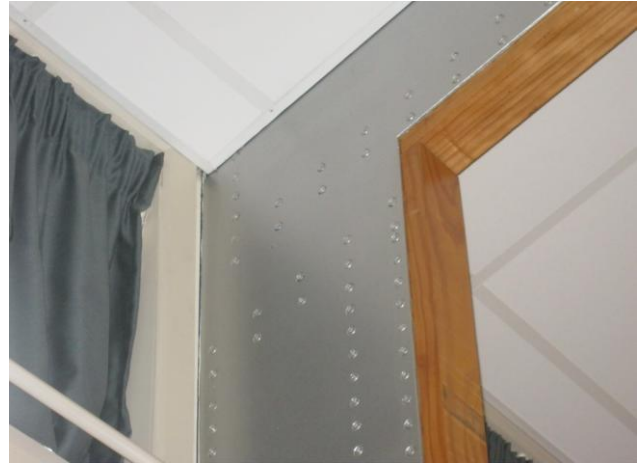
(b) No damage to nailed knee joint.

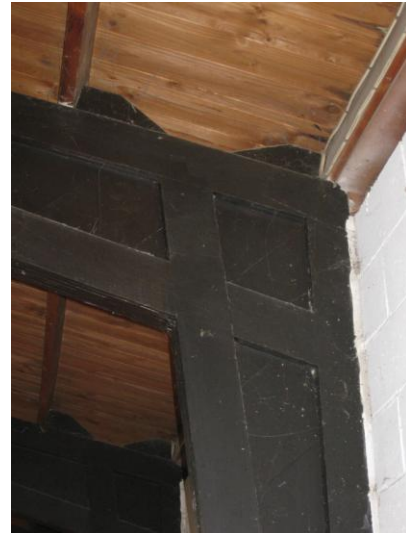
(b) Portal frame knee joint and purlin blocking.

Other portal frame structures are also part of the stock of single storey engineered timber structures around Christchurch and some of these were investigated and shown to have minimal damage, particularly to the timber portal frames. One example was an older building located in the Eastern suburb of Shirley and used for sports activities, which was comprised of a series of nail-laminated frames having a span of approximately 13m (Figure 5). This type of construction was described by Walford [6] and proved to be a robust and seismically resistant system. The building consisted of seven frames having masonry infill between them to provide lateral bracing. While the masonry walls were damaged the frames remained intact and were in no danger of failure.

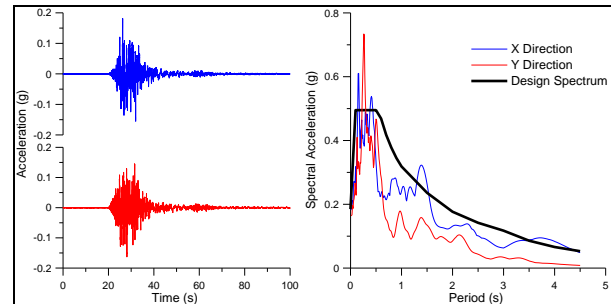
Figure 7: Response of EXPAN building to M6.3 aftershock of 13 June 2011, (a) Base accelerations in X and Y directions; (b) Acceleration response spectra (right).

In the February 2011 earthquake, the building suffered no damage to the structure, the interior linings or the exterior cladding. Since then the building has been instrumented with accelerometers for monitoring movement during aftershocks. The most significant event captured by the instruments to date was the M6.3 aftershock of 13 June 2011, registering peak ground accelerations of 0.18g and 0.16g in the X and Y direction respectively, as shown in Figure 7(a). When this motion is compared to the ULS design spectrum, a close fit is

found as shown in Figure 7(b). Once again no damage to either the structure or architectural fittings was found.
