Twenty-five years of strengthening Wellington

A. W. Thornton

Dunning Thornton Consultants Ltd, Wellington.

2010 NZSEE
Conference

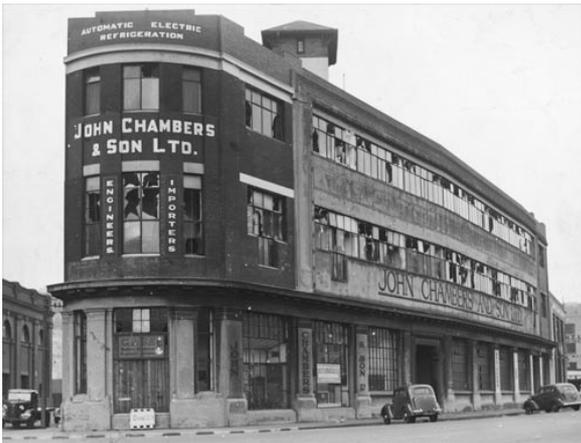
Damage resulting from 1942 Wairarapa Earthquake:

Seismic retrofit of significance first occurred in Wellington following the 1942 Wairarapa Earthquake. It involved primary mitigation by securing and by removal of decorative pediments, parapets, chimneys, cupola and the like that had been damaged or had been demonstrated to be unsafe during the shaking that occurred in June and August. Much of the damaged brickwork was simply repaired. Reports state that Bricklayers from all over New Zealand came to help.

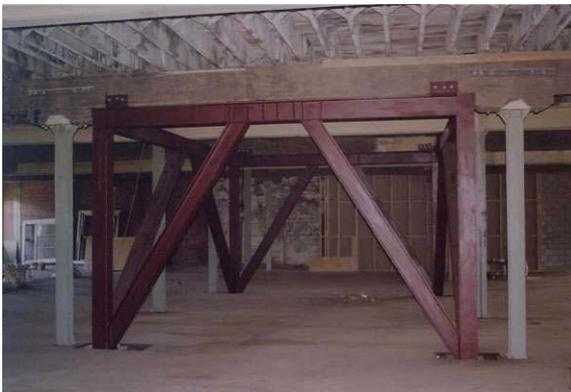
Eccentric Chevron Bracing (K-Frames)

- Installing primary transverse frames – concrete moment resisting frames (MRFs) or steel, rectangular, portal frames. The eccentrically braced ‘K’ frame came to prominence during the 1980s, and this soon became a frame of choice because of its relative affordability and stiffness. Generally not preferred by the architectural/heritage community, we now try our best not to place them in the shop-front window.

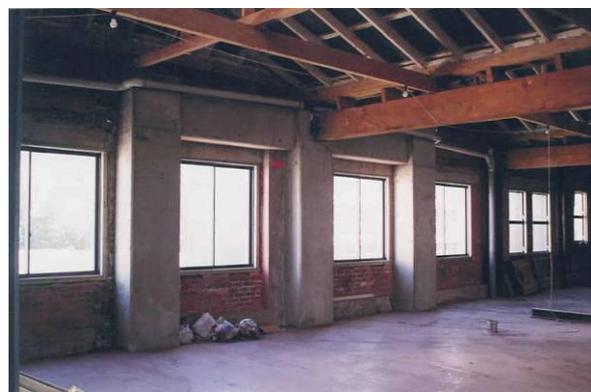
Reinforced Concrete MRFs

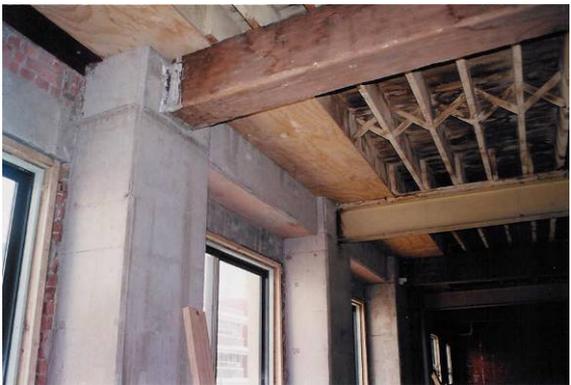
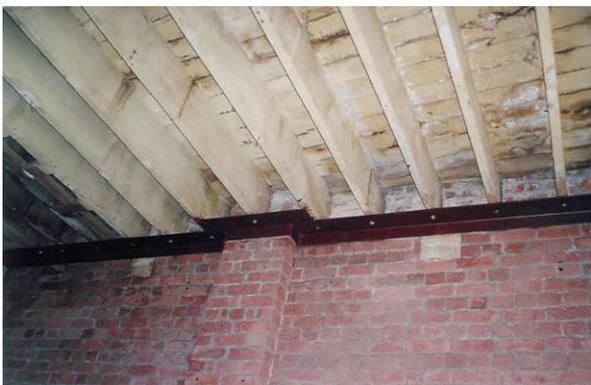
Diaphragm/wall connections

- Fixing floor and roof diaphragms to the brick walls (and the new transverse frames). This inevitably involved many low-capacity fixings between a perimeter member (steel angle or timber ribbon plate) and both the brickwork and the timber joists. Different solutions were required for parallel and perpendicular joists, and were developed from first principles and common sense.

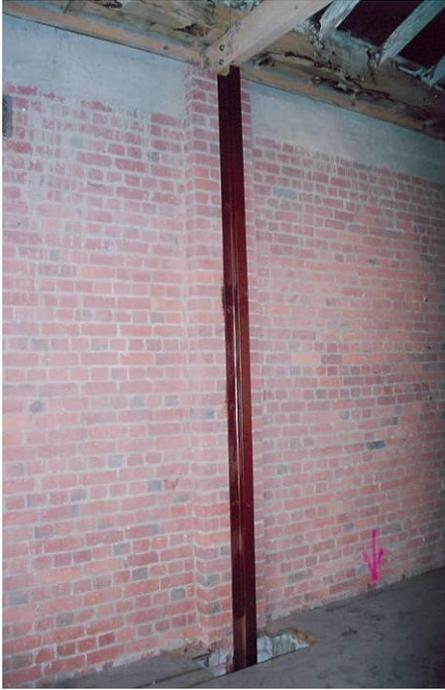
Out-of-plane strengthening

- Providing out-of-plane strength to the brickwalls, typically by way of steel mullions, particularly for upper-storey walls carrying small gravity loads.

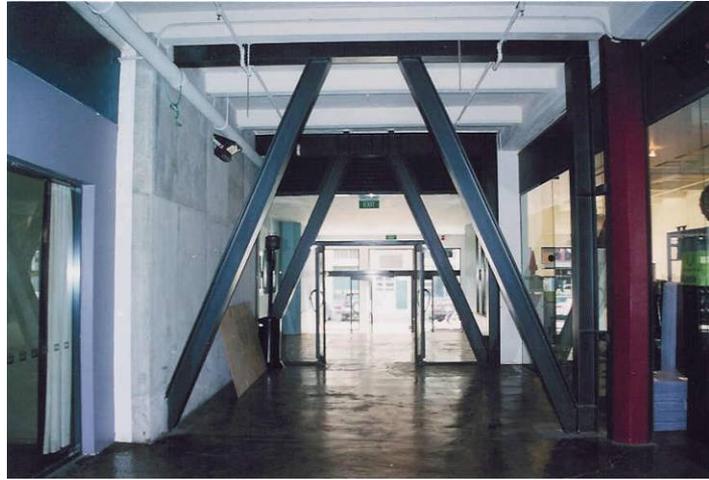
Added shear walls

Where brick walls were found to have insufficient in-plane strength, they have been strengthened typically with sprayed concrete and/or additional walls or stiff frames.

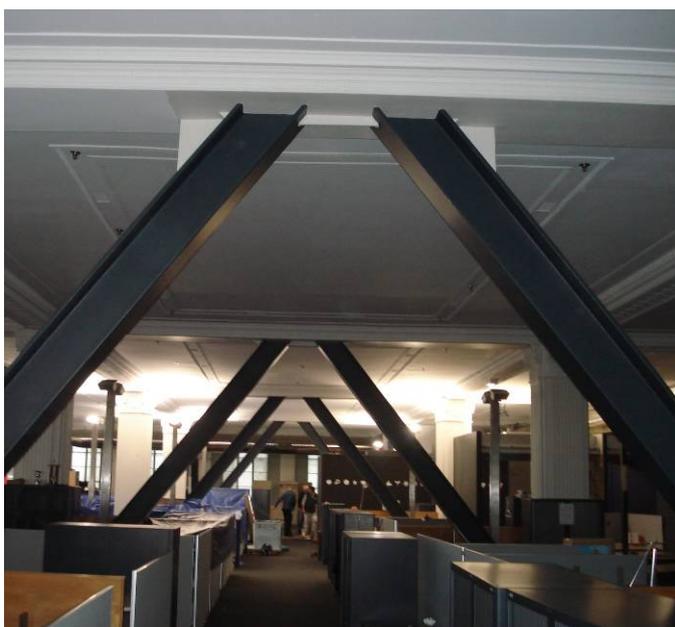
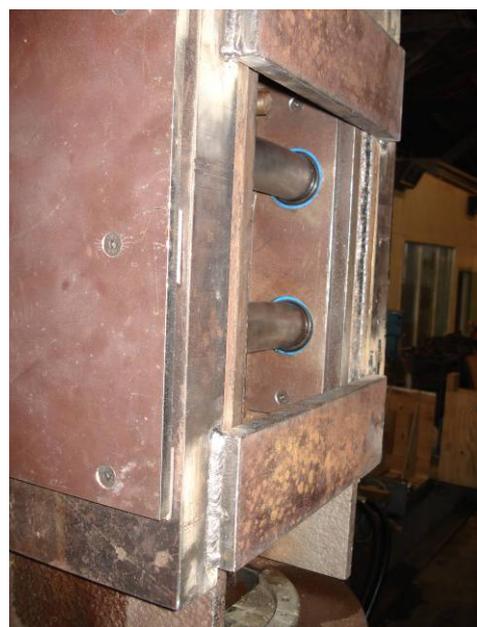
Harbour City Centre (DIC)

Testing of axial hysteretic damper

The Harbour City Centre was strengthened in the 1970s with concentric, steel, chevron bracing which leaves it earthquake-prone by current standards. Consent-ready design proposes axial hysteretic dampers to be inserted into the braces to provide dependable compression/tension yielding.
