Rehabilitation of earthquake damaged external RC beam-column joints

2014 NZSEE
Conference

ABSTRACT: Post-earthquake inspections of damaged RC buildings have demonstrated that poorly detailed beam-column joints can suffer serious damage. The effectiveness of a rehabilitation method based on joint enlargement using prestressed steel angles to enhance the seismic behaviour of damaged external reinforced concrete beam-column joints was experimentally investigated. Three half scale external RC beam-column joints with seismic and non-seismic reinforcement details were tested before and after rehabilitation by applying lateral cyclic loading of increasing amplitudes. Tested specimens were comprised of one unit having seismic reinforcement detailing and two units having non-seismic reinforcement detailing. Two defects were considered for the non-seismic units, being the absence of transverse steel hoops and insufficient bond capacity of beam bottom steel reinforcing bars in the joint panel zone. The damaged specimens were rehabilitated by injecting epoxy grout into existing cracks and installing stiffened steel angles at the re-entrant corners of the beam-column joint, both above and bel

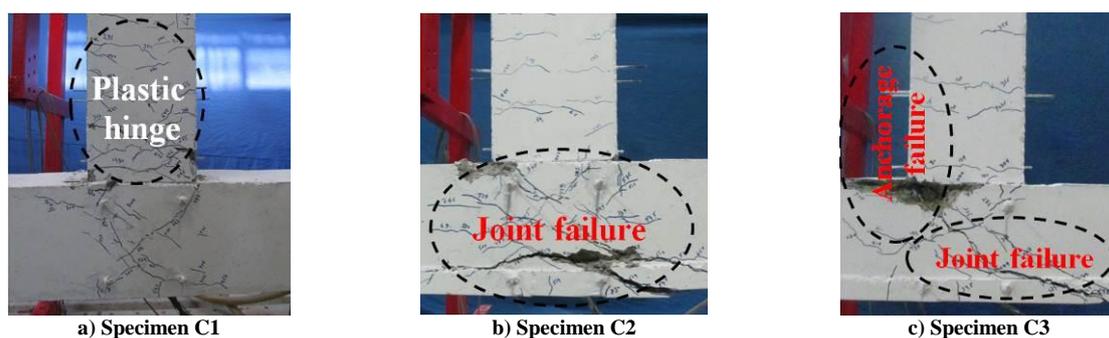
Figure 4. Damage pattern of control specimens C1, C2 and C3 at the end of testing.

The damage pattern of control specimens at the end of testing are shown in Figure 4, illustrating that specimen C1 was controlled by the flexural mechanism of the beam at the beam-column interface, whereas specimens C2 and C3 failed by concrete crushing in the joint region. The first flexural cracks of all control specimens appeared at the bottom of the beam at 0.25% drift, and for specimens C1 and C2 these cracks gradually propagated to a height of 750 mm whereas for specimen C3 these cracks propagated to a height of 300 mm for the pull direction, and to 650 mm for the push direction. Yield of longitudinal and transverse reinforcement was measured by strain gauges, with first yield of the beam longitudinal reinforcement occurring at a drift ratio of 1.1% for specimen C1, while yield of the beam longitudinal reinforcement was not recorded for specimens C2 and C3.

For specimen C1, spalling of concrete cover at the column surface commenced at a drift ratio of between 1.75 to 2.2%, and diagonal cracking in the joint zone began at a drift of 1.75% for the push direction. Additional cracking in the joint panel zone appeared thereafter as loading progressed, but crack widths remained fine throughout the test. At a drift ratio of 3.5% the beam became extensively cracked along a distance equal to its depth from the column face, and at a drift ratio of 4.5% wide cracks developed in the beam potential plastic hinge zone and spalling commenced, as shown in Figure 4a.

For Specimen C2, X-shape cracks in the joint panel zone commenced at a drift ratio of 0.75%, indicating imminent joint failure. The flexural and diagonal cracks grew in size and number as the drift ratio increased. Spalling of concrete cover appeared in the joint region at a drift ratio of between 1.4 to 2.0%, and from a drift of 2.0% the cracking was mainly concentrated in the joint region and formed a typical X-shaped pattern, as shown in Figure 4b. At a drift ratio of 3.5% the concrete in the joint panel zone spalled and crushed, exposing the column longitudinal reinforcement. Lateral cyclic loading was continued with substantial damage in the joint panel zone until 4.5% drift, as shown in Figure 4b.

For specimen C3 the vertical cracks in the joint panel formed at a drift ratio of 0.5%, due to bond-slip of the beam bottom reinforcement for the pull direction, and diagonal shear cracks in the joint zone developed at a drift ratio of 0.75% for the push direction. When the specimen was next loaded in the opposite direction the bond-slip cracks opened and the lateral load-carrying capacity deteriorated significantly, and then when reversed back the diagonal shear cracks in the joint panel zone opened, causing crushing of the concrete, deterioration of the bond condition of the beam bottom reinforcement, and degradation of the lateral load-carrying capacity. Specimen C3 reached a maximum load of 20.0 kN for the pull direction, and a maximum load of 35.0 kN for the push

direction, which was much less than the strength calculated for yielding of the beam longitudinal reinforcement of 32.0 kN and 41.5 kN for the pull and push direction respectively (see Figure 4c). The test was stopped at a displacement of 54 mm, corresponding to a drift of 4.5%, as the load-carrying capacity was greatly reduced.
