Establishing the resilience of timber framed school buildings in New Zealand

2014 NZSEE
Conference

ABSTRACT: Following the Canterbury earthquakes, the Ministry of Education has applied significant effort and resources to better understand the seismic performance of its existing buildings. Approximately 90% of its building stock is timber framed low-rise construction, with the majority of these being constructed prior to modern structural design codes. Many of these buildings feature elements such as fully glazed facades that have little quantifiable strength, often leading to low assessment ratings. However from a structural perspective, it has been a common view amongst engineers that these buildings pose little life safety concern.

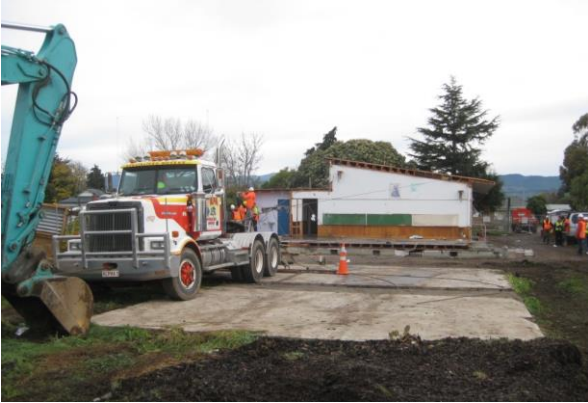
Figure 3. View of the Avalon block during testing

Two classrooms were tested from the block of four to ensure that the strength of the building could be reached with the available test equipment. Lateral loads were applied cyclically to both ends of the two classrooms at roof level (Figure 33) and also an isolated transverse wall using hydraulic actuators integral to house moving trucks connected to the 5th wheel of each truck. The loads were distributed to three attachment points on each end of the building using steel pre-stressing tendons. The 5th wheel attachments were connected directly to hydraulic actuators having 30 tonnes of pulling capacity and a stroke length of approximately 1.4 m. They could also be held at displacements corresponding to target load increments to allow for displacement recording using surveying station equipment.

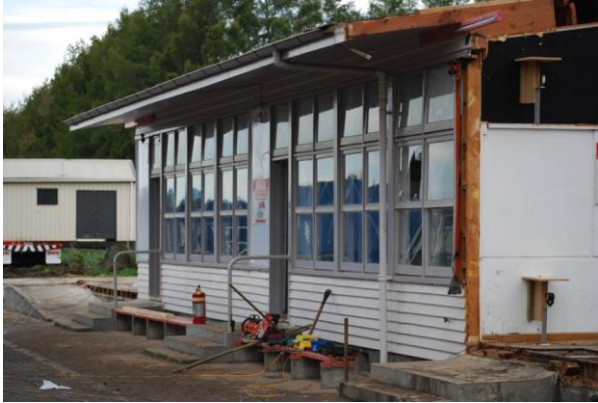
Figure 4. Building at end of longitudinal test

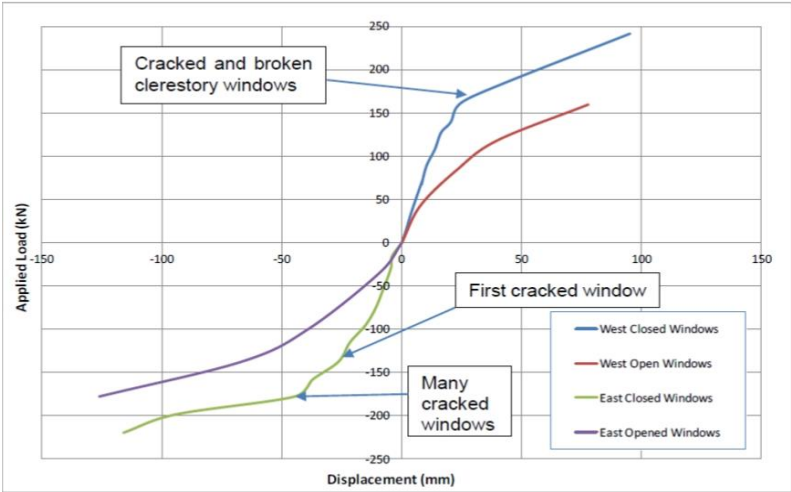
Figure 5. Load-displacement backbone plots for windows closed and windows open

Throughout the testing of the classrooms, loads were recorded using load cells on each of the steel tendons and the displacement was recorded near the roof apex using a rotary potentiometer. In addition, displacements of selected locations on the end walls were recorded at peak loads and zero loads using surveying station equipment. Load levels were increased in approximately 20 kN increments at each end of the building and held at each increment so that displacement measurements could be obtained. The majority of testing was undertaken with the windows closed but at different

times during testing load was applied with all of the windows open for comparisons of stiffness. Figure 5 shows the two load-displacement backbone plots for pulls to the east and the west with windows opened and closed. Loads were increased up to the point of significant building damage, but at no time was there imminent collapse of the building.

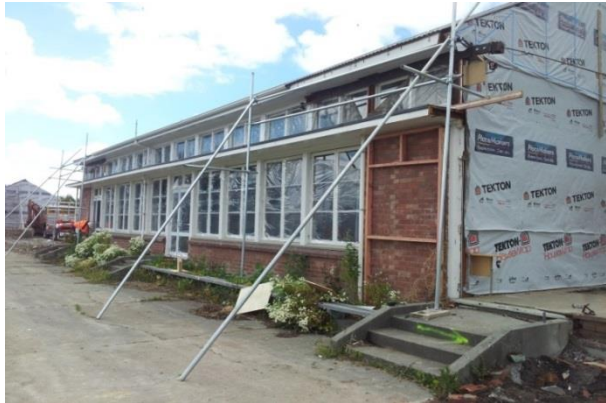
Figure 6. The Dominion block in early stages of the longitudinal test

A similar process was employed by BRANZ to test two classrooms of a Dominion block at Hammersley Park school in Christchurch in the longitudinal direction and a single classroom in the transverse direction in December 2013 (Figures 6 and 7). For these test buildings, the load was applied at the wall top plate level on both sides of the building because the roof was well braced in the ceiling plane and not expected to have any greater weaknesses than the side walls.

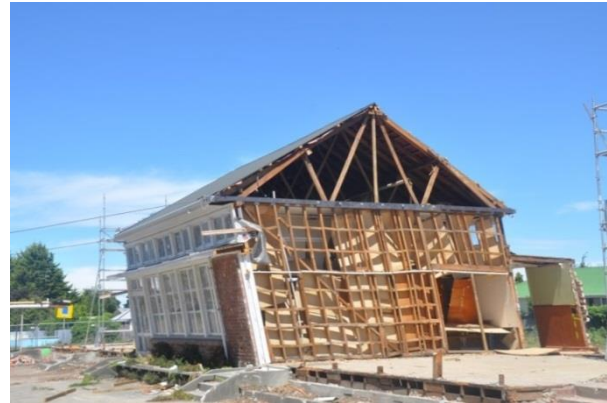
Figure 7. Building showing high levels of drift during the transverse test

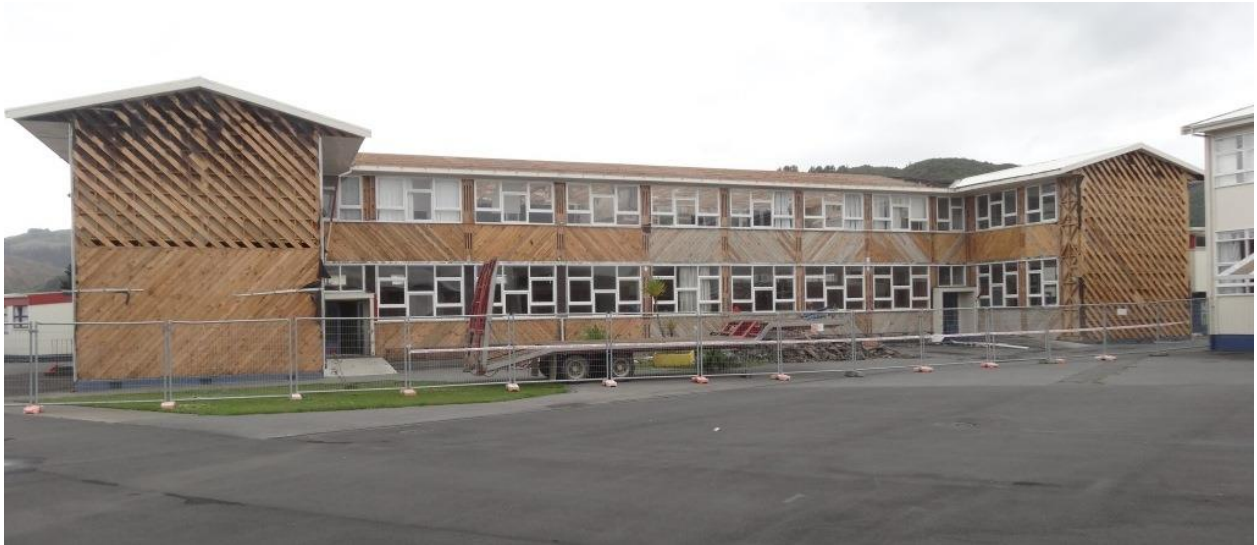
Figure 8. Nelson block structural framing

performance in the Canterbury earthquakes and knowledge gained from the other destructive tests outlined above, these structures are not at risk of collapse in strong ground shaking. Figure 8 shows the structural framing elements of the Upper Hutt College Nelson block following removal of the exterior cladding. This image also highlights the large footprint and hence low aspect ratio of these buildings.
