Low damage non-structural drywalls: Details and their performance

2014 NZSEE
Conference

ABSTRACT: Non-structural drywall partitions are the most common partitions used in buildings. They are usually bounded by either a structural frame or by two floor slabs, which makes them prone to damage by imposed inter-storey deformations. Usually the loss of serviceability occurs at very low drift levels. As part of a research investigation into the development of low damage solutions for non-structural walls, experimental and numerical studies were carried out. This paper will present the seismic performances of existing as built drywall practice and the proposed low damage drywall solution. The developed low damage solution for drywall partitions, capable of reaching high level of drift without loss of serviceability, was developed based on the refinements of existing (as built) drywall construction practice. The experimental campaign confirmed the enhanced performance of the proposed low damage solution for non-structural drywalls, based on simple reconfiguration and detailing of the traditional solutions adopted in the current practice.

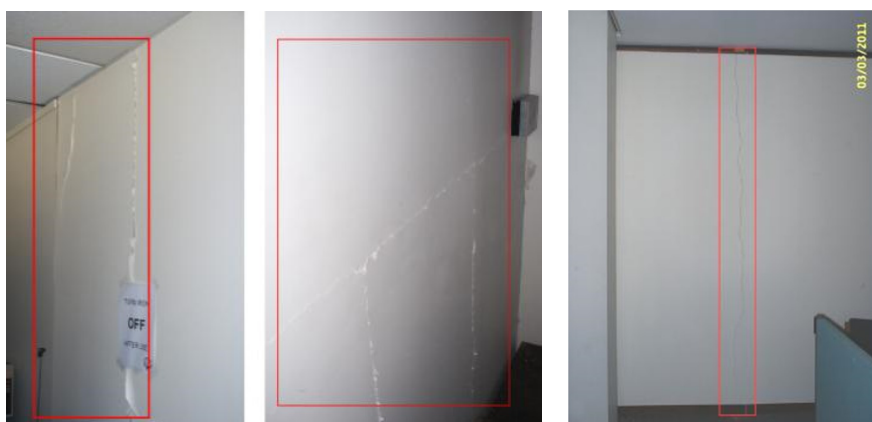
Figure 1. Typical drywall partition damage in buildings observed after 22nd February 2011 Christchurch earthquake in New Zealand

Over the years, non-structural elements repeatedly showed to be the most vulnerable elements in buildings during earthquakes. For newly designed buildings that are capable of undergoing moderate-to-severe earthquakes with low-to-moderate structural damage (Buchanan et al., 2011; Palermo et al., 2005; Priestley et al., 1999) the vulnerability of the non-structural elements potentially holds a high economical burden. During the recent earthquake series in Christchurch, one of the most common observations was that many of the modern buildings suffered moderate or extensive damage to the drywalls that needed repeatedly extensive repair or complete replacement. This represented a severe economical burden required to bring the buildings back to serviceable condition for reoccupation considering that the costs associated with the loss of the non-structural components approximately constitute 62% for offices, 70% for hotels, 48% for hospitals (Taghavi & Miranda, 2003). Some examples of the damage associated with the seismic events in Christchurch are shown in **Figure 1**.
