# Preliminary results from damage and vulnerability analysis of URM churches after the Canterbury earthquake sequence 2010-2011

2015 NZSEE  
Conference

**ABSTRACT:** The damage assessment of monumental buildings after numerous seismic events in different countries has systematically highlighted the vulnerability of monumental structures, in particular churches, and the critical importance of reducing their risk from an economic, cultural and social point of view. This evidence has been highlighted, once again, by the Canterbury earthquake sequence, that dramatically affected New Zealand in 2010-2011. Within this context, detailed analysis is reported of the earthquake-induced damage to a stock of 48 unreinforced masonry (URM) churches located in the Canterbury Region and the seismic vulnerability analysis of a wider stock of 293 URM churches located all around New Zealand. The final aim of the study was the collection of meaningful data and evidence to support mitigation strategies and policies for reducing the seismic risk for churches. To support this aim, new tools and forms were developed that are specifically oriented to facilitate analysis of the features of New Zealand chu

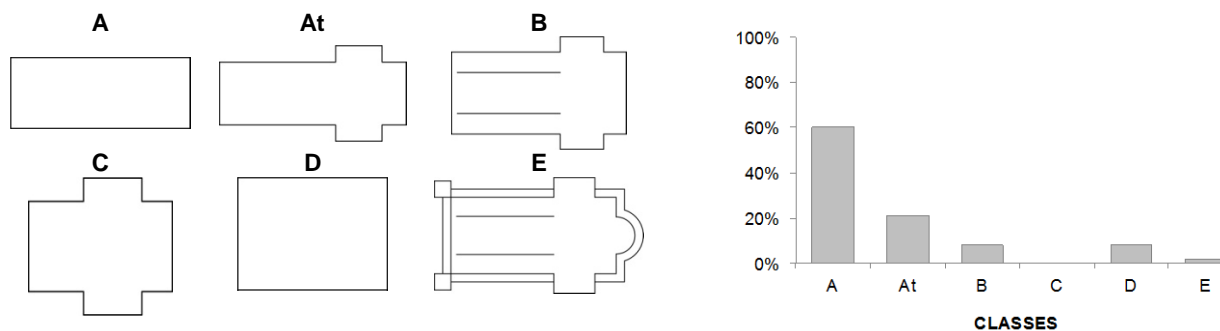
**Figure 1. Classification of URM churches in New Zealand: a) recurring types; and b) their frequency within the stock of the 48 churches analysed as part of the project.**

The histogram in Figure 1 shows the frequency of the typological classes for the Christchurch stock (48 URM churches), whereas at the end of the paper the statistics are extended to the entire stock of New Zealand URM churches. It is worth noticing that the majority of the churches fall in the A class, meaning that a typical NZ church is mainly composed of the following macroelements: nave, presbytery, sloping timber roof, buttresses (possibly). The At class includes the same macroelements as for the A class, but in the presence of the transept. The combined percentage of A and At types covers 80% of the analysed stock. This result outlines the simplicity of the architecture of New Zealand churches. The most recurring macroelements, as a consequence of the predominance of class A, are the central nave, façade, and presbytery, which are present in almost 100% of the churches (Fig. 2). A further macroelement that characterizes the sample is the Atrium (Narthex), is present in 80% of the churches. In some cases there is more than one atrium along the nave or in proximity of the apse (respectively classified as AN1 and AN2 in the proposed classification). A similar subdivision is proposed for the chapels. A considerable number of macroelements are present in less than 25% of the surveyed churches, related to the lateral naves, transept and dome, as illustrated in Figure 2.

The histograms in Figure 12 show the frequency of the typological classes on: (a) the entire sample of churches; and (b) most recurring macro-elements. A correspondence with the analogous graphs referring to the Christchurch sample is clearly evident (Fig. 1 and Fig. 2). It was once again confirmed (Fig. 12a) that class A is the most widespread typology for New Zealand churches (60% of the whole sample), with the percentage rising to 80% when considering the presence of transept (class At). This result corroborates the already highlighted simplicity of the architecture of New Zealand churches. Consequently, the most recurring macro-elements, listed in Figure 12b, are the central nave and the façade, in almost 100% of the churches. A considerable number of macro-elements are present in about 50% of the surveyed churches, mostly related to: the presbytery, the atrium, the bell tower and the projections.

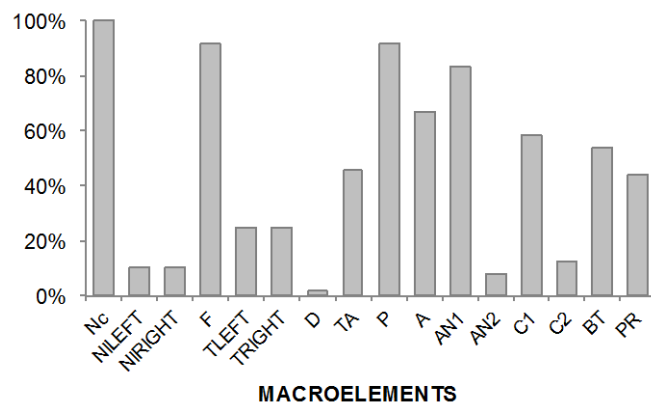
- Nc CENTRAL NAIVE
- N<sub>LEFT</sub> LEFT LATERAL NAVES
- N<sub>RIGHT</sub> RIGHT LATERAL NAVES
- F FAÇADE
- T<sub>LEFT</sub> LEFT TRANSEPT
- T<sub>RIGHT</sub> RIGHT TRANSEPT
- D DOME
- TA TRIUMPHAL ARCH
- P PRESBYTERY
- A APSE
- AN<sub>1</sub> ATRIUM/NARTHEX (1st group)
- AN<sub>2</sub> ATRIUM/NARTHEX (2nd group)
- C<sub>1</sub> CHAPELS (1st group)
- C<sub>2</sub> CHAPELS (2nd group)
- BT BELL TOWER
- PR PROJECTIONS

**Figure 2. Frequency of the macroelements on the stock of 48 URM churches from Christchurch**

The new proposed method is based on these steps: 1) subdivision of the church into macroelements (considering those listed in Figure 2); 2) attribution of a weight to each identified macroelement, as a function of the geometrical importance within the church (i.e. plan and height dimensions); 3) check of any different activated collapse mechanisms for each identified macroelement.

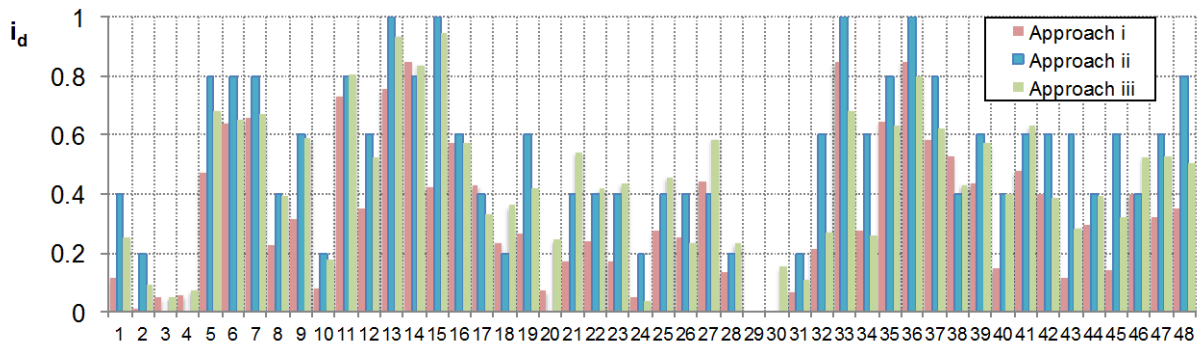
Figure 3. Comparison between the damage indices obtained from the different approaches

Figure 3 shows the comparison among the abovementioned methods. As approach (ii) is the most qualitative, it usually overestimates damage with respect to the other two methods. Approach (i), on the contrary, tends to underestimate damage when compared to approach (iii), as the latter is calibrated to the actual macroelements present in the church, assigning a weight to them and also considering the peak of damage.

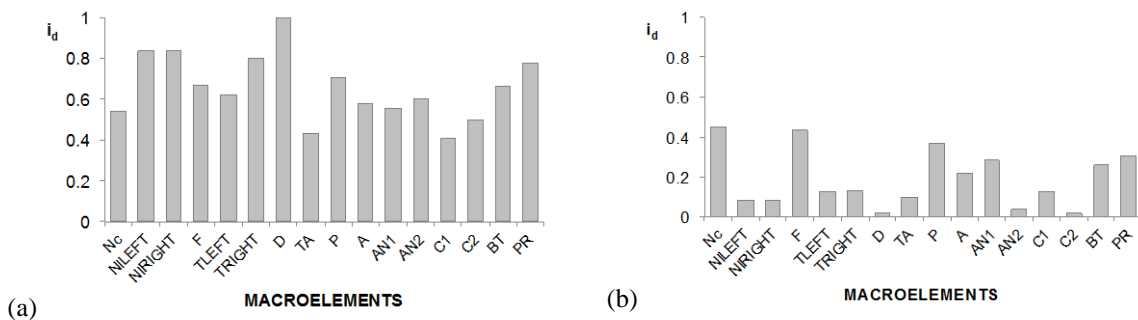
Figure 4. Frequency of the damage index not weighted (a) and weighted (b) on the sample.

Figure 4 summarizes the damage index of each church of the sample obtained from approach (iii). In particular, Figure 4 illustrates the average damage index from the latter method for each macroelement in two conditions: a) the average index weighted only for the churches that have that macroelement; b) the average index weighted on the entire sample. From Figure 4a it is evident that the highest average damage value, (e.g. related to the dome, the lateral naves, the transept), but at the same time the most vulnerable macroelement, should be also widespread in the sample, as shown in Figure 4b).

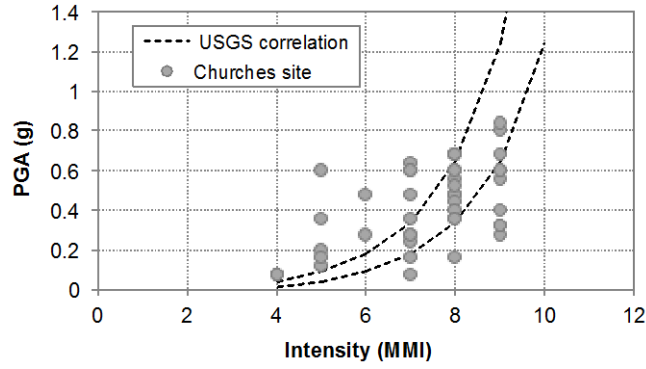
**Figure 5. Correlation between Intensity and PGA.**

From the statistical analysis of the damage data a Damage Probability Matrix (DPM) was produced for churches, being a matrix in which for the different values of the macroseismic intensity, the probability histogram of the damage levels is listed (Whitman, 1973). Each church of the sample is associated with two different values of macroseismic intensity: a) one directly ascribed (Goded et al. 2014); b) one obtained from PGA data taken from shake maps, by using an Intensity-PGA correlation, calibrated in the study area through the data of the US Geological Survey (USGS 2011). Figure 5 shows PGA values (obtained from data and maps available from the US Geological Survey, 2011) and macroseismic intensity (Goded et al. 2014) associated with each church, together with correlation curves, derived from minimum and maximum values of PGA associated by USGS to each single value of intensity. The graph shows that in many churches low values of intensity were associated with high levels of PGA.

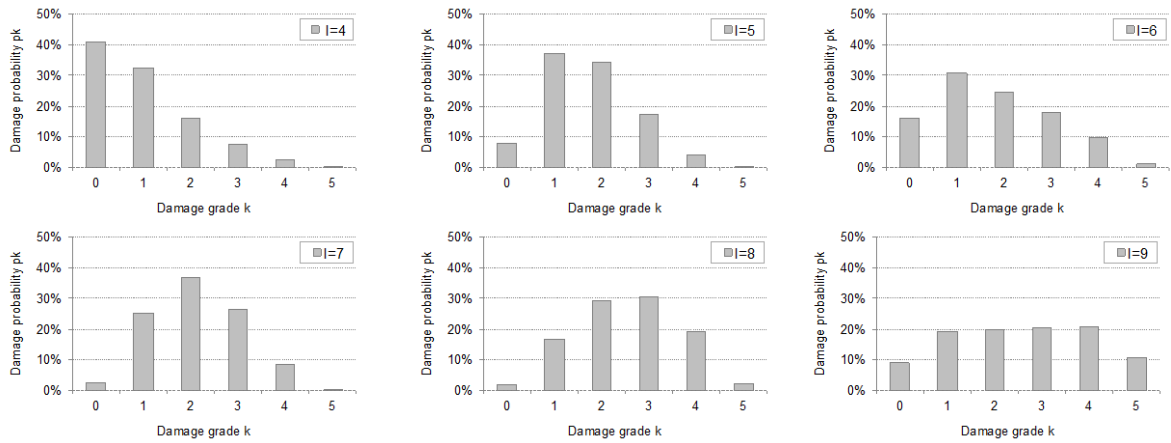
**Figure 6. Beta discrete distribution for I from 4 to 9 MMI.**

Having defined the intensities, the churches of the sample were grouped according to shaking intensities that varied from Intensity 4 to 9 of the Mercalli Modified scale (MMI). For each intensity, the mean damage index and the variance were computed to identify the parameters of Beta distributions and so obtain the DPMs (Fig. 6), by transformation of the beta distribution into discrete terms.

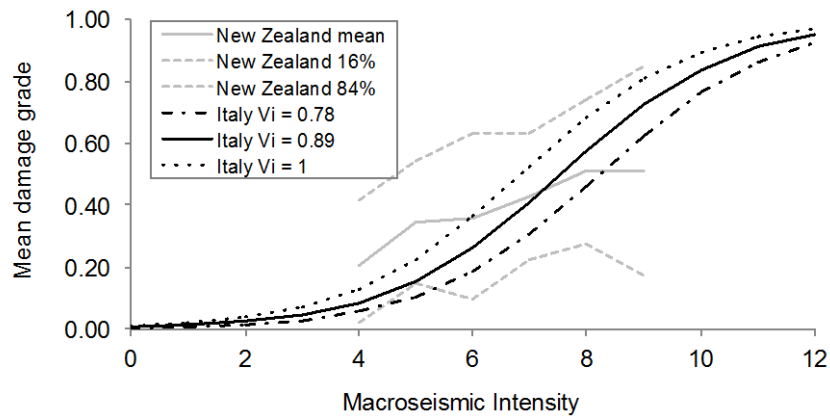
**Figure 7. Vulnerability curves for New Zealand and Italian churches.**

From the mean damage index and the values corresponding to the 16 and 84 percentiles, the empirical vulnerability curves of New Zealand churches were drawn, which correlate the intensity to damage. These curves were compared with the curves calibrated for Italy, defined by the following expression and illustrated in Figure 7, adopting different values of Vulnerability Index and Ductility Index  $Q$  equal to 3. This expression is proposed in Lagomarsino (2006) for churches and it is calibrated on the basis of the observed damage in Podestà and Lagomarsino (2004b):

$$\mu_D = 2.5 \left[ 1 + \tanh \left( \frac{I + 6.25V - 13.1}{Q} \right) \right] \quad (1)$$

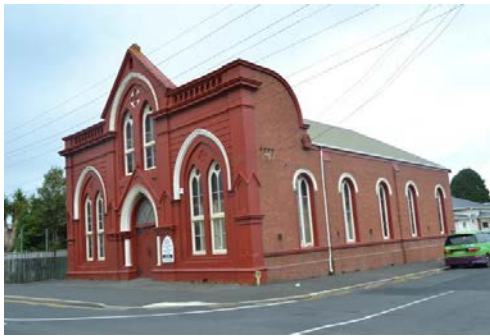
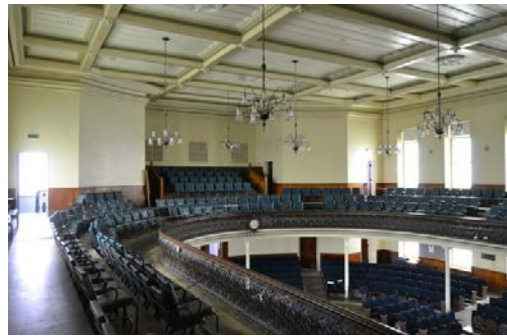
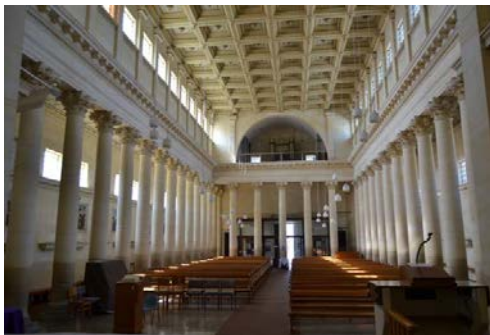
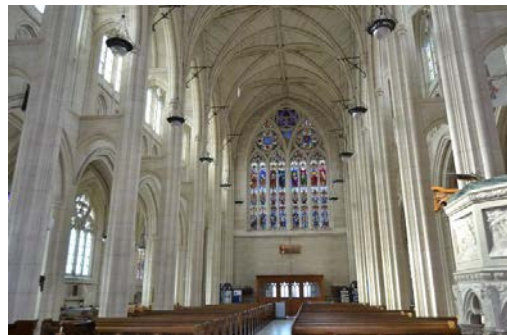
(a) Wesley Church, Dunedin (class D)

(b) Baptist Tabernacle, Auckland (class D)

(c) St Patrick's, Oamaru (class E)

(b) St Paul's, Dunedin (class E)

**Figure 8. Examples of New Zealand plan configuration, according to Figure 1.**

- Architectural features: referring to typological classification proposed above (Fig. 8), taking the overall dimension and noting geometric irregularities in plan and elevation (e.g. presence of adjacent buildings and/or tower, interaction with buildings of different height - Figure 9).

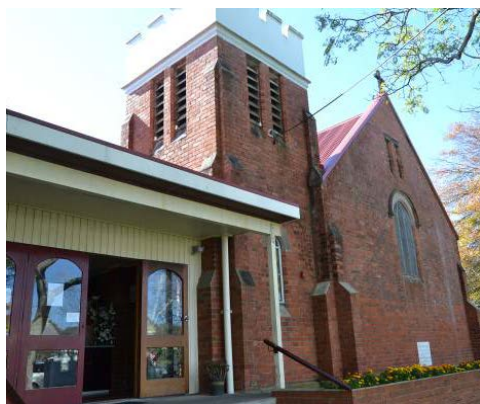
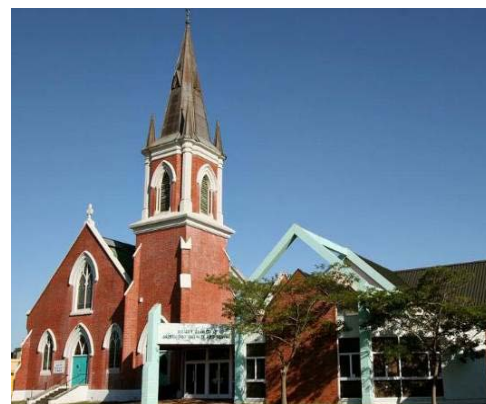
(a) Church of St Thomas, Auckland

(b) Wesley Broadway Methodist Church, Palmerston North

**Figure 9. Geometric irregularities in plan and elevation and position with respect to other buildings**

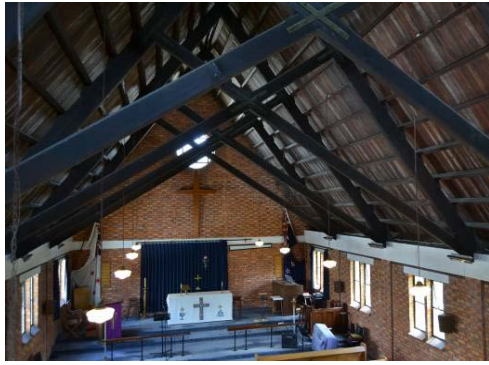
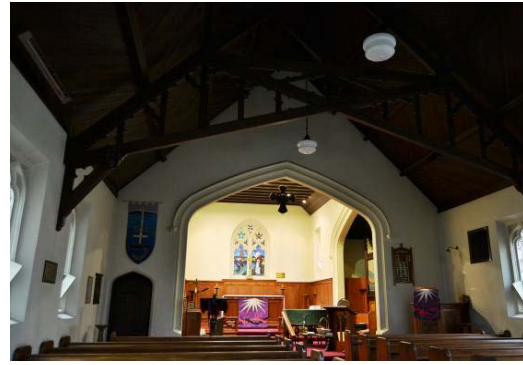
(a) St Augustine, Auckland

(b) St Peter's, Queenstown

**Figure 10. Common typology of thrusting roof in New Zealand churches.**

- Structural characteristics: masonry type and quality (distinguishing between good and bad masonry and highlighting the masonry transversal section), type of roof (e.g., exerting or not thrust at support, mass size, Figure 10), connections between walls (e.g., interlocking, tie rods, ...) and between walls and floors (e.g., ring beams, ...), presence of buttresses, of large openings, of thrusting structures (e.g., arches, vaults, domes), of slender elements (e.g. pinnacles, parapet belfries, parapets).

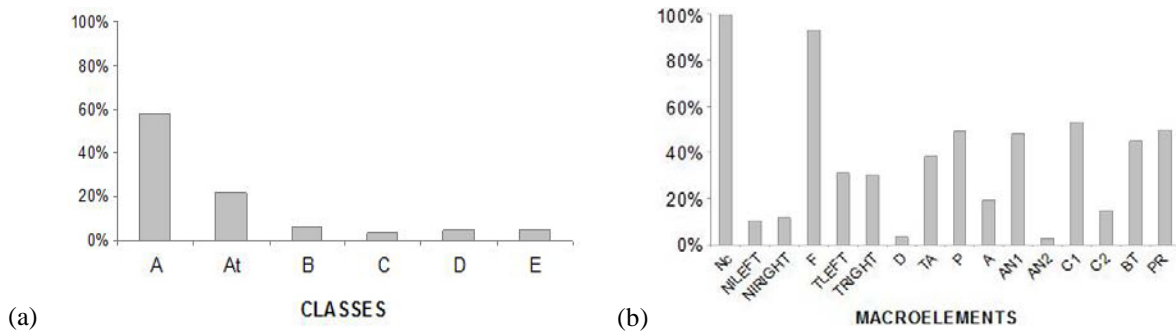
**Figure 12. Classification of the recurring types of URM churches in New Zealand (a) and frequency of the macro-elements on the entire sample of churches (b).**
