Seismic strengthening and uplift of the 1904 Wellington Town Hall

L.A. Whitehurst, H.S. McKenzie & A.E. Philpott

Holmes Consulting, Wellington.

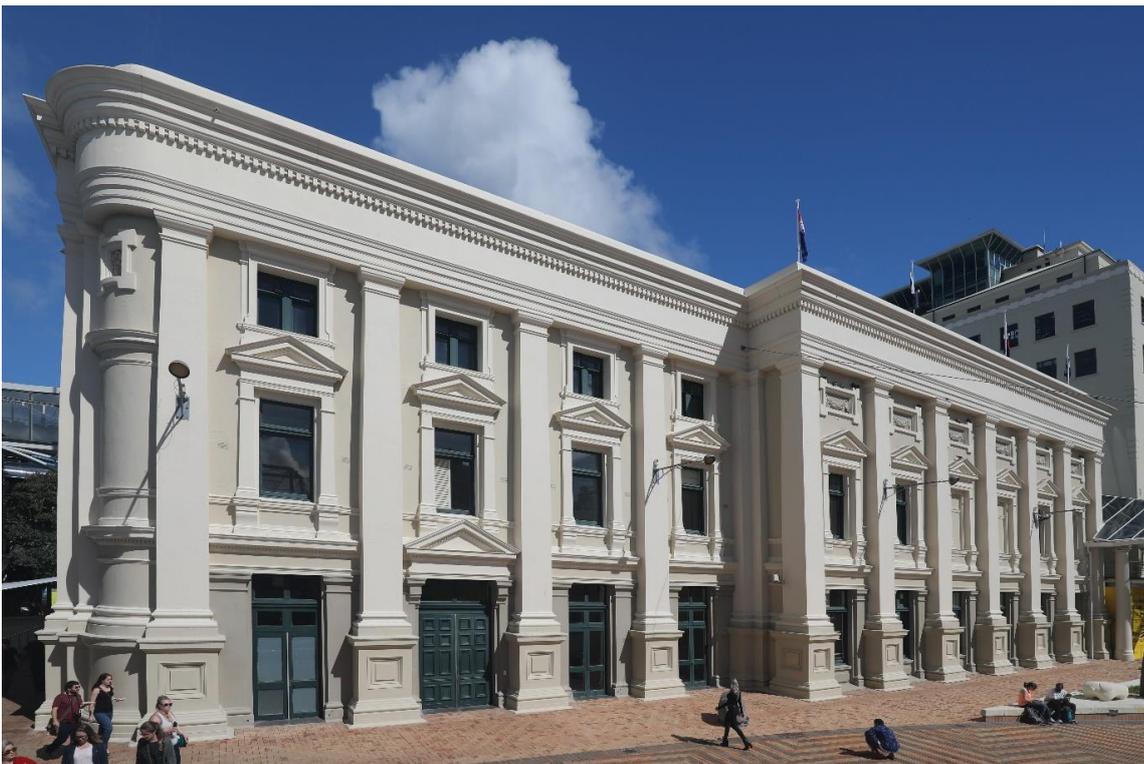
Figure 1: Northern Façade as it currently stands

The Wellington Town Hall is a large unreinforced masonry building constructed circa 1904 in Wellington, New Zealand. Figure 1 shows the northern (Civic Square) façade of building. The building features a large
