The 30 September 2009 “Padang” Earthquake

Dick Beetham GNS Science

6 October 2009

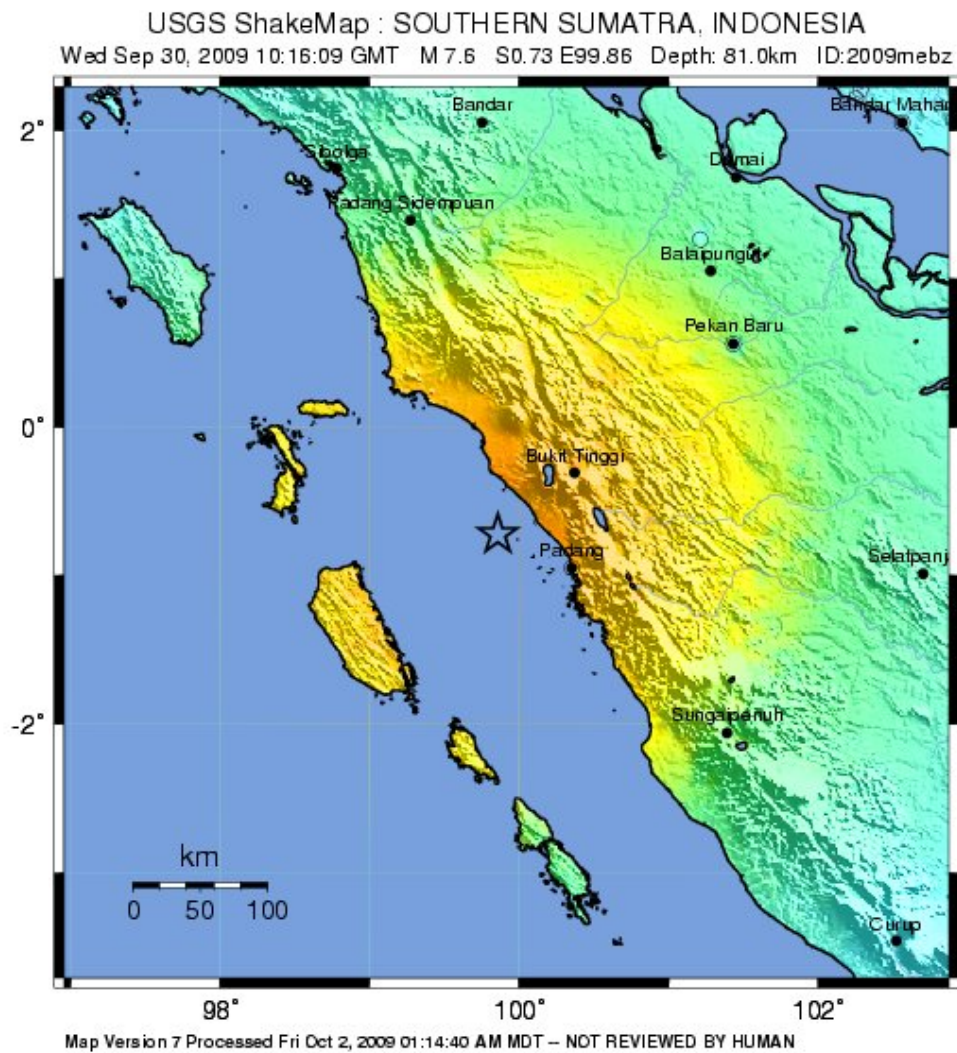
PERCEIVED SHAKING	Not felt	Weak	Light	Moderate	Strong	Very strong	Severe	Violent	Extreme
POTENTIAL DAMAGE	none	none	none	Very light	Light	Moderate	Moderate/Heavy	Heavy	Very Heavy
PEAK ACC.(%g)	<.17	.17-1.4	1.4-3.9	3.9-9.2	9.2-18	18-34	34-65	65-124	>124
PEAK VEL.(cm/s)	<0.1	0.1-1.1	1.1-3.4	3.4-8.1	8.1-18	18-31	31-60	60-118	>118
INSTRUMENTAL INTENSITY	I	II-III	IV	V	VI	VII	VIII	IX	X+

Figure 1. The USGS Shake Map shows the earthquake epicentre and gives a MM Intensity of 7 to 8 in Padang

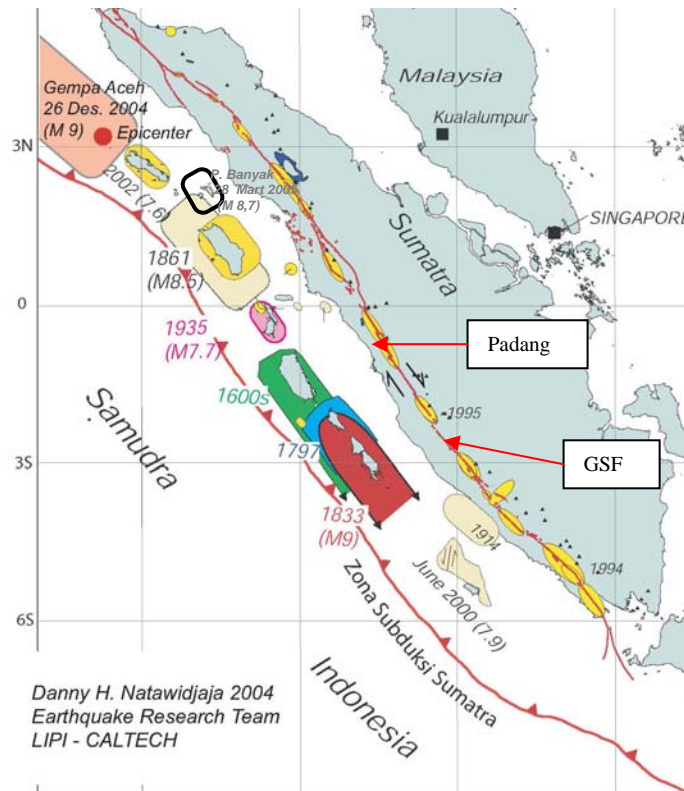
Figure 1. Map of tectonics and major earthquake sources of the Sumatran Plate Margin. The yellow ellips along the Sumatran Fault Zone are ruptures of the past earthquakes. The numbers indicate years of occurrences. Colored rectangles offshore the Sumatran west coast indicate major seismic sources beneath the ocean, on the subduction interface.

Figure 2. Source areas of earthquakes of the Sumatra region. The yellow zones along the Sumatran Fault are also historic earthquakes.

A second earthquake, which measured 6.6 M_w , struck the province of Jambi in central Sumatra, 08:52:29 local time on 1 October 2009 at a depth of 15 km, about 46 km south-east of Sungaipenuh. This earthquake appears to on or close to the trace of the Great Sumatran Fault, which is also a regular source of earthquakes. (Figure 2)

The subduction zone surrounding the immediate region of this event has not witnessed a megathrust earthquake in the recent past, rupturing last in an earthquake of M 8.5 or larger in 1797. Approximately 350 km to the south, a 250 km section of the plate boundary slipped during an Mw 8.4 earthquake in September 2007, while approximately 300 km to the north, a 350 km section slipped during the Mw 8.7 earthquake of March 2005. In early 2008, the plate boundary up-dip of today’s earthquake was active in a sequence of Mw 5-6 earthquakes. It is not clear how today’s earthquake is related to the sequence of mega thrust subduction zone events on the shallower section of the plate boundary (Figure 2).

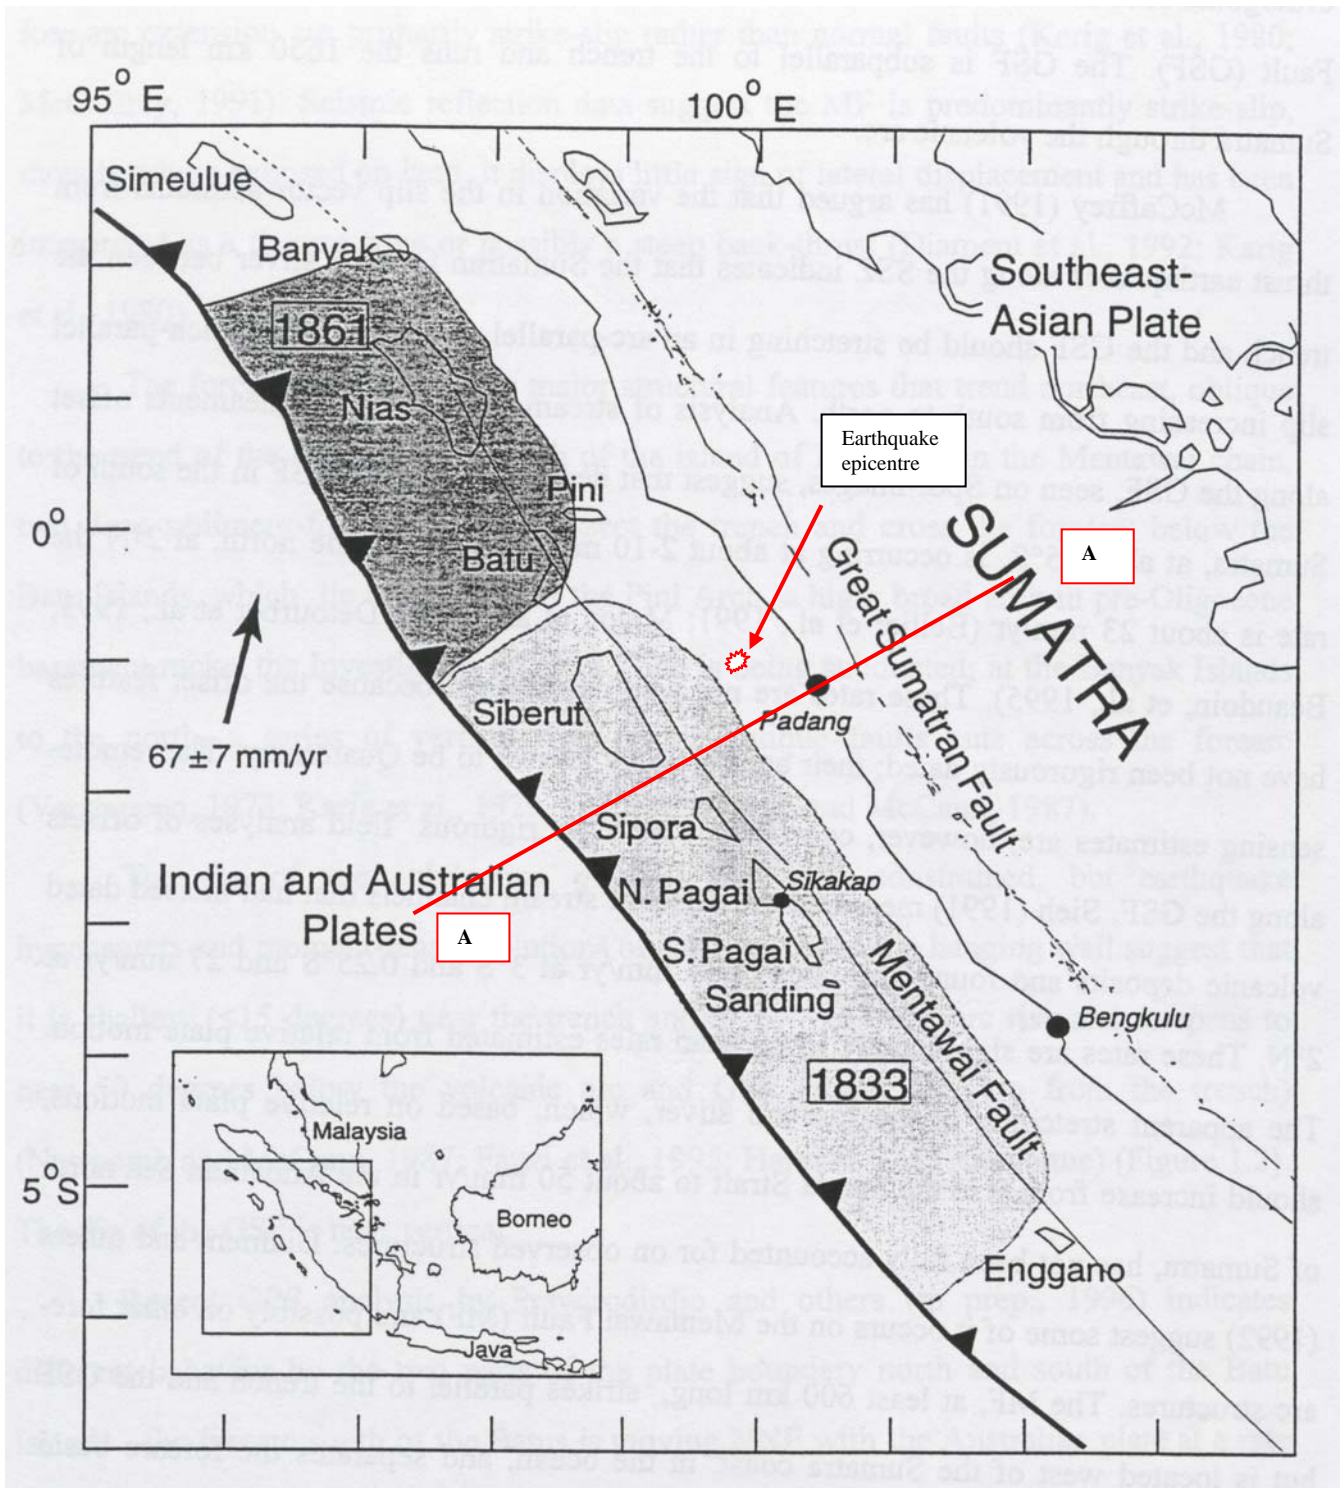
Figure 3. The previous Great earthquakes on the subduction zone were in 1866 under Nias on the Nias Segment and in 1833 under the Mentawai Islands on the Padang Segment. The Nias Segment has already ruptured again in the Great Nias Earthquake of 28 March 2005, and there is a high probability of a great earthquake on the Padang Segment in the coming (10's of) years as it is already ~180 years since the previous event and accumulated strain is about 11 m (from PhD thesis by Judy Zachariassen).

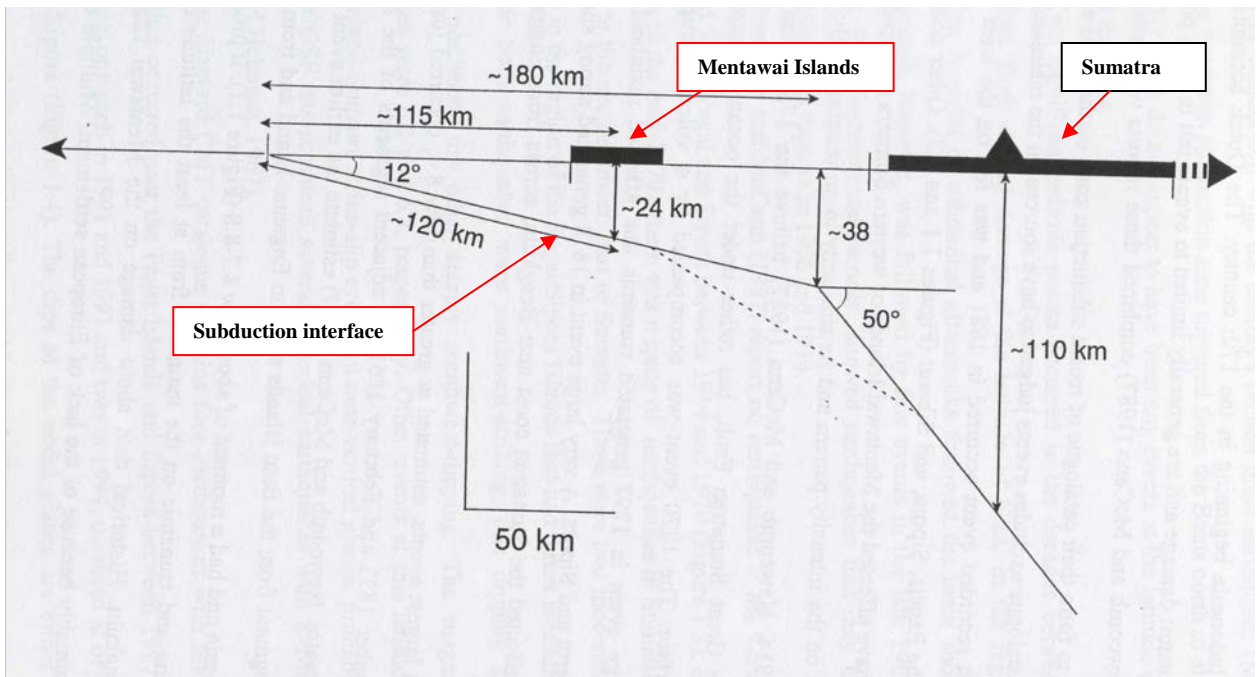
Figure 4. Section A – A. The Great Subduction Zone earthquakes occur on the subduction interface this is 20 to 24 km below Mentawai Islands. In the ~180 years between the 1833 and 2009, approximately 11m of strain has accumulated (60mm/yr over 180 yrs = ~11m) if the subduction interface is locked. This strain would be released by sudden rupture movement along the subduction interface, as was the case during the Great Nias Earthquake of 28 March 2005.

Figure 5. A cross-section by the USGS through the subduction zone at Padang, showing the subduction interface (dotted red line) and the focus, at 80km depth below the centroid of the Padang Earthquake. Compare this Figure with Figure 4.

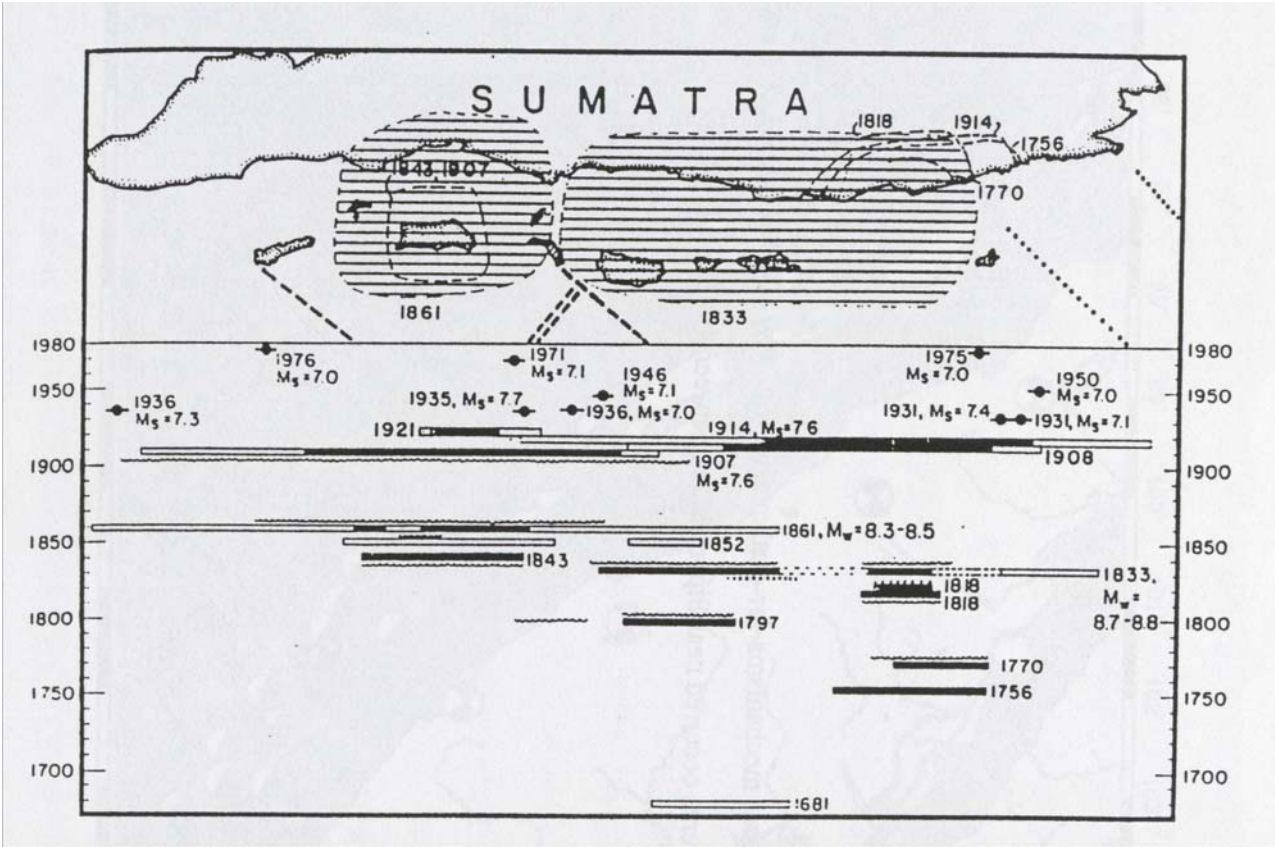
Figure 6. The known historic earthquakes in the Nias and Padang areas as shown by Judy Zacharisen. The dates, magnitudes and earthquakes which caused tsunami are shown on the diagram. The tsunami are the wavy lines. The 28 March 2005 Great Nias

Earthquake was caused by rupture of the subduction zone beneath Nias, essentially the same as the 1861 earthquake, as shown above.

Photo. A tsunami evacuation bill-board in Padang , near the provincial parliament (DPRD) buildings. Padang has experienced tsunami from local great subduction zone earthquakes in the past. The last great earthquake on the subduction zone was in 1833 and there is a high probability of another one in the coming 10's to 20's of years as these earthquake occur about every 200 years. Previous earthquakes were in 1833, 1797 and in the 1600's (Figure 5 below).

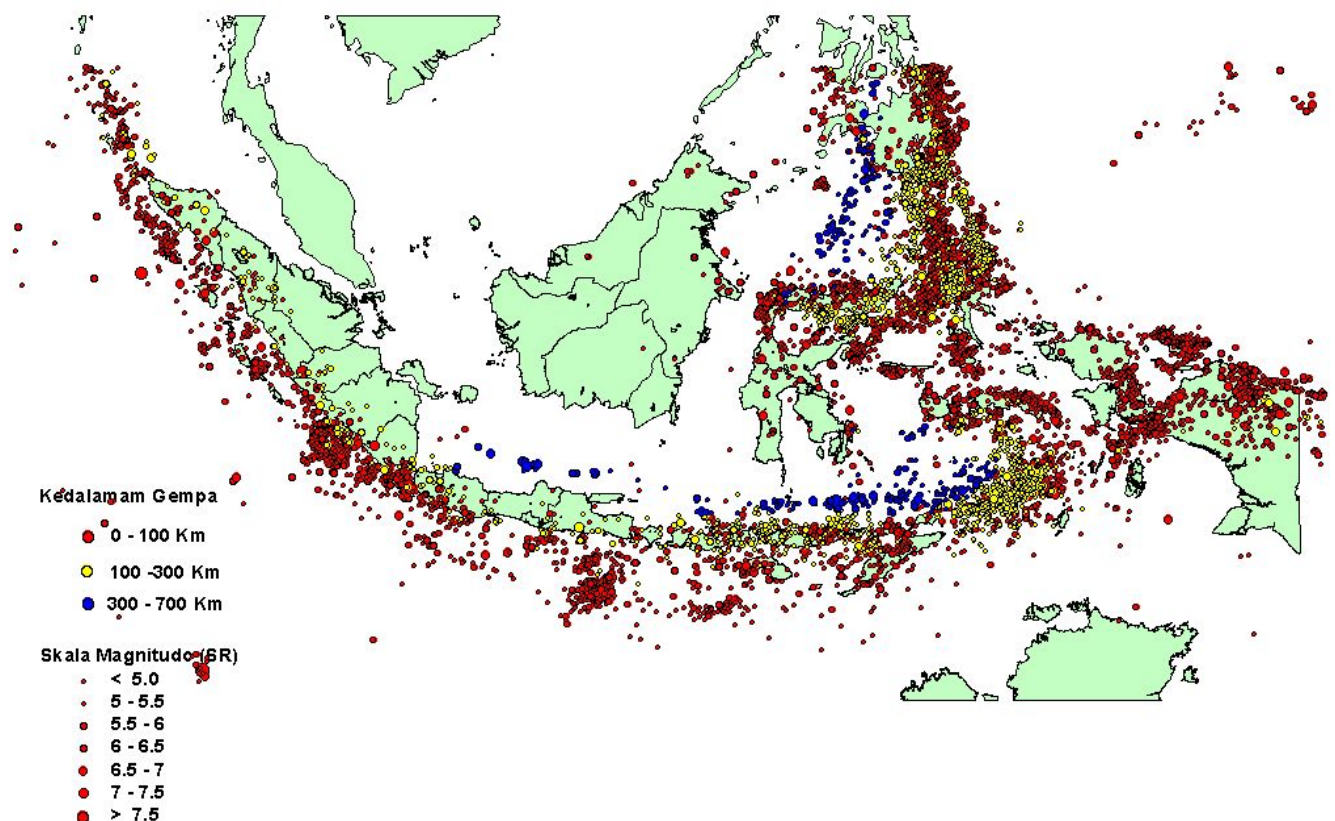
Figure 7. A sample of Indonesian seismicity – with colours showing depth. Red dots are shallower earthquakes (0 to 100 km deep) and blue are the deepest (300 to 700 km deep), outlining the subducting Australian Plate as it descends beneath the Sunda Plate – which in this location is the Indonesian and Malaysian land masses seen above.

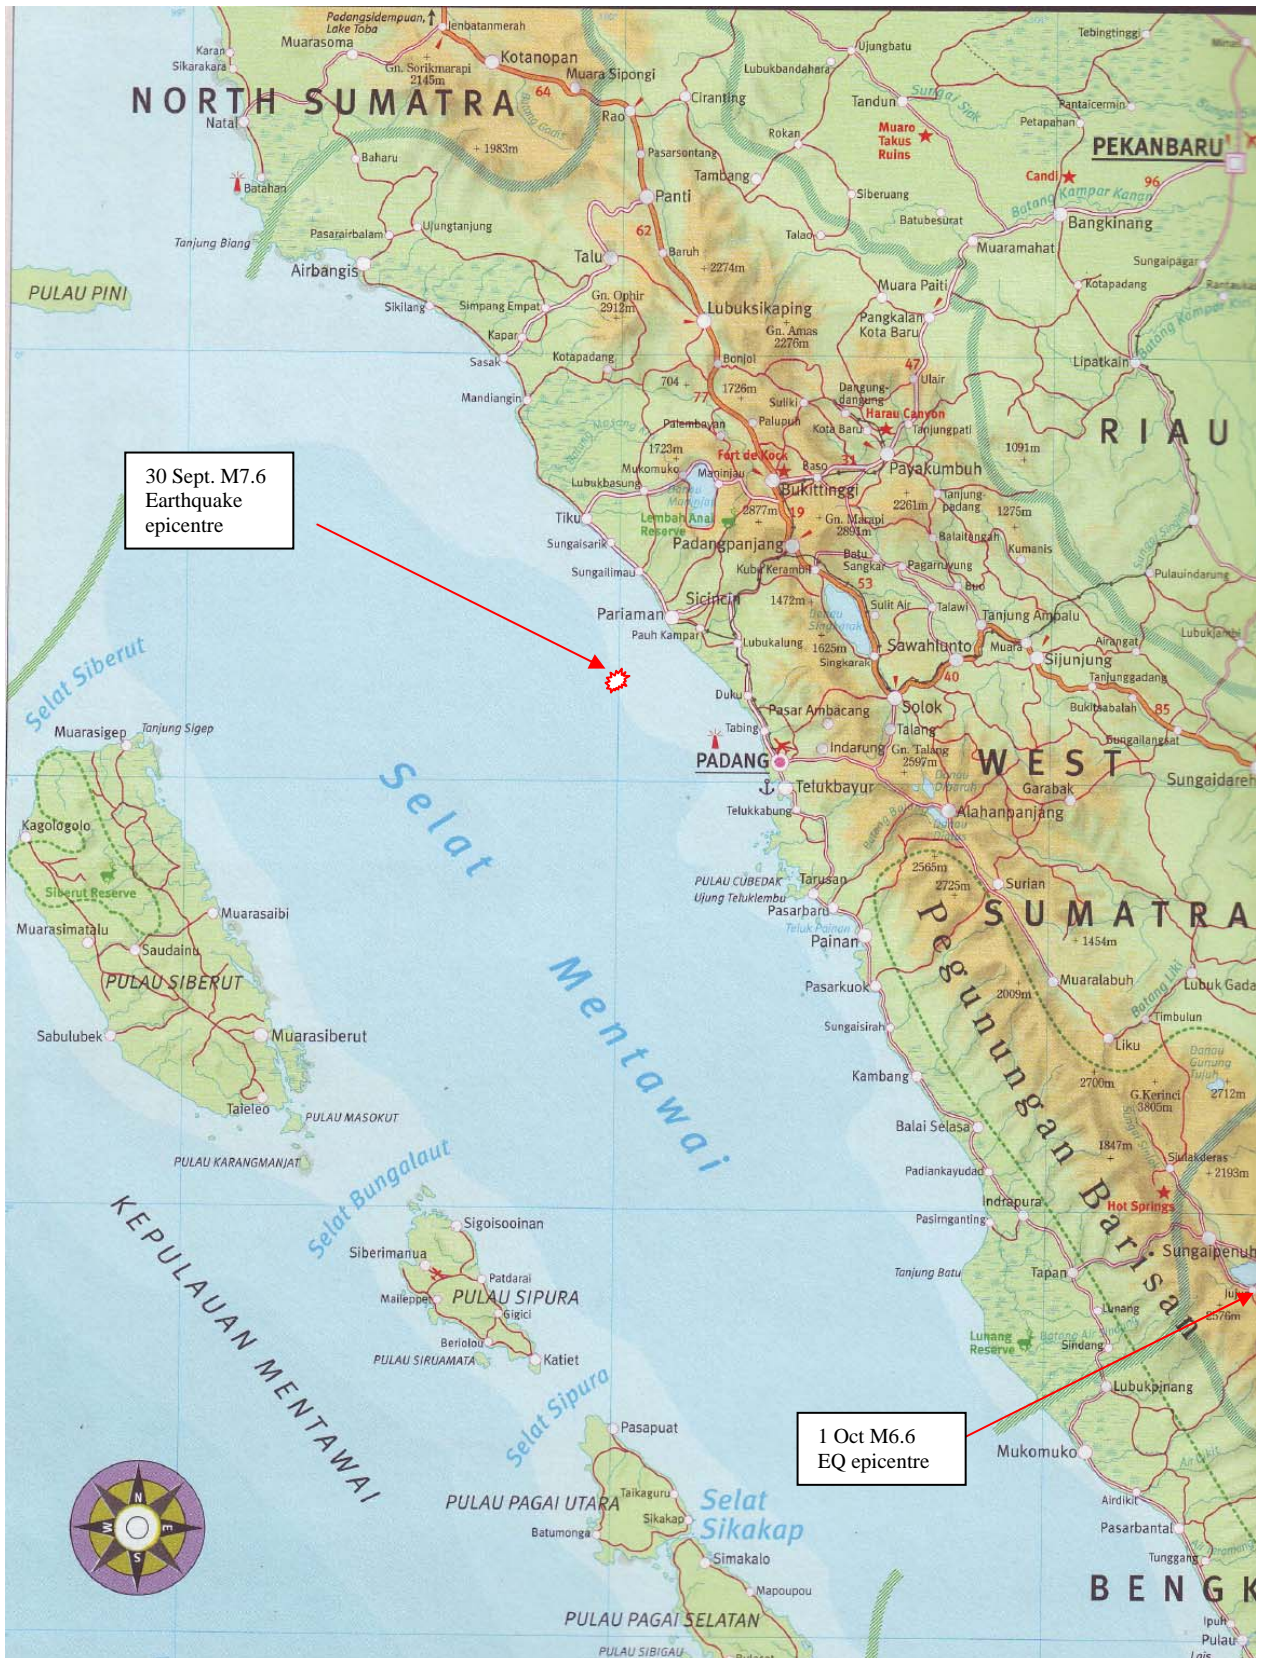
Figure 8. Relief map of the earthquake area. The lineament of the Great Sumatran Fault can be followed from Sungaipenuh in the south, through Liku, Muaralabuh, Surian, Solok, Lake Singkarak, Padangpanjang, Bukittinggi, Lubuksikaping, Panti.

Padang is located on a coastal strip of geologically sediments which have been deposited by rivers with their source in the volcanic mountains to the east (Figure 8). These rivers meander across the low-lying coastal strip, depositing fine-grained sediments and in places forming swampy ground, over which the city of Padang has now spread. The accumulated deep soils of the swampy coastal strip are likely to be classed as D (deep or soft soil sites) and E (very soft soil sites) in terms of NZS 1170.5 2004. News reports from Padang after the earthquake suggest that there may have been both liquefaction and ground amplification of the seismic waves - which were particularly damaging to taller buildings, with a longer natural period? Eye witnesses are describing visible ground waves from the earthquake.
