# Beam-column joint tests with grade 500E reinforcing

**2004 NZSEE  
Conference**

**ABSTRACT:** A database of beam-column joint test results has been assembled and analysed to determine appropriate design drift limits for the prevention of bond failure in reinforced concrete frames. In order to enhance the coverage of the database for units in which higher grade reinforcement with bar diameters in excess of 16mm were used, further beam-column joints have been designed at the University of Auckland using 25 mm beam reinforcement. The result of the first of these tests is reported. Despite not meeting the requirements of the recent amendment to NZS 3101:1995 with respect to column depth, the unit did not exhibit a bond failure in the joint region.

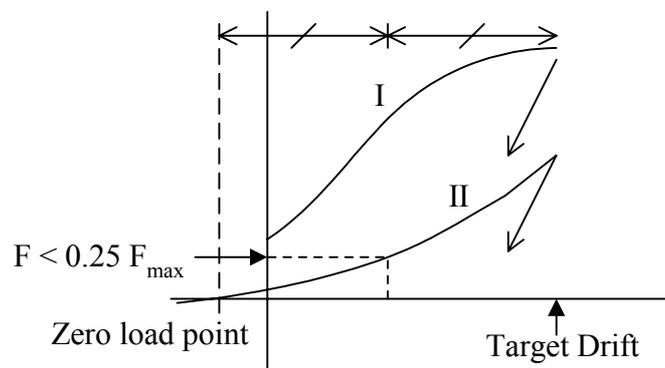
Bond failure was assumed to have occurred if the load sustained at a target drift was less than 25% of the maximum value when the drift was half way between the target drift and a position of zero load (see Figure 1). The failure was assumed to have taken place at the peak drift of the previous cycle. To recognize the superior performance of cases where a unit sustained a drift level several times before bond failure occurred, 0.25% was added to the failure drift (drift limit) for each successful half cycle to the same peak displacement before bond failure.

**Figure 1** Criteria used to determine occurrence of bond failure.

It was thought likely that bond failure occurred at an earlier stage than that where strength loss was noted. This assumption was accounted for by defining a “modified drift limit” as equal to the drift limit from above divided by one plus the proportion of strength lost. Use of the modified drift limit reduced the scatter of plots relating drift limits to other variables.

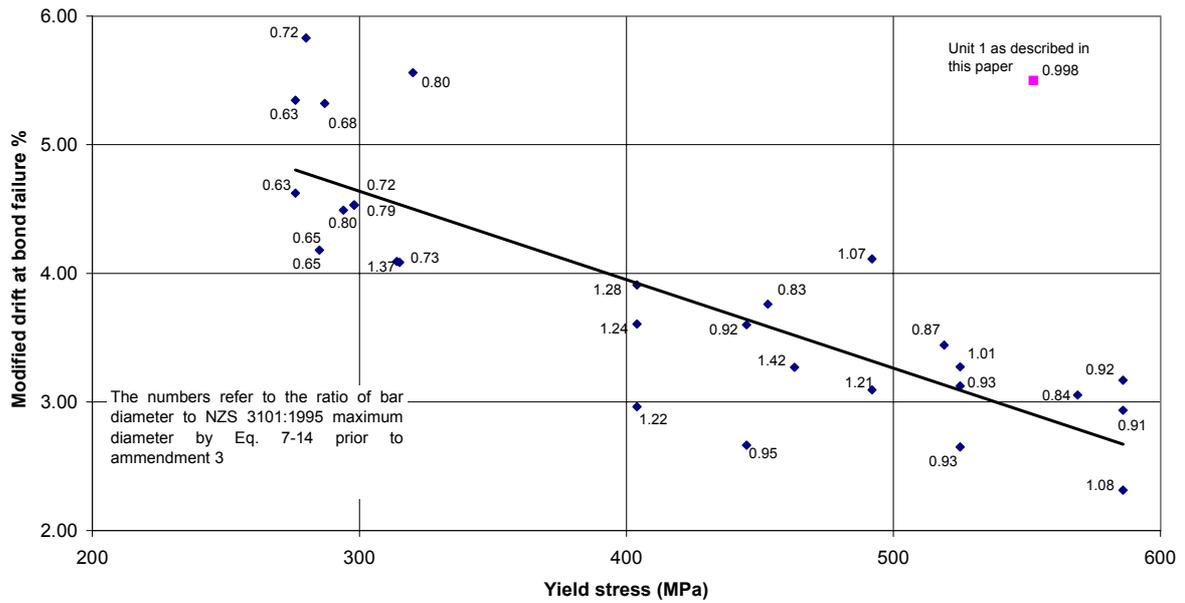
It is evident from **Figure 2** that there is a strong correlation between the modified drift limit and the yield stress. It is noted that for the tests using higher grade reinforcement the ratio of bar size used in the test to the maximum bar size allowed by NZS 3101:1995 (numbers by data points) increased with reinforcement grade. This can be attributed to the relaxation of the bond criterion in the standard around the time grade 430 reinforcing steel was introduced.

Figure 2 Modified drift at bond failure versus yield stress of reinforcement.

By plotting modified drift at bond failure multiplied by the square root of the ratio of actual bar size to allowable bar size against yield stress (see **Figure 3**) design values of allowable drift can be assessed. If the maximum permitted bar diameter to be used (i.e.  $d_{ba}/d_{bc} = 1.0$ ) the average value of modified drift at bond failure can be determined. For grade 500 reinforcing ( $f_{y \text{ average}} \sim 550$  MPa) the value is 3.1%, with a standard deviation of 0.47%. Similarly, for grade 300 steel ( $f_{y \text{ average}} = 320$  MPa) the value is 4.7%, standard deviation 0.55%. The data from the unit described in this paper is shown on both **Figure 2** & **Figure 3**, but was not included in the analyses based on these figures.

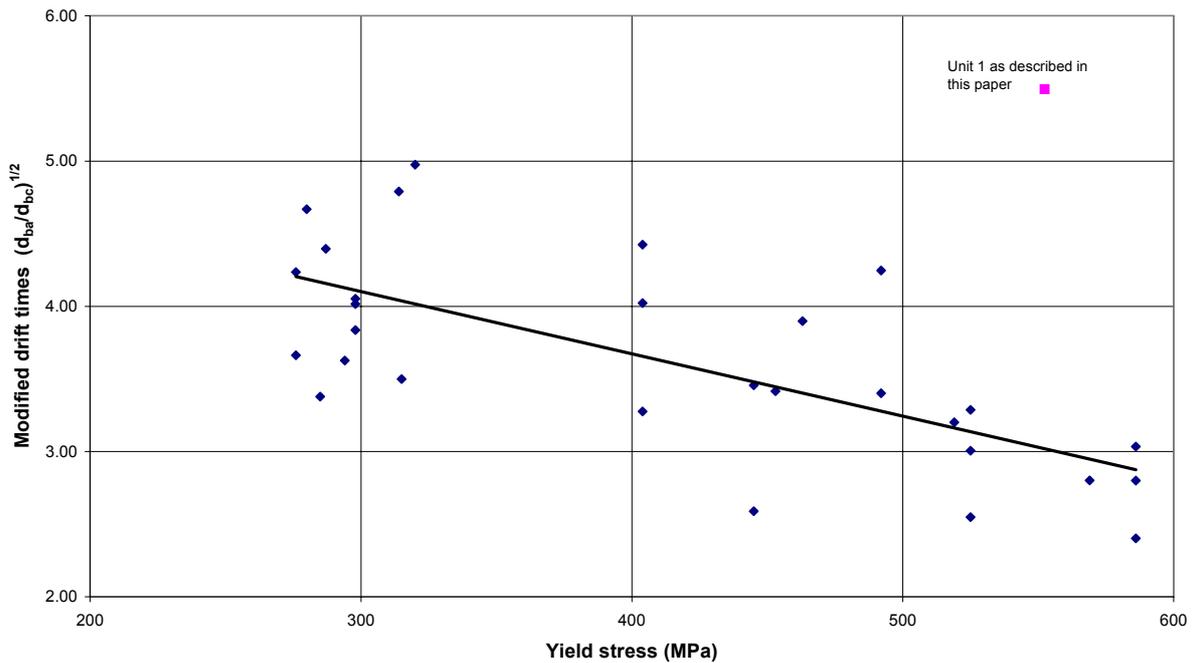
Figure 3 Modified drift at bond failure \*  $(d_{ba}/d_{bc})^{1/2}$  versus yield stress.

For a 90% probability that bond failure will not occur in the ultimate limit state, the drift limits for the two grades of reinforcing are reduced to (Fenwick and Megget 2003):

- 3.5% drift for Grade 300 reinforcement
- 2.5% drift for Grade 500 reinforcement.

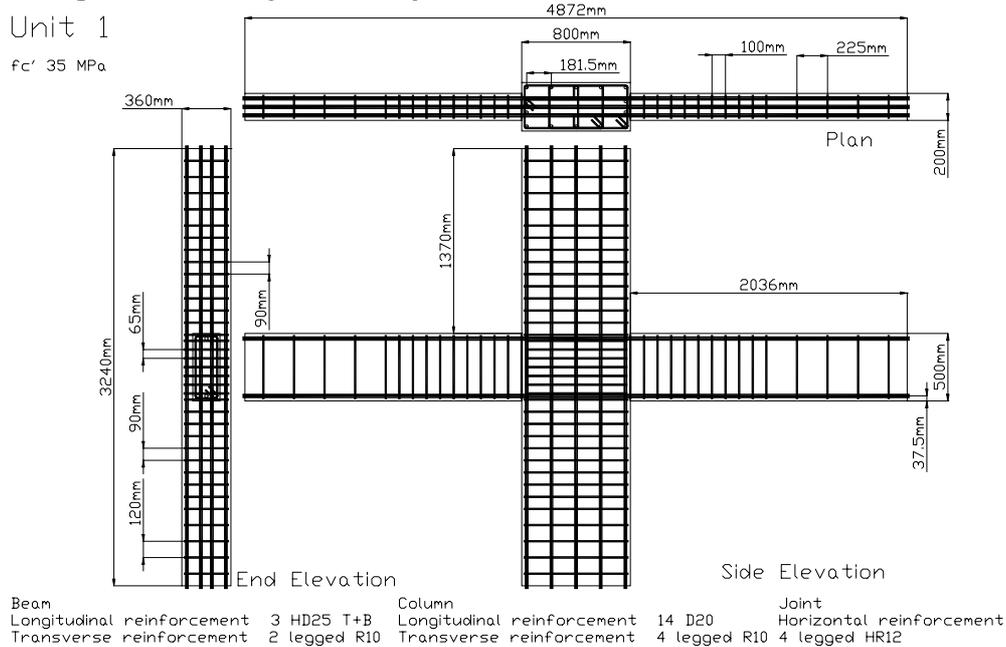
**Figure 4 Principal dimensions and reinforcement plan of unit 1B (Brooke)**

Where possible dimensions were kept the same as those used by Young (Young 1998) and Megget et al. (Megget et al. 2003). The beam dimensions were 500 mm deep and 200 mm wide. The columns were 360 mm wide, and the column depths were determined by bond strength requirements. Using 3 HD25 reinforcing bars gave a reinforcement ratio ( $A_s/bd$ ) of 1.6 %. For unit 1B this was greater than the maximum ratio of 1.5% allowed by NZS 3101:1995. For units two and three, the higher target concrete strengths allow higher reinforcement ratios (2% and 2.67% respectively). Details of unit 1B can be seen in **Figure 4**, and design details of the units tested by Young (1998) and Megget et al. (2003) are summarised in Table 2. Note that bond failure occurred in all these four units at 4.5% drift or less.

In order to fill the gaps in the database of beam-column test results, four further tests are being undertaken at the University of Auckland. Three of these units have been designed, and the first has been built and tested. The beam longitudinal reinforcement for the first three units is to be kept constant as 3 HD25 bars top and bottom, while the target compressive strength of the concrete selected was 35, 50 and 70 MPa for units one, two and three respectively. Except where it was impractical to do so, the units are designed to comply with the New Zealand concrete design standard (NZS 3101 1995), including amendments up to February 2004.

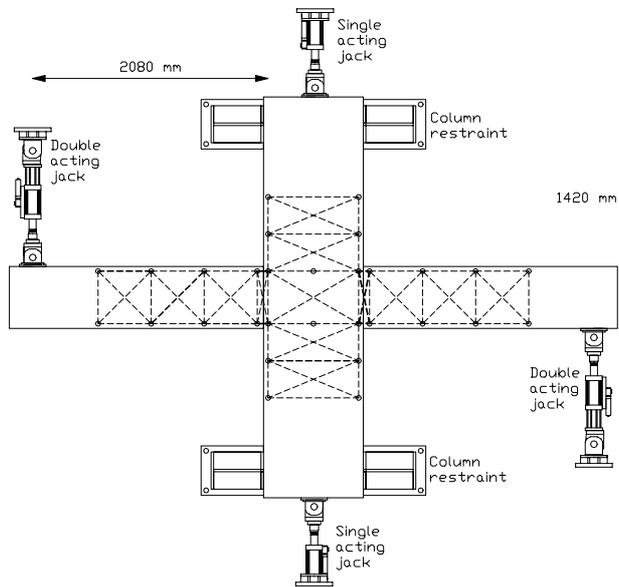
**Figure 5 Portal gauge layout and loading arrangement for unit 1B.**

The unit was instrumented extensively with portal displacement gauges as shown in **Figure 5**. Displacement at the load point was measured using turnpot gauges.

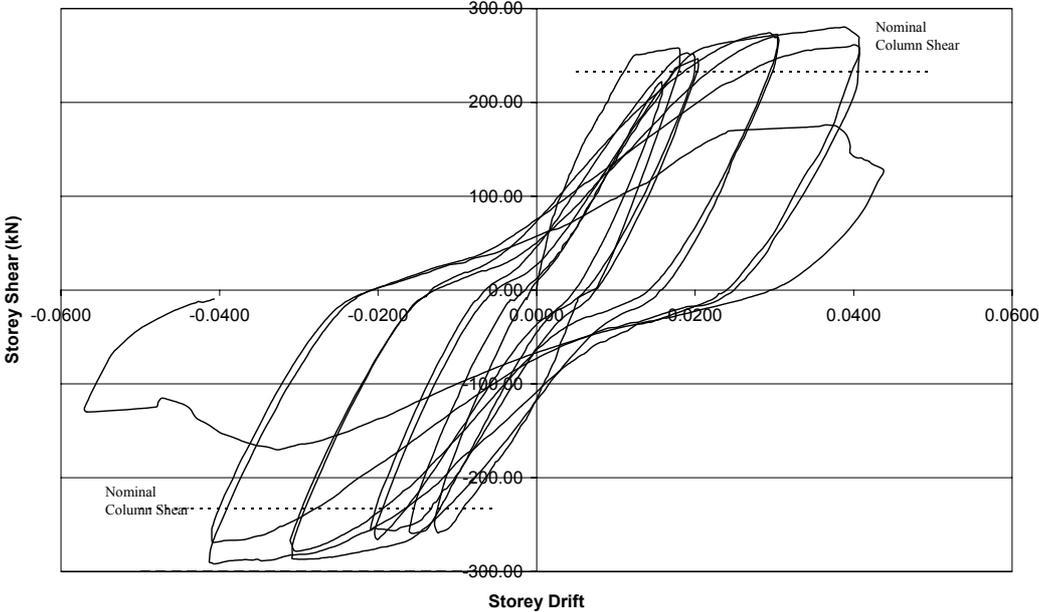
When compared to the nominal column shear force, i.e. the column shear force calculated to occur when the beams develop their nominal moment capacity, the yield strength of unit 1 was reasonably close to that calculated using actual material properties (see **Figure 6**).

**Figure 6 Unit 1B storey column shear versus storey lateral drift.**

completed in both loading directions. Problems were encountered with the test setup during the first semi cycle. These caused the applied load to exceed the yield load, and a decision was made to load the unit in the other direction to a displacement equal to that reached in the first direction (see **Figure 6**). Following this “elastic” cycle, double reversing cycles to 1.5%, 2%, 3% and 4% lateral drift were applied, continuing until a significant drop in strength occurred.

From the first semi-cycles of the test it was determined that the yield lateral drift of the unit was approximately 1.27%. This value was approximately in agreement with the value of 1.35% predicted using methods presented by Priestley (Priestley 1998). Using standard moment-area theory and the deformations measured on the beam alone it is straightforward to evaluate the effective moment of inertia of the beams based on the force and displacement at yield, and assuming a linear force-displacement relationship up to first yield. The ratio of effective to gross moment of area is

Testing was halted when the primary longitudinal reinforcement of both beams buckled during the first complete cycle to 5% lateral drift. Therefore, the maximum drift achieved before strength dropped below 80% of the previous maximum was 4%, and the ductility achieved was  $\mu = 3.14$  based on a yield drift of 1.27%. It is noted that the final drift level considerably exceeds the maximum allowable drift in NZS 4203 (NZS 4203 1992), AS/NZS 1170 (AS/NZS 1170.4 2003) and over-seas codes of practice (Fenwick et al. 2002).
