Seismic performance of non-structural elements within buildings

H. Ferner, M. Wemyss, A. Baird & A. Beer

Beca Ltd, Auckland, New Zealand.

2014 NZSEE
Conference

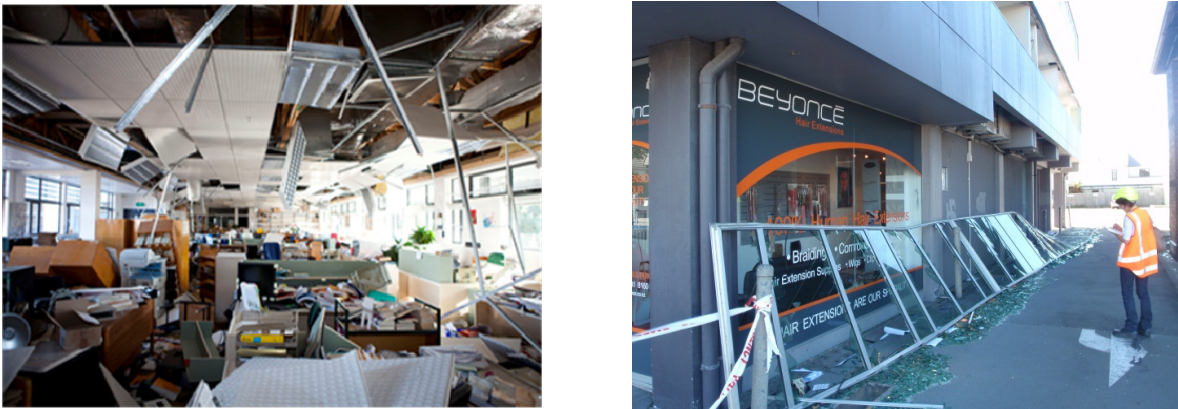
Figure 1. Widespread damage to a ceiling system (left), failure of a lightweight cladding system (right)

The recent earthquakes have highlighted that while New Zealand has a requirement to brace non-structural elements for seismic loads, this may not be happening consistently resulting in damage. Anecdotal evidence suggests recent construction includes buildings built without effective restraint systems or in some cases without restraint systems installed at all.
